ARCHIVES
of
FOUNDRY ENGINEERING

The Reasons of Steam Pipeline Elbow Rupture

A. Mesjasz ^{*a}, J. Piątkowski ^b^a GE Power – Joint Stock Company, Stoczniowa 2, 82-300 Elbląg, Poland^b Silesian University of Technology, Faculty of Materials Science, Krasińskiego 8, 40-019 Katowice, Poland

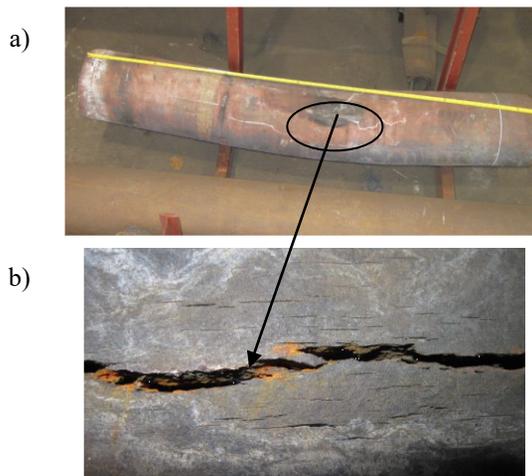
The photo of the steam pipeline elbow and the crack is being shown on the Figure 1.

Fig. 1. Pipeline elbow subjected to testing: a) overview; b) the elbow's crack area

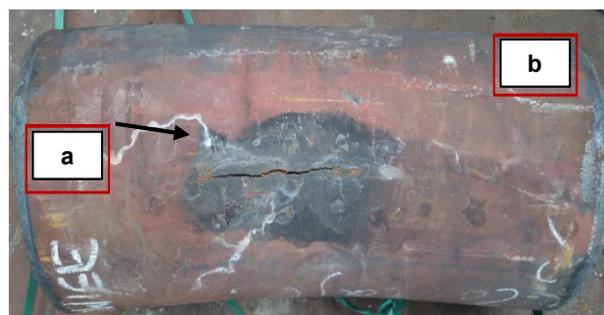
Fig. 2. (a, b) The areas from which samples were taken for mechanical properties testing: a) damaged area, b) not damaged area

Out of the data shown in the Tables 3-6 comes, that the 13CrMo4-5 steel material sampled from the place where crack occurs has lower yield strength $R_{p0.2}$ and $R_{p0.2}^{500C}$ of about 2%

from the requirement for the same steel in it's base state as per the standard PN-74/H-74252. The material sampled from the area without any internal damages complies with the requirement of mentioned above standard.

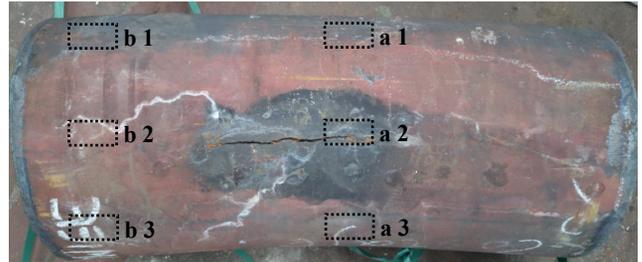
Fig. 3. The sampling places for representative samples for micro structure testing: a) damaged area, b) not damaged area

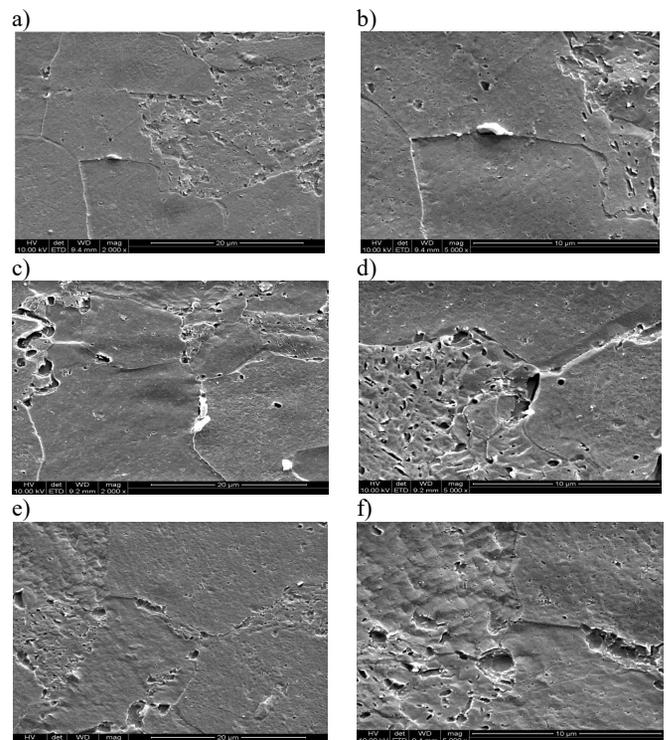
Fig. 4. The microstructure of the tested pipeline's elbow, from the area without the damage: a and b) area b1; c and d) area b2; e and f) area b3 with different magnitudes

Out of the micro structure tests it comes, that in the not damaged areas the structure depletion is the same as in the base material, and the changes are on the level I (Table 1) what equals to partial decomposition of bainite/perlite areas. In the areas where the damage was observed, the structure depletion level is B/1, and the micro structure changes are on the level I/II, what equals to decomposition of bainite/perlite secretions, and carbide balling, with distinctive micro-cracks net.

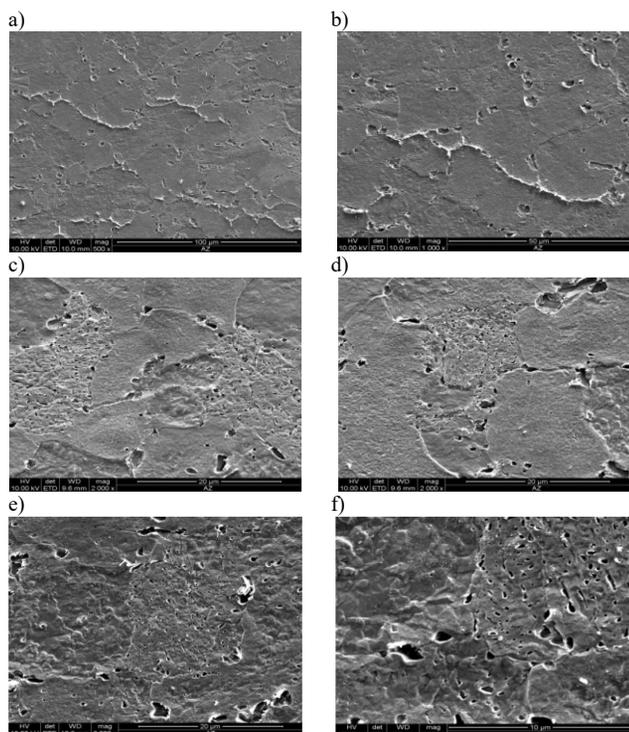
Fig. 5. The microstructure of the tested pipeline's elbow, from the area with the damage: a and b) area a1; c and d) area a2; e and f) area a3 with different magnitudes

The conducted tests proved, that the pipeline's elbow rupture happened as a result of complex tension system, which substantially exceeds the admissible tensions. One of the degradation factors was the natural and at the same time – considerable structure damage level, notes both in the damaged area (areas: a1; a2; a3) and outside the damaged area (areas b1; b2; b3).

On the basis of the conducted tests it may be stated, that the exploitation of the tested pipeline can be continued with maintaining certain exploitation regimes, with special consideration for pipeline's material temperature increase, which should not exceed 490°C. In the balance exploitation time, the use of the pipeline should be limited to minimum.

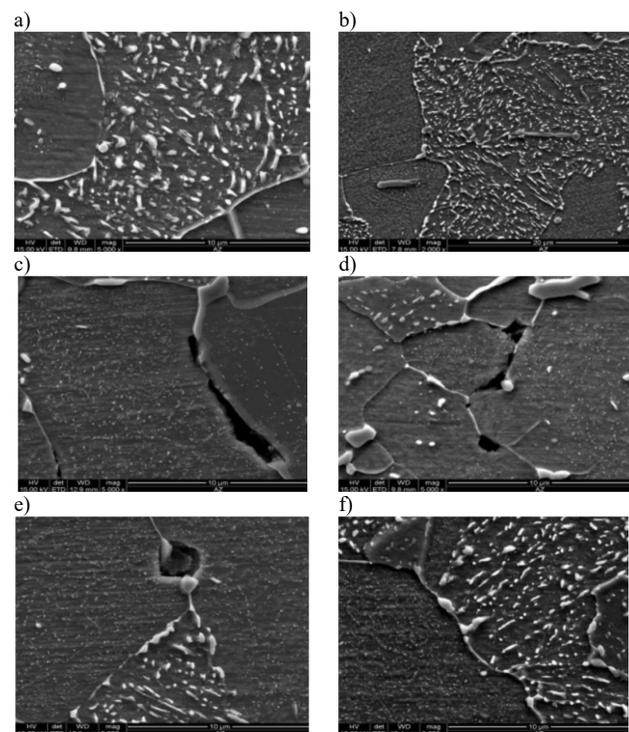
The SEM micro structures of the areas without damage and of those with damages are shown on the Figure 6.

Fig. 6. The microstructure of the tested pipeline's elbow: a, c, e) of the area without the damage, b, d, f) of the area with the damage
