STANISŁAW BARYCZ*, KAROL FIREK*, WOJCIECH KOCOT*,
AGNIESZKA MALINOWSKA*

THE EFFECT OF PREVENTIVE CONSERVATION MEASURES ON THE TECHNICAL CONDITION OF A RELIGIOUS BUILDING LOCATED IN THE MINING AREA

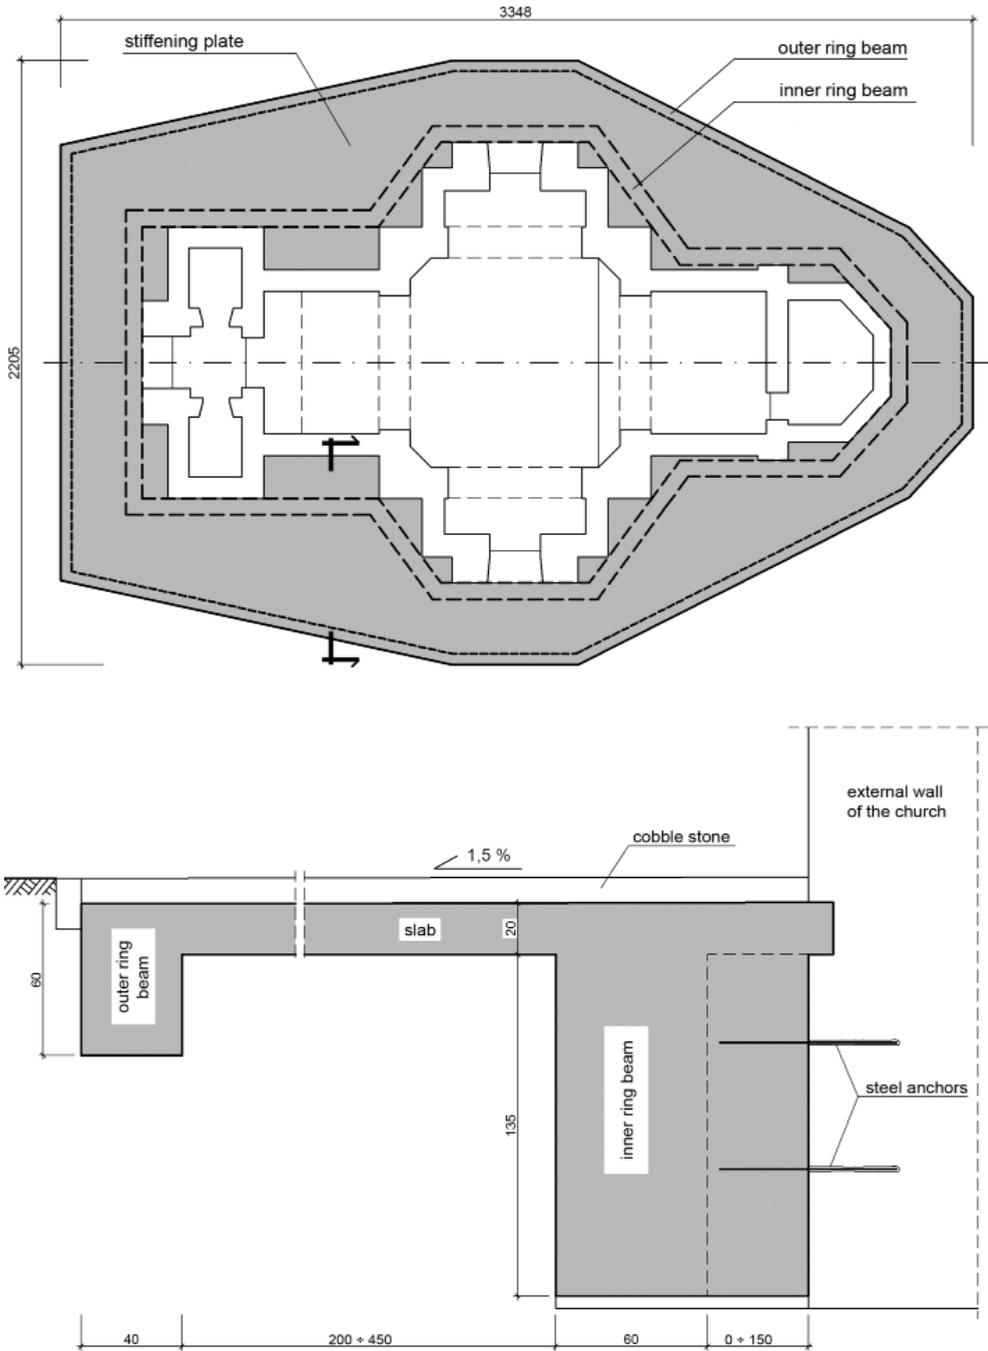
Fig. 4. Scheme of preventive conservation of the structure with reinforced concrete stiffening plate – a horizontal projection and cross section of the stiffening plate.
 Source: Own study based on Szczepaniak and Wach, 2002

The task of the plate was to receive all the horizontal surface deformations and to ensure geometric invariance of the horizontal projection of the building at the ground level. The plate was designed as a wide reinforced concrete band embracing the whole projection of the church building and a directly adjacent to the external walls. The plate was composed of three basic elements combined into one monolithic whole (Fig. 4):

- reinforced concrete slab, 20 cm thick,
- inner reinforced concrete ring beam with cross-sectional dimensions of 60×155 cm,
- outer reinforced concrete perimeter ring beam with cross-sectional dimensions of 40×60 cm.

In the sections where the inner reinforced concrete ring beam runs at a certain distance from the wall (e.g. in the inner corners), the space between it and the foundation wall was filled with concrete during the concreting of the ring beam. Therefore, the inner ring beam (or the concrete spacer) adheres tightly to the foundation walls of the structure, at their entire height. In addition to the concrete adhesion to the masonry wall, the connection of the ring beam with the foundation walls is ensured by steel anchors $\phi 20$ mm, embedded in these walls every 0.5 m. Due to its considerable structural height and the resulting rigidity, the inner ring beam also stiffens the structure in the vertical direction, thus partially protecting it as a whole against deformation resulting from the curvature of the area. The outer edge of the plate is stiffened with a perimeter ring beam, which in a plan has the shape of a convex polygon. To execute all the elements of the plate, concrete B20 was used, with F100 degree of frost resistance and W4 water resistance, as well as stainless steel of A-II class and 18G2 type.

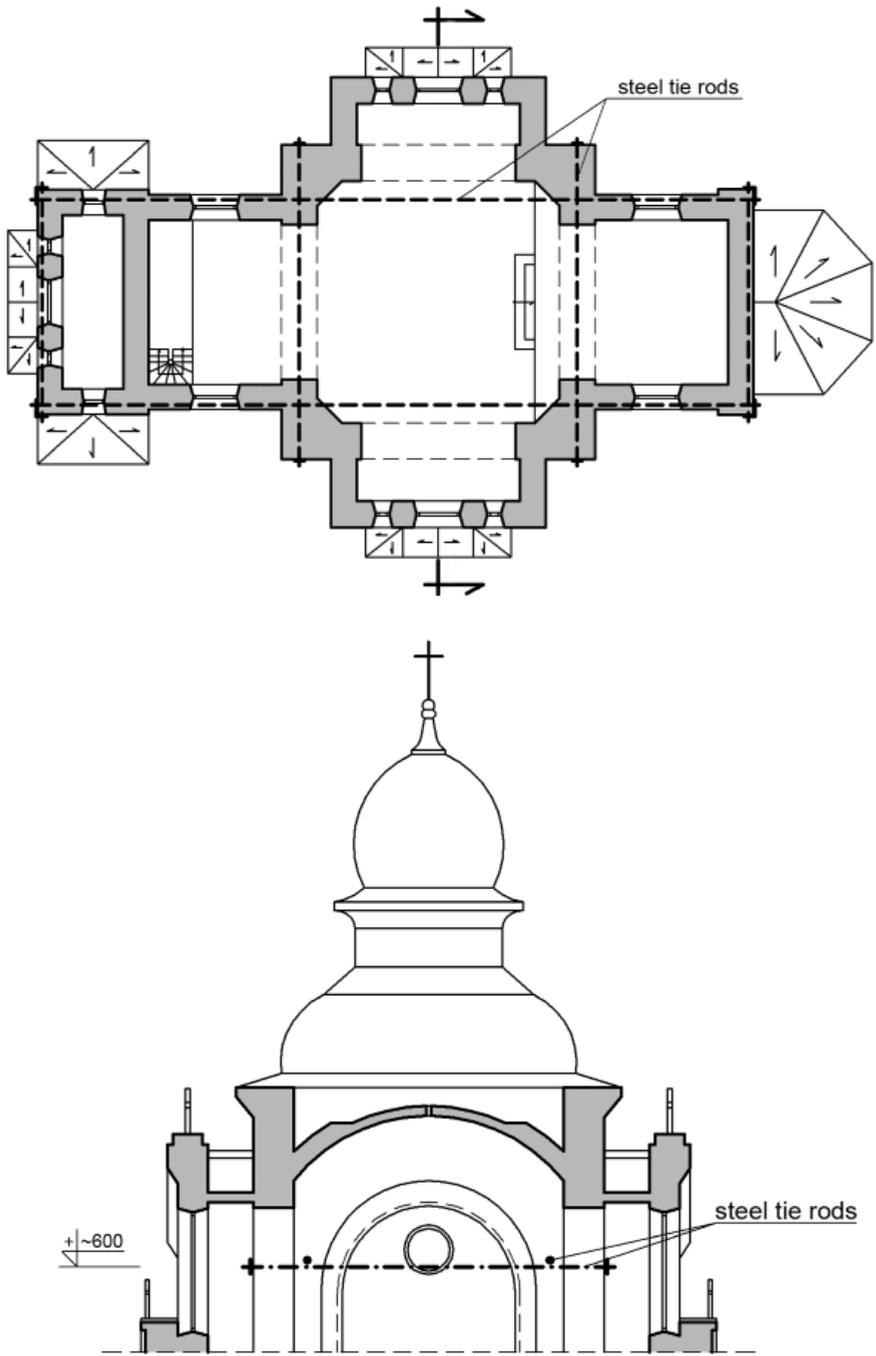
Fig. 5. Arrangement scheme of steel tie rods (anchoring) at the level of +6.00 m – a horizontal projection and cross section of the stiffening plate.

To ensure invariable support for the vault arches construction of the roofing, anchoring of the walls was used (Fig. 5). For this purpose, on the outer side of the walls at the level of +6.00 m, steel tie rods $\phi 30$ mm in grooves were mounted. The nave with the bell tower, the central part (without the extreme parts of the transept) and the chancel were secured by this system.

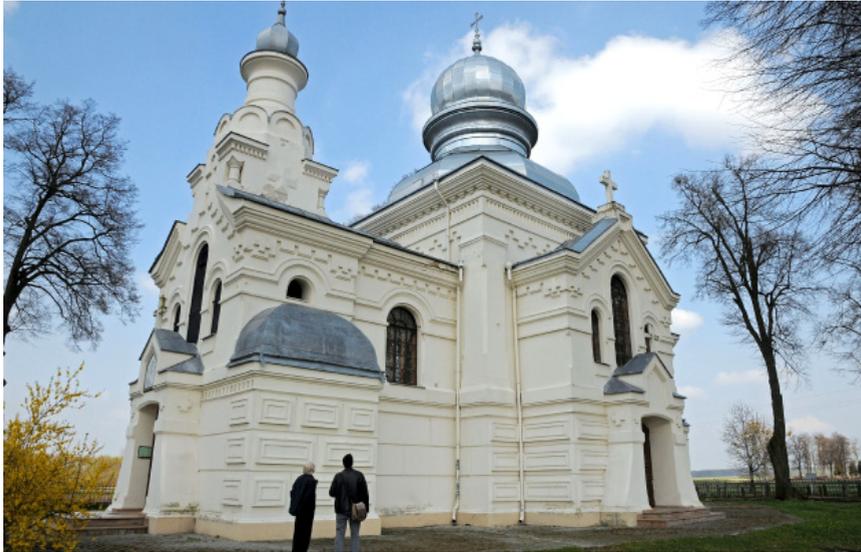
Fig. 6. The Orthodox Church in Dratów (as of 2014), the view from the south.
Source: Own study

There were no cracks found in the facade, which was renovated after the completion of the preventive conservation works. Few scratches of the window lintels, occurring before the renovation, did not renew themselves. The only damage, currently visible from the outside, are local shrinkage scratches of the plaster of irregular course, as well as local dampness and corrosion of the plaster caused by inaccurate performance of roofing and flashing works. The overall condition of the object was assessed as fair (in a 6-point scale – Wodyński, 2007).

All the conservation works were carried out in late 2002 and early 2003, based on the technical project (Szczepaniak and Wach, 2002), prepared pursuant to the concept presented in (Barycz et al., 2002). After the completion of the works, a thorough renovation of the facade of the building was carried out, together with replacement of the roofing, guttering and flashing (Fig. 6).

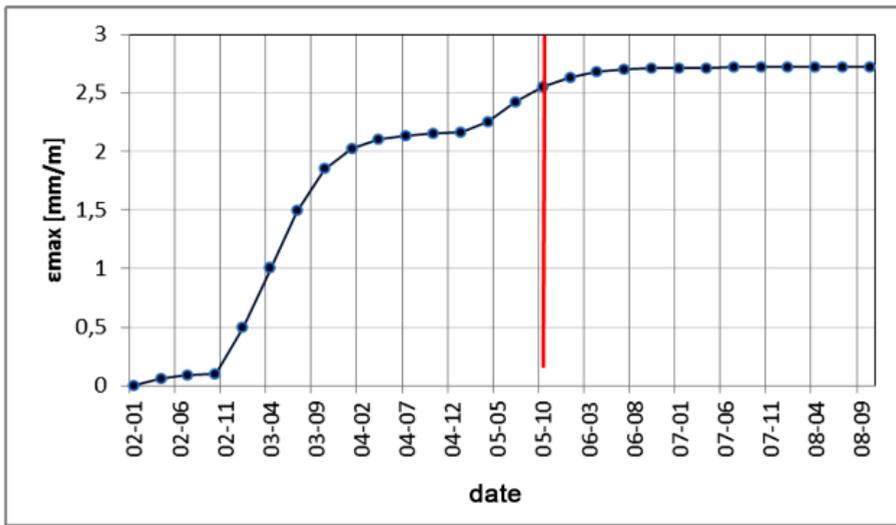
The analysis of continuous surface deformations in time showed that in the period from November 2002 to October 2005 the dynamics of displacement field under the church was the largest (Fig. 9).

When analyzing the values of maximum ratios of the surface deformation that occurred under the church building, it should be noted that the maximum subsidence reached 0.5 meters (cf. Tab. 1). The maximum slope of the ground surface under the church building was $T_{max} = 3.67$ mm/m. The direction of the maximum slope was in line with the x-axis (the horizontal axis in a mathematical coordinate system). The maximum tensile loads of the area surface occurred at about 300 meters to the outside of the exploitation field. It was the area located west of the church building. Therefore, larger tensile loads occurred around the western part of the structure (calculation points K1 and K4). Horizontal strains reached the maximum of $\varepsilon_{max} = 2.86$ mm/m. The direction of the maximum main strains was deflected by 15 gon relative to the direction of the x-axis. The angle of the church axis relative to the direction of the x-axis was 42 gon. Maximum directional strains are tensile strains, which were $\varepsilon_{alfa} = 2.66$ mm/m. The direction of the main strains was similar to the direction of the longitudinal axis of the structure.

Fig. 9. Development of horizontal deformations at the point K2 in time.

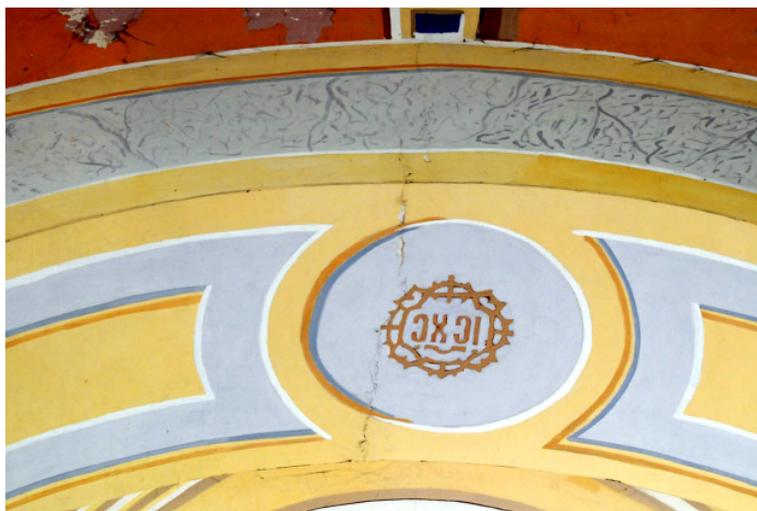
Since the interior of the building had not been renovated, a comparison of the status quo with the condition observed in 2001 was made. Detailed examination revealed the existence of exactly the same damage as before. These included scratches and minor cracks of the arches (buttresses) crowning the chancel, of the nave and the transept, as well as of the lintel bows over window and door openings. Their width usually did not exceed 0.5 mm, and only in two cases it reached 1 mm (e.g. Fig. 10, 11). Scratches of the lintels over side entrances to the church (in the transept gable walls) run up until they reach the window openings located above. Inside the building, traces of dampness of the walls, exfoliation of paint coatings and corrosion of plaster occurring in the places of leaks (mostly old) caused by the leaking roof were found. It should be emphasized that there were no new cracks or scratches, and the width of the existing ones remained unchanged.

Fig. 10. Scratches of the arch crowning the nave from the side of the main entrance (unchanged).
Source: Own study

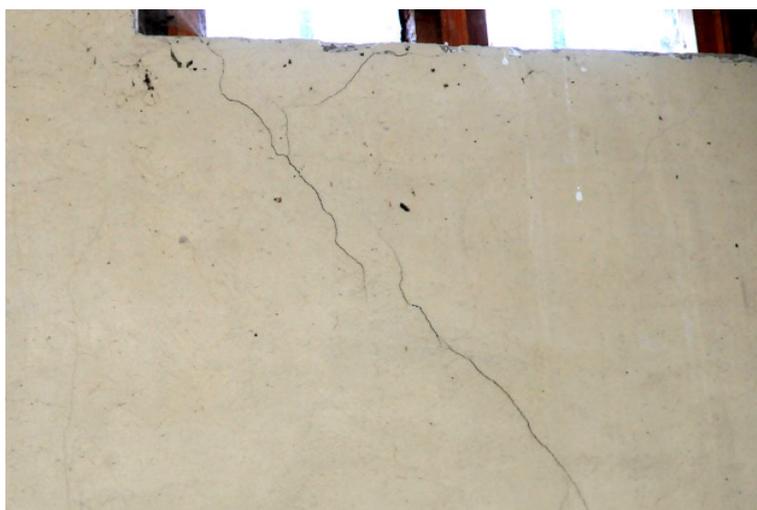
Fig. 11. A scratch, 1 mm wide (the largest in the building) extending from the door lintel to the window above the western entrance (unchanged).
Source: Own study

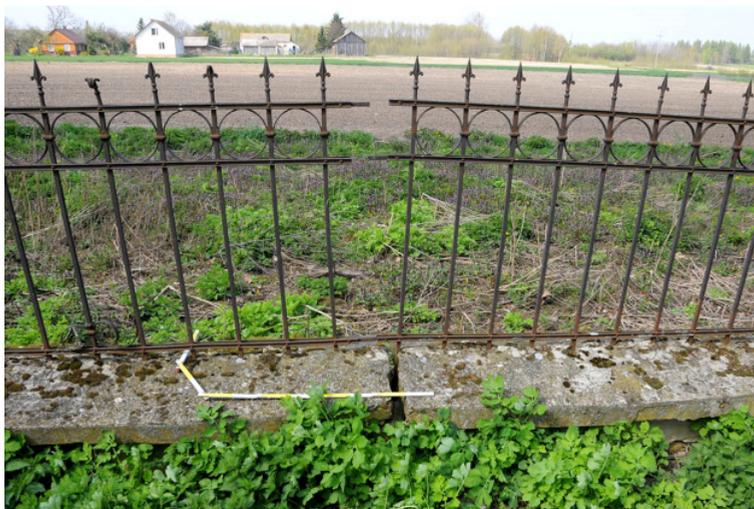
During the on-site inspection, evidence was found demonstrating the occurrence of mining impacts in the area. They resulted in significant cracks of structural elements of the fence

around the building, both in its brick and stone foundations and in steel elements above the ground (e.g. Fig. 12). It may be argued that in the event of a failure to carry out preventive conservation works, or in the case of a less decisive action in this regard, the walls and vaults of the church building would crack as well.

Fig. 12. One of the cracks in the construction of the fence around the church building on the north-east side (present situation).
