# The role of structural analyses and queries in recognizing damage causes and selecting remedies in historic buildings: case of the Dominican monastery in Lublin

Anna Halicka<sup>1</sup>, Anna Ostańska<sup>2</sup>

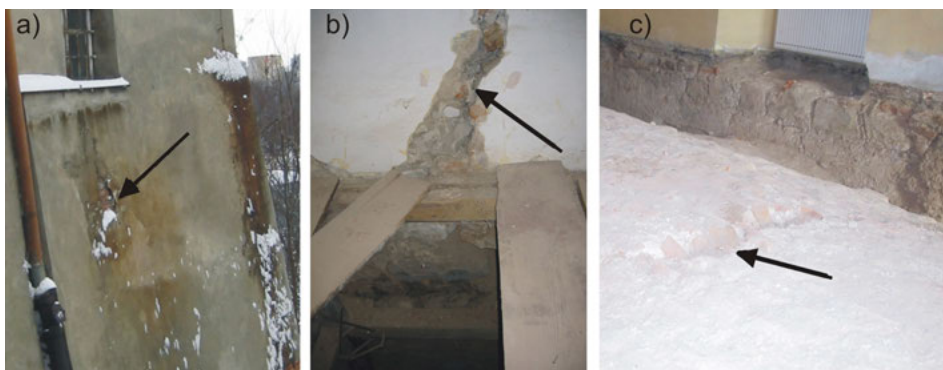
Strong damage emerged in the monastery's south-east corner: several wide cracks crossing the whole masonry width (the example is shown in Fig. 3a and Fig. 3b) as well as bursting and cracking of the vaults above the ground and first floors which were the continuation of wall cracks (Fig. 3c).

Fig. 3. Examples of cracks in the south-east corner of the monastery: a) and b) the same crack in the south wall photographed from the outside and inside, c) burst of the barrel vault above the ground floor

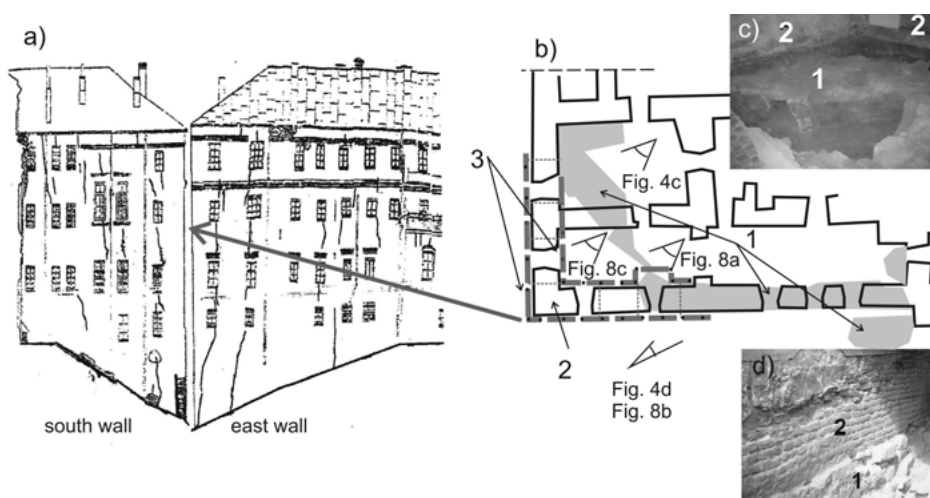
During the works aimed to strengthen the building's foundation zone, medieval limestone masonry was uncovered. This medieval masonry constitutes the foundation in the long section of the building (Fig. 4b, Fig. 4d). Its character varies in different sections: beginning with rubble work, *via* a layered wall (outer layers from regularly placed limestone elements and rubble work inside) up to uniform limestone masonry. In the corner, the course of the wall from the 17<sup>th</sup> century and the course of the medieval masonry do not overlap. The medieval masonry is located inside the building. It is probably the “missing” part of the town wall (Fig. 4b, Fig. 4c).

Fig. 4. South-east corner of the monastery: a) crack pattern of the corner, b) course of the medieval walls uncovered during structural restoration works and the course of the applied supporting structures, c) uncovered medieval wall inside the building, d) uncovered medieval outer wall. Numbers indicate the following: 1 – medieval wall, 2 – wall from the 17<sup>th</sup> century, 3 – course of the underground micropiled structure strengthening the foundation, introduced during structural restoration works

To conclude, the outer wall was founded in a non-uniform manner – virtually the full length of the wall stands on the medieval wall, whereas the corner of the structure was founded directly on the subsoil. It should be emphasized that the corner was founded 3.0–4.0 meters deeper than the medieval wall. It stands on the top of a loess layer. Above the loess layer, up to the level of the ground floor, outside and inside of the building, a layer of uncompacted embankment was revealed. The characteristic feature of loess is that after soaking its strength drops and strain rapidly grows. Water infiltrated to the loess under the corner wall via the embankment, which resulted in the corner's settlement. This in turn caused the shear of the wall above the zone where of the foundation's condition varied (Fig. 3, Fig. 4a). This entailed the bursting and cracking of vaults.

The south-east corner (Sec. 3.1) was supported on the reinforced concrete micropiled structure, hidden in the soil. The decision was motivated by the fact that the repeated measurement of the cracks' width proved that they were not stabilized. The corner and the zone where walls take course outside the town wall were connected by two reinforced concrete underground beams joined via the historic wall with tensioned tendons [25]. The beams were supported with micropiles (Fig. 4b, Fig. 8a, Fig. 8b).

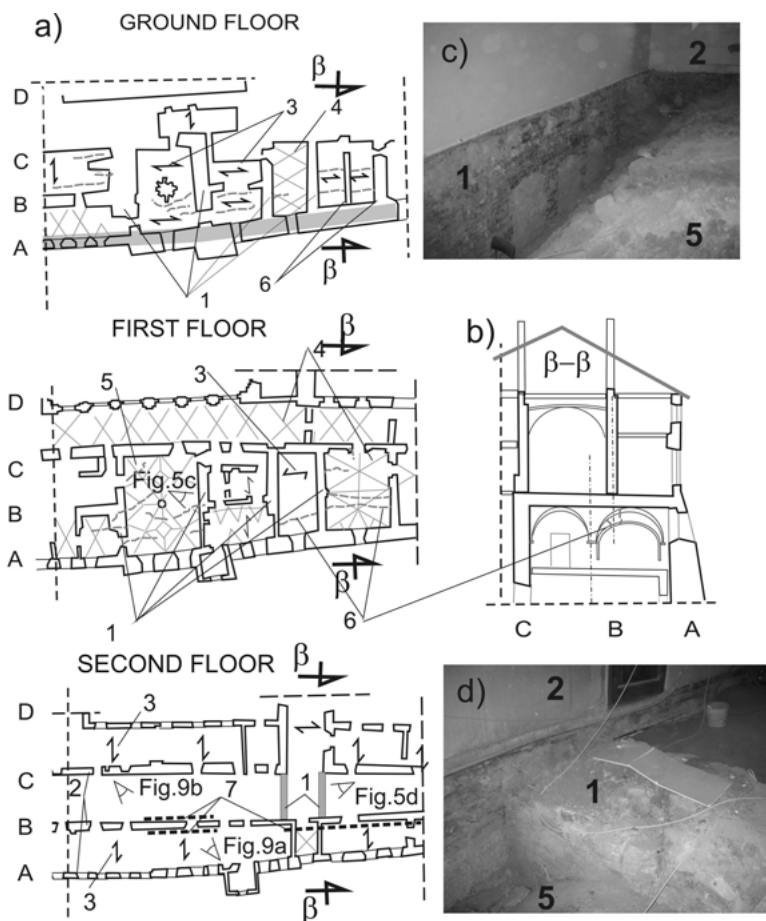
Fig. 5. Analysis of the load-carrying system of the monastery's east wing: a) horizontal projections of the ground, first and second floors with crack pattern b) cross-section of the building, c) wall with openings uncovered during the ground floor vault restoration, d) upper edge of the transverse wall uncovered during the restoration of vaults above the first floor. Numbers indicate the following: 1 – transverse load-carrying walls in the basement and first floor and their upper edge uncovered in the second floor, 2 – parallel load-carrying wall from the 17th century, 3 – arrows indicating the direction of barrel vaults load bearing, 4 – cross vault, 5 – lierne vaults, 6 – cracks of the vault loaded with longitudinal wall, 7 – course of steel frames supporting the ceiling introduced during structural restoration works

This may suggest that the transverse walls between “A” and “C” axes in the ground and first floor (see Fig. 5) are remnants of older buildings adjacent to the town wall, which were incorporated into the monastery in the 17<sup>th</sup> century. It should be emphasized that the existence of these buildings was unclear earlier and only the rehabilitation works confirmed their presence. They were uncovered during a temporary removal of backfill from vaults.

Fig. 5c shows the remnants of the building (a transverse wall with openings) uncovered during the basement vault’s restoration. Fig. 5d shows the upper edge of the transverse wall uncovered in the second floor. These remnants were recognized by the researcher of architectural heritage to be the walls of a medieval tower [26].

In Fig. 5, the pattern of cracks in vaults above the ground and first floor is shown with a broken gray line. The cracks are parallel to the longitudinal walls. This allows to deduce that the differential settlement of longitudinal and transverse (loaded with heavy vaults) walls was the cause of cracking of vaults and walls.

The analysis of projections shown in Fig. 5 indicates that the builders not only incorporated the older buildings between “A” and “C” axes into the structure, but also added a new part between “C” and “D” axes. In this location, they arranged the vaults supported on the longitudinal walls. The ceilings above the second and third floor are supported on the longitudinal walls as well. What is more, the wall in “B” axis runs above certain vaults and is supported on flat arches arranged on its bottom edge. However, with the passage of time, one of the arches settled and loaded the vault. This resulted in vault cracking right below the wall (the cracks are marked in Fig. 5 with number 6).

The rehabilitation design scheduled a change in timber ceilings above the second and third floor into fire-resistant ones, replacement of the roof's steel sheets with ceramic tiles, and the adaptation of the unused space under the roof for dwelling purposes. All these changes were connected with the increase of the load exerted onto the load-carrying wall in "B" axis and the vault under it (Sec. 3.2). It was decided that the increase in the load should be avoided by the arrangement of new two-storied steel frames, which transfer the excess load onto the transverse walls again and prevent the propagation of cracks in the vault (Fig. 5a, Fig. 9).

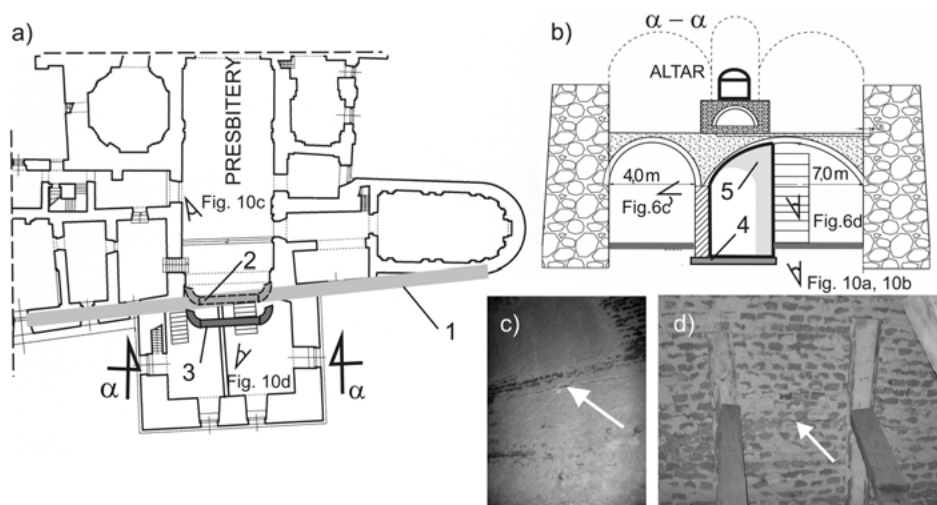
However, during structural diagnostics, it was found that the cause of the vaults’ destruction is much more complex. Two crypts directly abutting on the town wall from the outside, supported on one internal wall (Fig. 6c, Fig. 6b), are of a different width. Therefore, the vaults’ spans are also different (the vault of the seven meter span is flat, whereas the vault of the four meter span is elevated). The calculations of vaults were executed assuming the “arch” scheme of vaults, their loading with the weight of the altar, stone floor, backfill and self-weight, as well as the tested stress-strain parameters of masonry, treated as the elastic material. These calculations confirmed that the thrust of the wide vault is

twice the thrust of the narrow one. Such differential thrusts induced the horizontal force to be exerted on the internal load-carrying wall towards the narrow crypt, which resulted in a non-uniform stress distribution in the wall section as well as under its foundation. The wall was founded in the weak uncompacted embankment. Therefore, the overloading in the zone of the maximum stress and wall rotation occurred. This explained the observed horizontal cracks running virtually along the whole length of crypts: in the brick joint of the internal wall in the level of the wide vault's support (visible from the side of the narrow crypt Fig. 6c), and in the top section of the wide vault (Fig. 6d).

Fig. 6. Structural system of the crypts of the Tyszkiewicz Chapel: a) projection of a part of the basilica with the course of the town wall (1) and locations of the altar: the presumed initial position (2) and present position (3), b) cross-section of crypts with the location of the altar and strengthening structures: widening the foundation of internal wall (4) and concrete structure supporting the vault (5), c) horizontal crack in the internal wall in the level of the wide vault support visible from the narrow crypt, d) wide vault supported by wooden shores and the crack in its top section

The unexpected factor increased the load and consequently, the unbalanced thrust. As mentioned above, the Tyszkiewicz Chapel was built outside of the town wall and outside the front wall of the initial church. It may be supposed that the high altar was then put on the town wall (Fig. 6c). However, during the structural restoration works it was found that the altar is placed not on this wall, but inside the layout of the chapel and crypts. It was moved from the town wall into the chapel. Timber beams were put under the altar. However, with the passage of time, due to their deflection and biological corrosion, the altar's dead load (assessed to be more than 15 tons) was exerted onto the backfill and consequently onto the vaults.

The damaged wide vault in the crypt under the Tyszkiewicz chapel (Sec. 3.4) was partially rebuilt or strengthened in the zone outside the altar's location. Calculations mentioned in Sec. 3.3 proved that the section of the vault supporting the altar has insufficient bearing capacity for the fulfilment of the ultimate limit states conditions. Unfortunately, the temporary unloading of the vault by removing the altar for the restoration time was impossible, would allow the introduction of effective strengthening. Therefore, the supporting structure was introduced under the altar (Fig. 6b, Fig. 10). The strengthening of the crypt's structure was supplemented with widening the foundation of the internal wall.

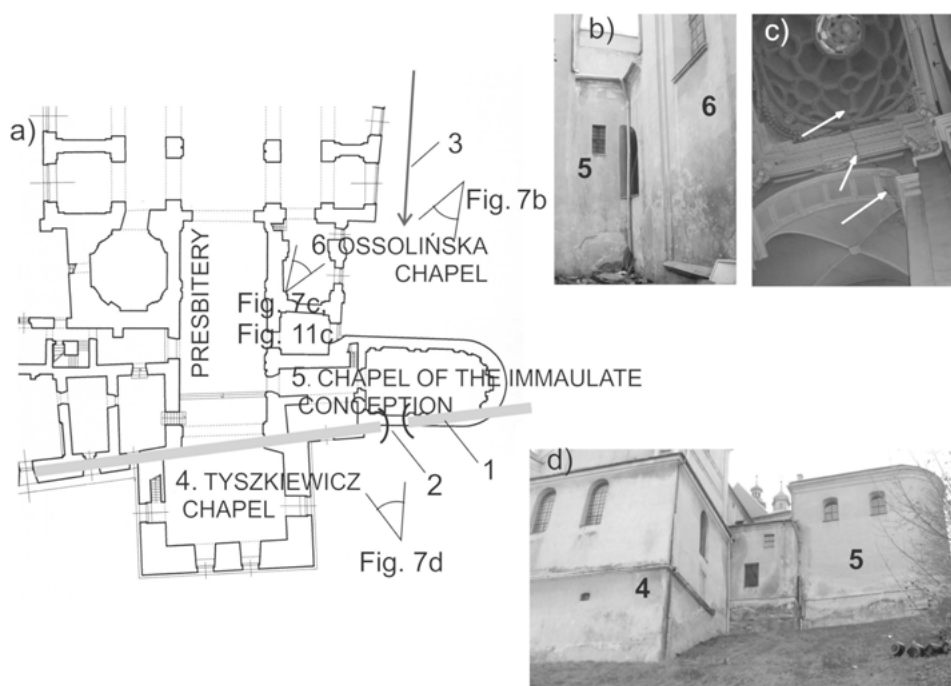
Originally, the town gate, the so-called "Butcher's Gate" existed in the location where the chapel is at present (Fig. 2b, Fig. 7a). It was a part of the path running next to the basilica leading from the Town Market away from the city. It also performed as the drain of liquid waste from the town's butcheries. The chapel crossed the path, putting a stop to this unpleasant neighborhood (Fig. 7b, Fig. 7c). However, the chapel began to act as a dam for rainwater and sewage flowing from the Old Town Hill. The loess which constitutes the subsoil in the corner between the basilica and the chapel soaked. This resulted in the settlement of chapels adjacent to the path, particularly the Ossolińska Chapel, and emergence of cracks in walls, vaults and the dome (Fig. 8).

Fig. 7. Location of the Chapel of the Immaculate Conception of the Blessed Virgin Mary: a) projection of the basilica, b) view from the inside of the Old Town, c) view from the outside of the Old Town Hill. Numbers indicate the following: 1 – town wall, 2 – Butcher's Gate, 3 – direction of water and sewage flow, 4 – Tyszkiewicz Chapel, 5 – Chapel of the Immaculate Conception of the Blessed Virgin Mary, 6 – Ossolińska Chapel

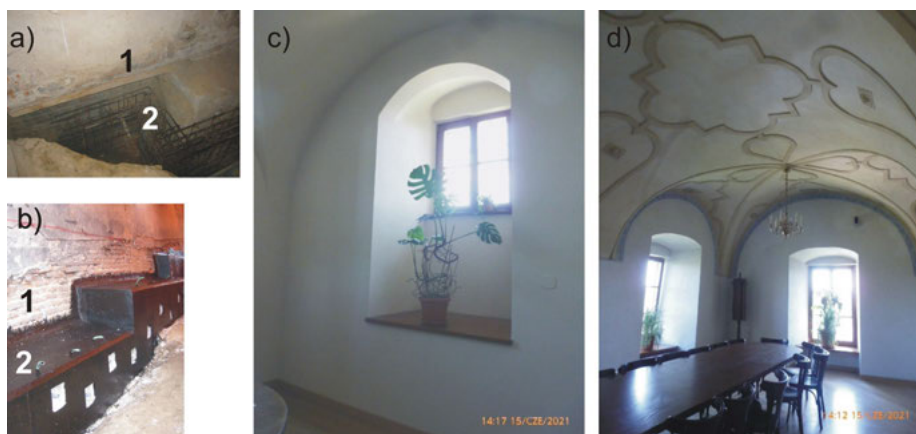
Fig. 8. South-east corner of the east wing in the Dominican monastery: a) and b) the micropiled structure supporting the corner – the internal and external grid beams photographed under construction (1 – east wall, 2 – micropiled structure), c) present view of the restored corner room in the ground floor (the wall shown in Fig. 3b), d) present view of the restored corner room in the first floor

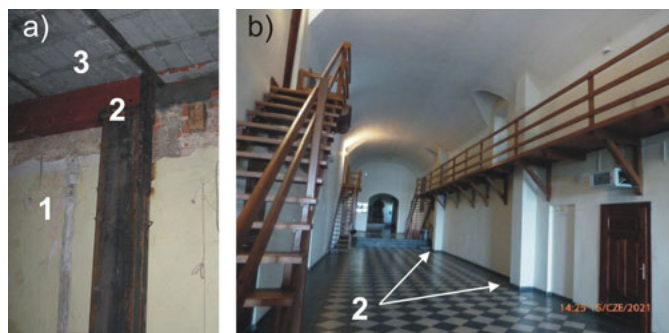
Fig. 9. Steel structures unloading the vaults in the east wing of the Dominican monastery founded on the transverse first floor wall: a) one of steel frames under construction, b) present view of the corridor in the second floor lined with the steel frame (1 – longitudinal wall standing on the vault, 2 – steel frame, 3 – ceiling above the second floor)

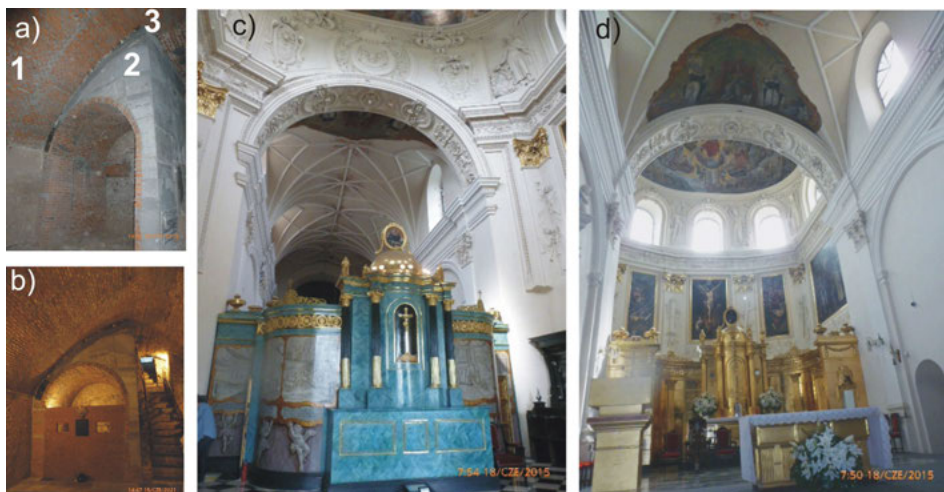
Fig. 10. The Tyszkiewicz chapel: a) and b) concrete structure in the crypt supporting the wide vault under the high altar, under construction and now (1 – rebuilt part of the vault, 2 – supporting concrete arch, 3 – original part of the vault), c) present view of the Tyszkiewicz Chapel's interior with the reverse of the high altar, d) present view of the high altar and the Tyszkiewicz Chapel behind it

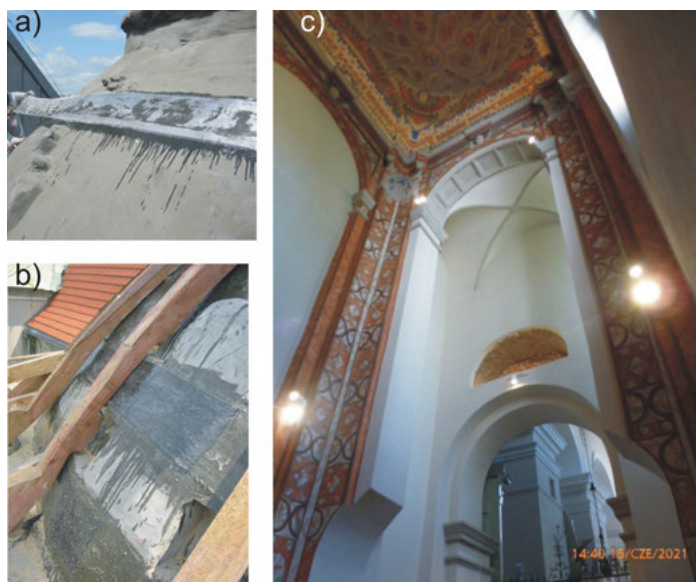
Fig. 11. The Ossolińska Chapel restoration: a) application of GFRP composite as the first layer, b) CFRP composites after strengthening, c) present view of repaired and restored arch and vault

The remedy applied in order to eliminate the cause of the damage in north side chapels (Sec. 3.4) was a new drainage system in the area adjacent to the basilica. The structural restoration, besides the injection and sewing of the cracks in walls, vaults and the dome, included the application of GFRP and CFRP composites in order to strengthen the hoop of the dome of the Ossolińska Chapel (Fig. 11). The effectiveness of GFRP and CFRP composite strengthening was proved for historic masonry, particularly for arches and vaults, based on several studies, e.g. compiled in [29]. This solution gives good results, also in comparison with today's widely developing TRM systems [30]. Nevertheless, due to the recognition of the disadvantages of CFRP composites gluing to historic masonry (difference of stress-strain characteristics and creating a barrier for moisture evaporation), only the lower half of the dome and, what is more, only strips of surface were covered with composites. The solution allowed the steam permeability. Before the composites' application, the whole surface was covered with trass-lime-based material. In order to "soften" the difference between masonry and CFRP moduli of elasticity, the first composite layer constitutes GFRP (Fig. 11a), which was the basis for CFRP (Fig. 11b).
