## Research paper

# Industrial floor faults caused by volume changes in concrete and subsoil: case study

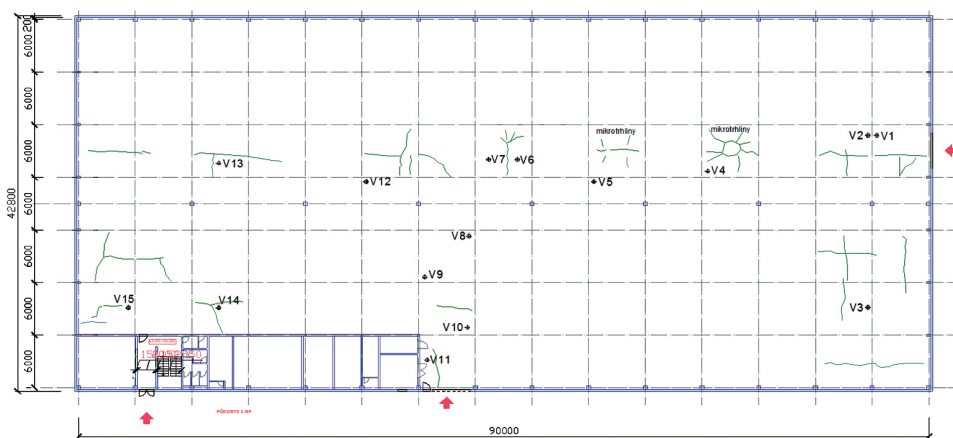
Fig. 1. Scheme of cracks and sampling points of the industrial floor of the production hall in Ostrava-Vítkovice

With regard to the operating conditions (operation in the hall with machine tools could not be interrupted), the actual area was divided into the reference section with the highest incidence of faults (Fig. 2). 15 samples were taken in this reference section. In Fig. 1, the locations of the samples taken (V1 to V15) are marked and numbered.

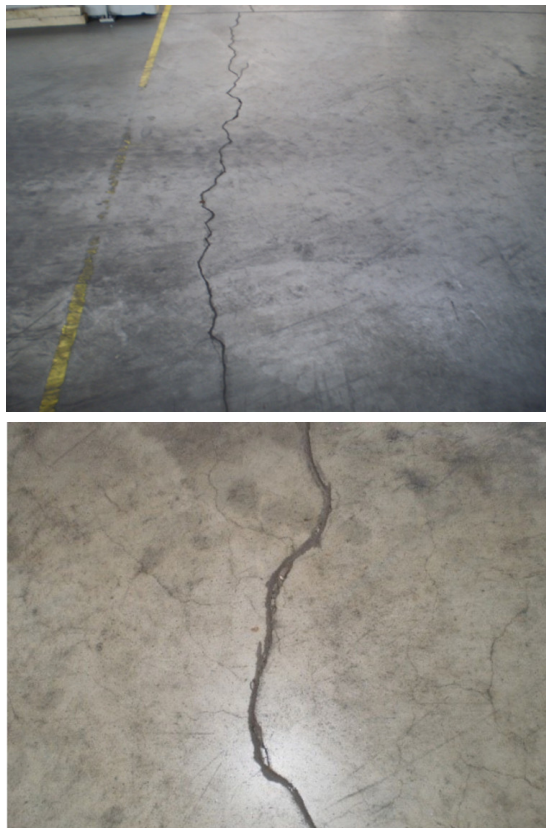
Fig. 2. Cracks of the industrial floor near the entrance to the production hall

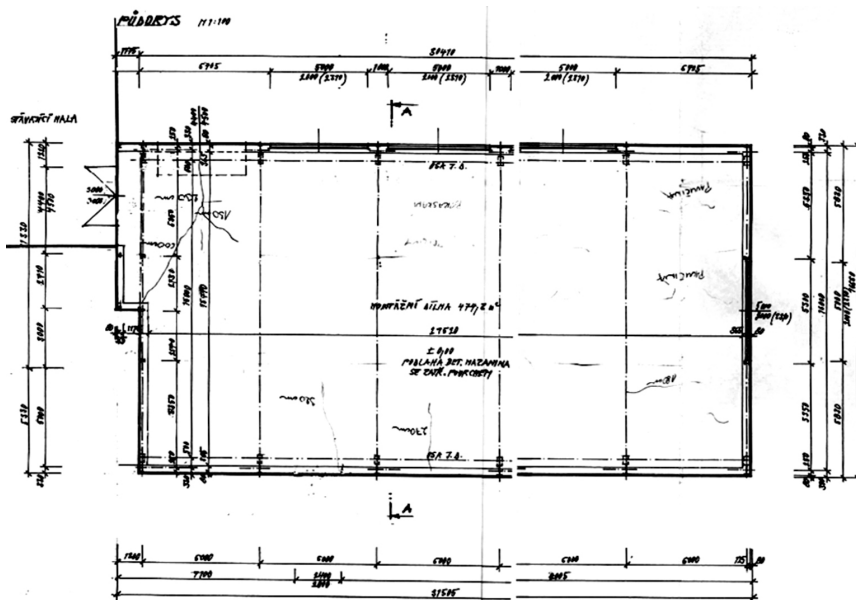
approximately one year, faults in the floorboard were found, consisting of microcracks (cobwebs) and visible cracks, the positions and lengths of which were recorded in the diagram below in the Fig. 3.

Fig. 3. Scheme of cracks in the floor of the storage hall in Frýdek-Místek

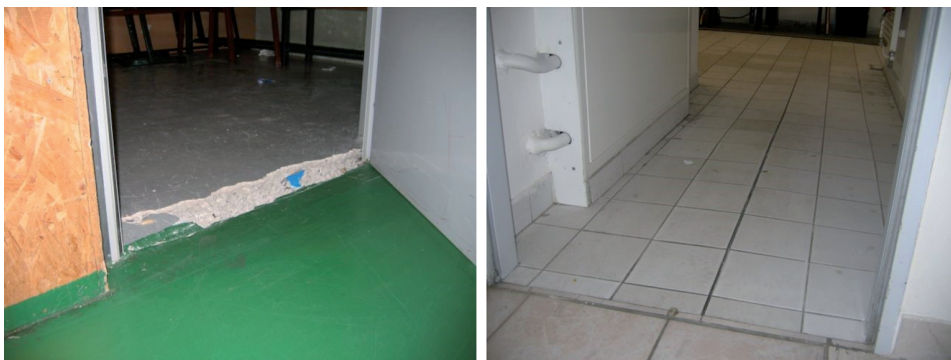
Fig. 4. Threshold failure caused by floor slab lift (left); Visible swelling of the floor with ceramic tiles (right)

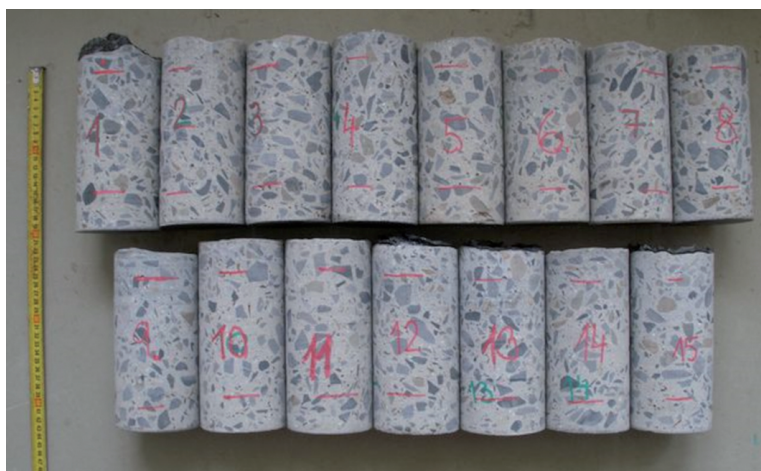
Fig. 5. Laboratory samples from the industrial floor of the production hall in Ostrava–Vítkovice

of concrete is 37.15 MPa. The resulting characteristic (cubic) compressive strength of concrete is 30.23 MPa, the concrete corresponds to strength class C 25/30.

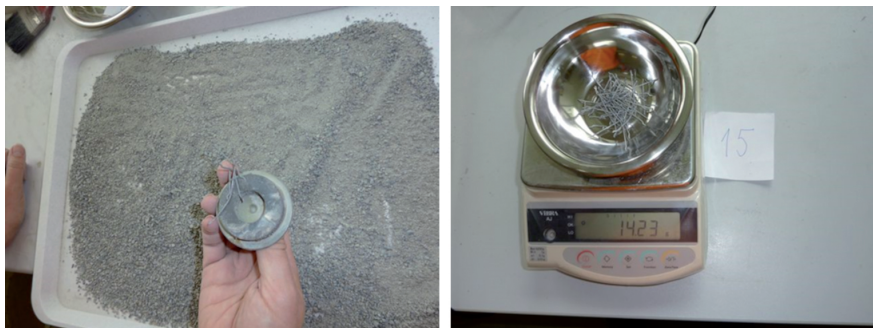
Fig. 6. Determination of the number of fibers in individual samples (Industrial floor of the production hall in Ostrava–Vítkovice)

The dispersion of fiber content is in the range of 6.39 to 26.77 kg of fibers in  $1 \text{ m}^3$  of concrete (on average 16.84 kg of fibers /  $1 \text{ m}^3$  of concrete). The dimensions and shape of the fibers correspond to the Dramix RL – 45 / 50BN type.

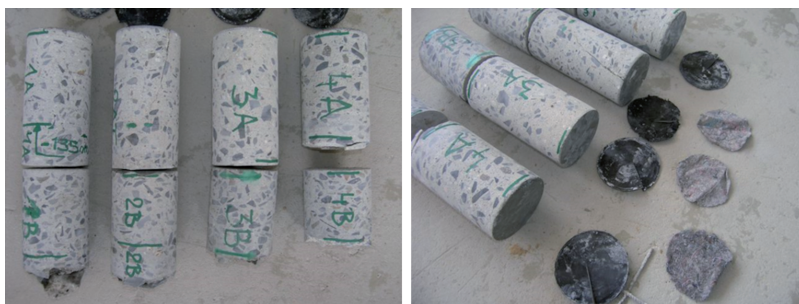
Fig. 7. Laboratory samples from the industrial floor of the storage hall in Frýdek–Místek

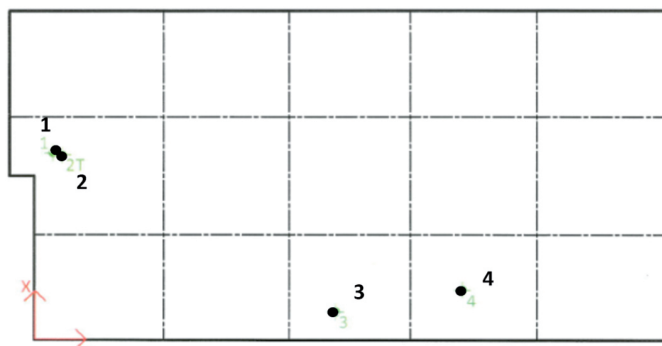
Fig. 8. Scheme of cracks of industrial floor and table of weight of fibers in individual laboratory samples (industrial floor of storage hall in Frýdek–Místek)

1 m<sup>3</sup> of concrete (average 16.3 kg of fibers / 1 m<sup>3</sup> of concrete). The dimensions and shape of the fibers correspond to the Dramix RL – 45 / 50BN type.

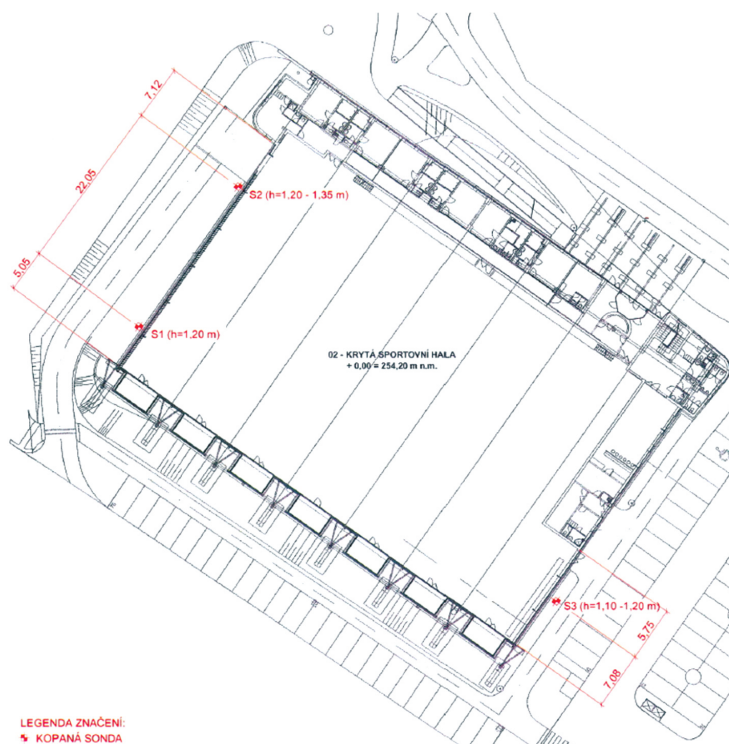
Fig. 9. Scheme and location of test sites

implementation of slag embankments – interruption of work due to frozen layers of water between the plain and slag, removal of slag and re-filling with slag. There is also a mention of wetting the subsoil from an undrawn pipeline. The subject of this analysis was the determination of the material composition of three samples of backfill material and a prognostic assessment of the susceptibility of samples of backfill material to volume changes based on the mineralogical and petrographic analysis of the delivered samples. Excavated probes that were carried out in the vicinity of the assessed object were marked with the description S1 to S3 (Fig. 10). Examination shows that in three supplied samples, therefore, stable pieces of mass of various origins and potentially unstable grains of slag from various metallurgical technologies are dominantly present. Coarse grains are cemented with a sandy-dusty mass of grains of steel slag, grains of sand from rocks and quartz, grains of tailings and ceramics incl. smelter of ceramics and bricks. Individual samples differ primarily in the relative representation of individual components. This is waste that is extremely unsorted, poly-component and materially heterogeneous – an extreme case of materials from the so-called “cold roll”. Further examination also shows that hydration and carbonation reactions and the volume changes of reactive components caused by them have not yet been completed.

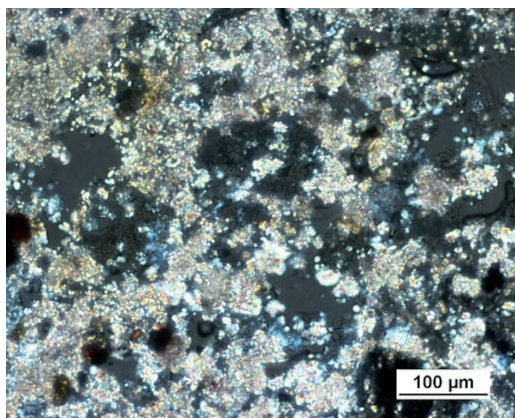
Fig. 10. An example of the secondary transformation of dust and sand grains from steel slag leading to the formation of variously intensely cemented masses referred to in the text as “slag agglomerates”. Intense carbonation associated with the formation of carbonate and uneven hydration of the starting silicates of steel slag
