# The landslide in the slope and side of the Warta River valley in the village of Wronki – process analysis, exploratory research, preventive measures, monitoring

Michalina Flieger-Szymańska<sup>1</sup>, Jerzy Sobkowiak<sup>2</sup>,  
Katarzyna Machowiak<sup>3</sup>, Dorota Anna Krawczyk<sup>4</sup>

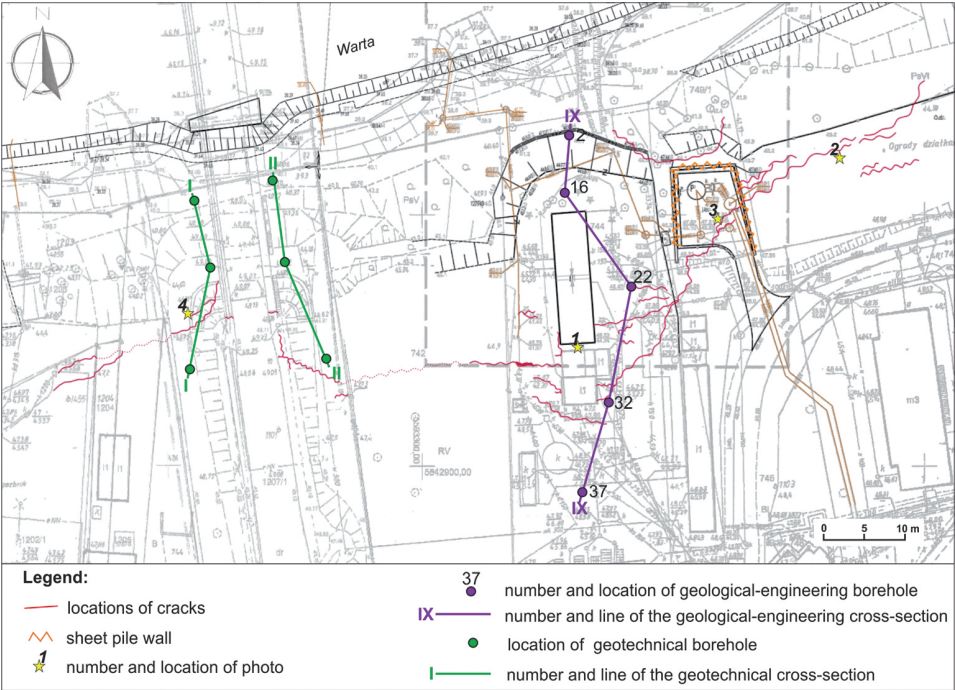
Fig. 2. Map of the distribution of deformations in the subsoil of the Warta side in Wronki [12]

During the site inspection, in the autumn of 2018, an inventarization of deformations in the subsoil was made. They arose after mass movements in the slope and side in the area of the road bridge in Wronki. Fig. 2 shows the research area with the, marked in pink, cracks in the surface caused by landslides. As can be seen on the map, the greatest amount of ground deformation developed in the area to the east of the bridge, i.e. in the area of the closed wastewater treatment station of the Correctional Facility, the sewage pumping station of the Municipal Enterprise in Wronki and allotment gardens.

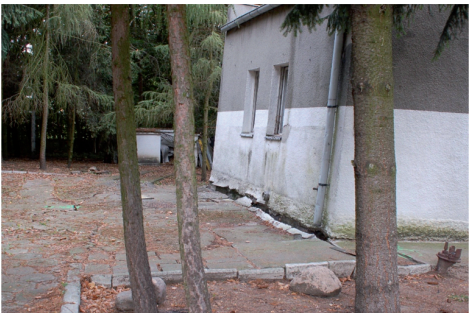
Visible inclination of the building by about 25 cm towards the river in the closed wastewater treatment station of the Correctional Facility in Wronki

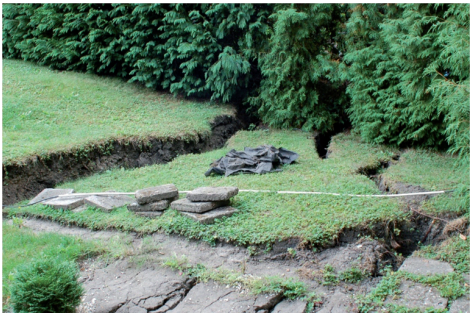
Cracks in the ground, approx. 50 cm wide, in the allotment gardens in Wronki

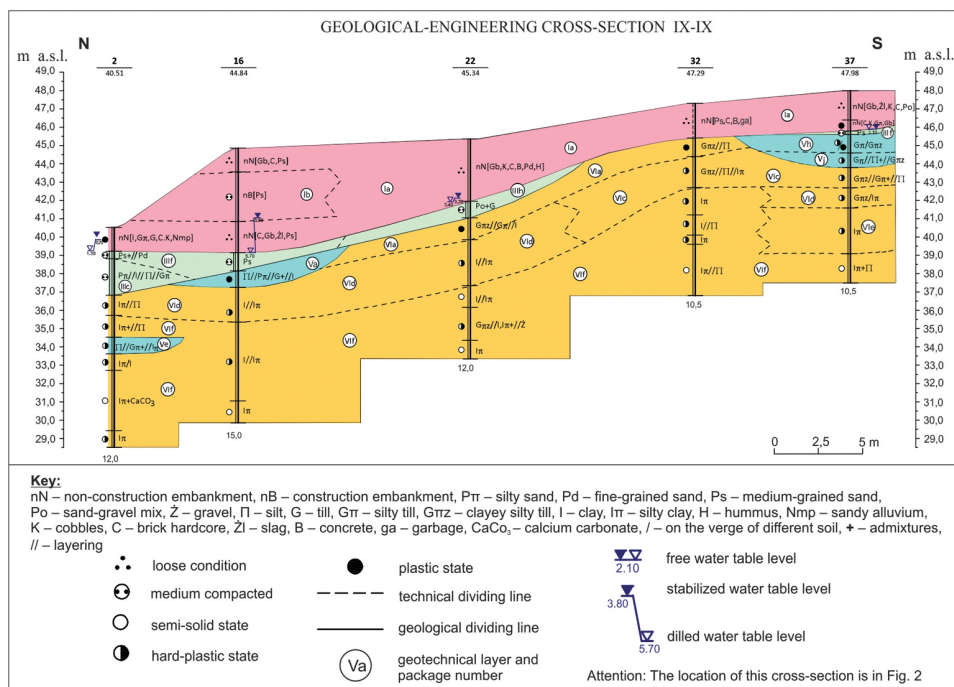
Fig. 6. The fragment of the geological engineering cross section IX–IX (modified) [16]

2018 (Fig. 6). The yellow color in the cross-section shows a package of Neogene sediments created mainly in the form of clays, silty clays and clayey silty tills with variable value of liquidity index. This package is locally layered with silts, silty tills and silty sands marked in blue. In the zone of the steepest slope of the roof of the Neogene formations, there is a small thickness layer of fluvial- and fluvioglacial accumulation sediments of the North Polish glaciation, formed as silty sand, fine-grained sand, medium-grained sand and sand/gravel mix, in moderate dense state (marked in green) and partially watered. The watered sediment layer is discontinuous with a unconfined and confined nature of the groundwater table (Fig. 6). Fluctuations in the groundwater table in the annual cycle may range from +1.0 m to -1.0 m depending on the intensity of precipitation and fluctuations in the level of the Warta River in this area.

The geological-engineering cross-section illustrates the characteristic geological structure within the range of the analyzed landslide and shows a significant transformation of the slope's subsurface zone, what is confirmed by all the testing boreholes made, in which non-construction and construction embankments with variable thickness of up to 5.7 m were drilled in the subsurface zone. Below these embankments, cohesive soils are generally deposited (Fig. 6).

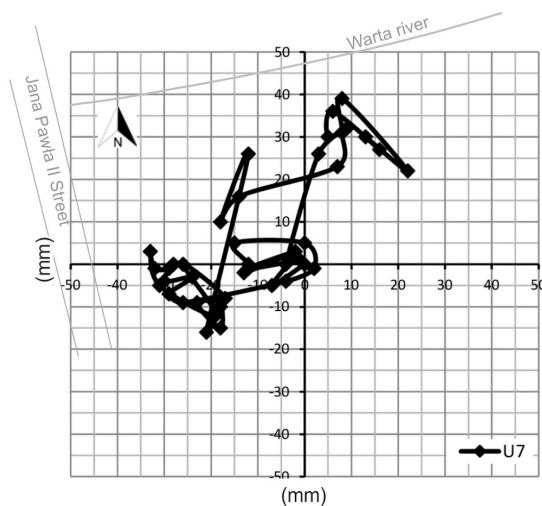
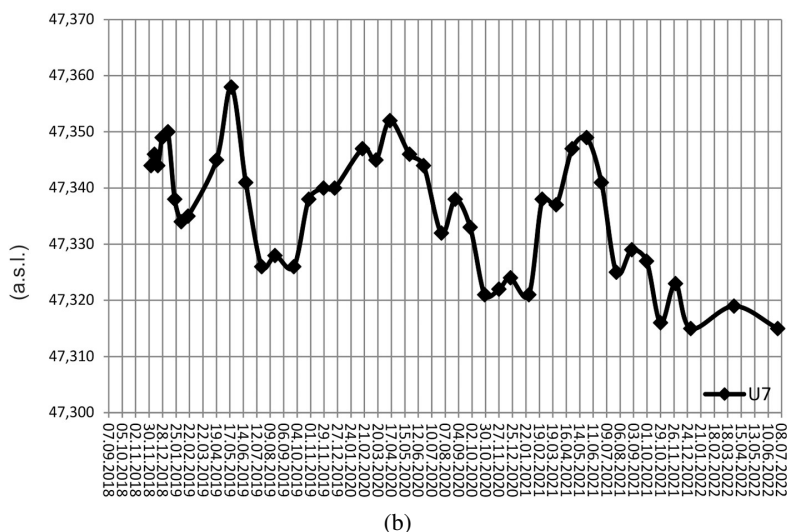
The graphs show the chaotic movement of control points. All points in the landslide zone have a very similar nature of displacements, i.e. they are ambiguous, unequal displacements, and therefore very difficult to interpret. Harmonic displacements of control points once to

Fig. 8. Diagrams of horizontal (a) – measurements made in the period from December 2018 to February 2019, every 1–2 weeks; from March 2019 to December 2021, every 1 month; from January 2022 to June 2022, every 3 months and vertical displacements (b) for the control point U7

the left, once to the right, once up and once down can be explained by the fact that the mass movement takes place in very specific geological-engineering conditions, i.e. within the slope and on the side, on the surface of intensely irrigated and plasticized expansive soils with considerable potential for changes in volume with changes in humidity. The high

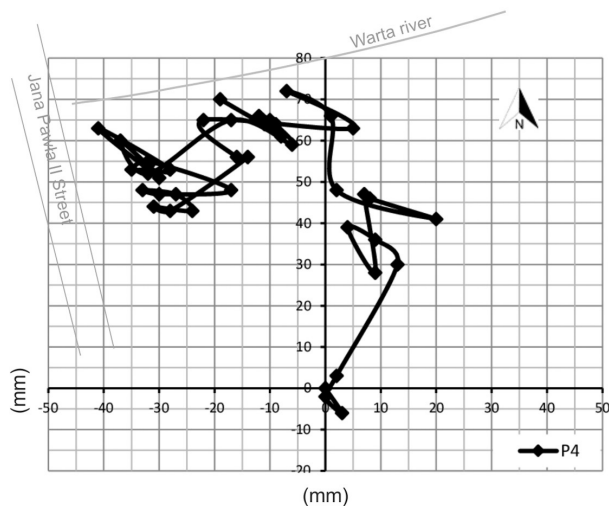
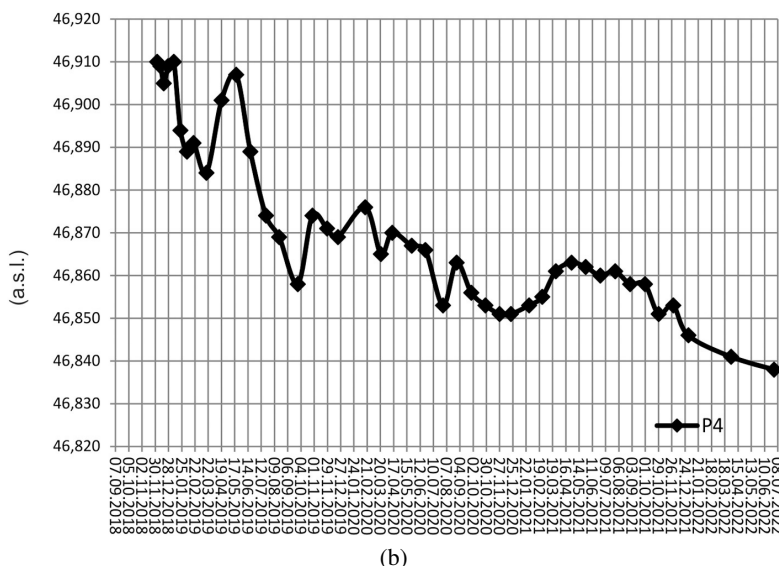
Fig. 9. Plots of horizontal (a) – measurements made in the period from December 2018 to February 2019, every 1–2 weeks; from March 2019 to December 2021, every 1 month; from January 2022 to June 2022, every 3 months and vertical displacements (b) for the control point P4

degree of expansiveness of Pliocene clays is related to the presence of a large amount of smectite minerals in their mineralogical composition. The average content of each group of clay minerals in the entire series of Pliocene clays is as follows: smectite – 46%, illite – 28% and kaolinite – 26% [8]. Smectite minerals absorbing water can increase their volume at least 4 times. This is undoubtedly one of the most important, cause of vertical movements of the studied benchmarks [11, 13–15].
