# Slope stability analysis of post-mining dumps with the use of photogrammetric geometry measurements – a case study

Magdalena Wróblewska<sup>1</sup>, Magdalena Kowalska<sup>2</sup>,  
Marian Łupieżowiec<sup>3</sup>

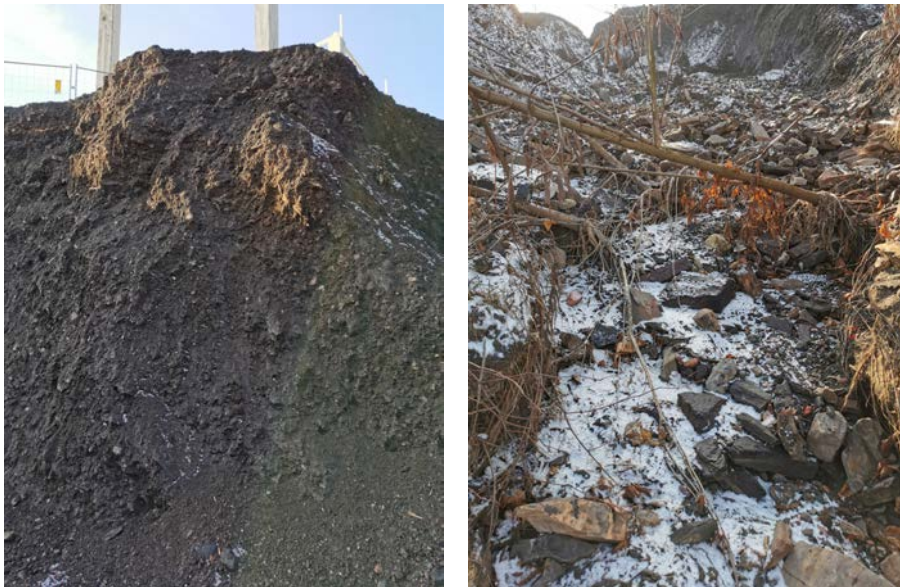
Macroscopically the dump consists mostly of fine soils, claystone, sandstone and black unburnt carbonaceous shale with grading ranging from clayey to boulder fractions (Fig. 1), indicating that the waste contains probably the material from the main production and enrichment processes (e.g. washery) [25]. The grains and rock fragments are angular with visible fissility and hard coal occurrence.

Fig. 1. Various fractions visible in the failure zone (P2 in Fig. 2a), photo. M. Kowalska

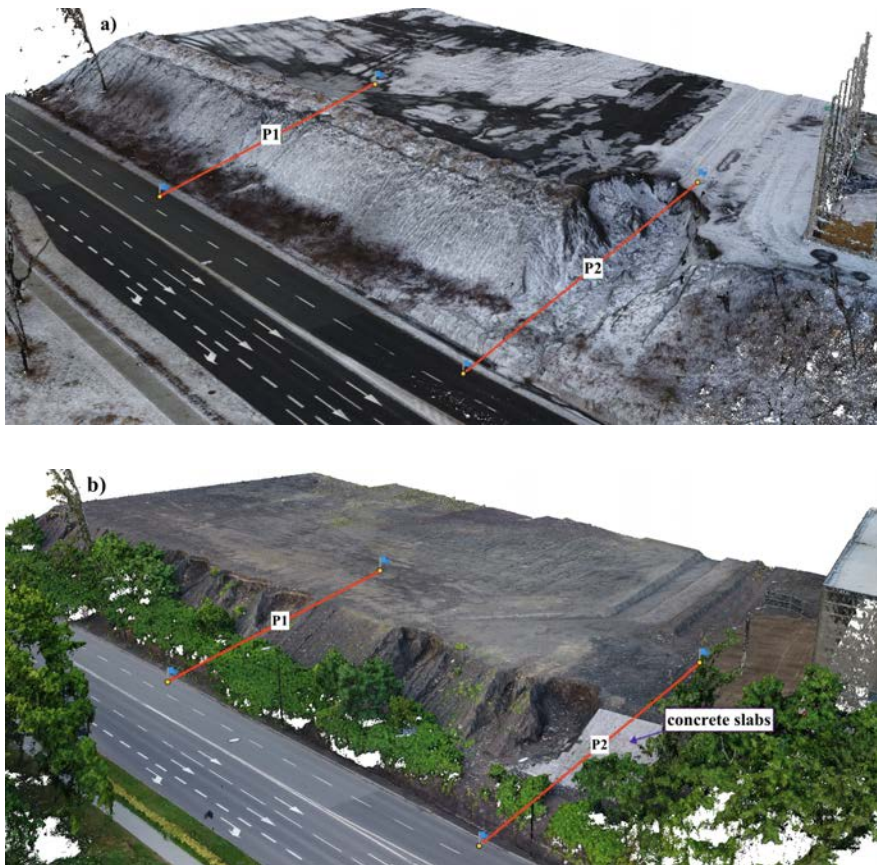
The measurements were conducted twice: in January 2022 and June 2022. In both cases, the post-processing stage included alignment of the photos and matching them to the ground control points (tracked using GNSS). As the result a cloud of points with the density of 500 points/m<sup>2</sup> was generated. The obtained 3D models of slopes with two characteristic cross-sections P1 and P2, used in the further analyses, are shown in Fig. 2.

Fig. 2. 3D visualization of the research area: a) 1<sup>st</sup> measurement (01.2022),  
b) 2<sup>nd</sup> measurement (06.2022)

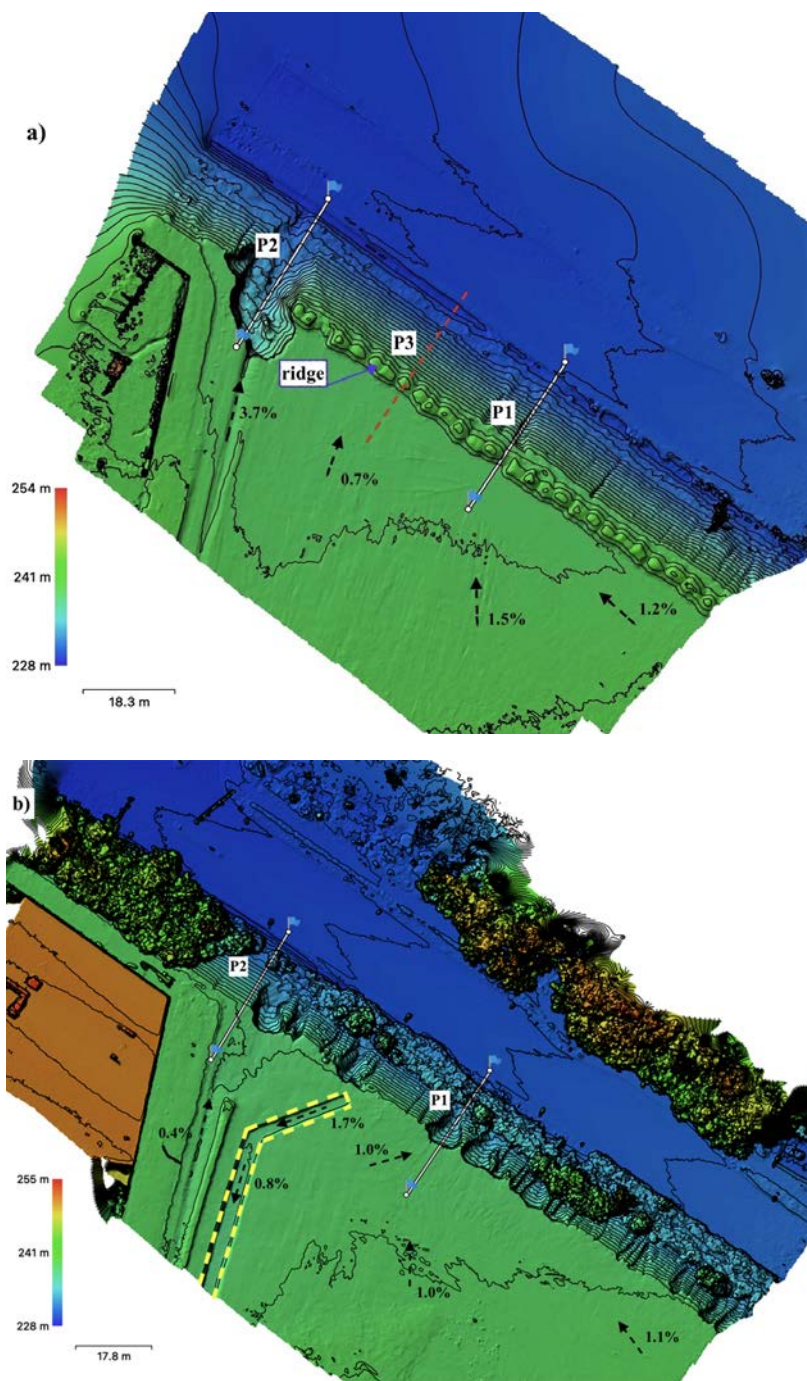
Fig. 3. DEM models with the cross-section lines and terrain slopes: a) 1<sup>st</sup> measurement (01.2022),  
b) 2<sup>nd</sup> measurement (06.2022)

every 0.5 meter of height. The main slopes of the upper surface of the dump (direction and % gradient) were assessed at several points (see the arrows in Fig. 3 and Fig. 4). To describe the observed failures, two cross-sections were chosen: P1 – with only slight disturbance in January 2022, and P2 – where the largest mass movement occurred on that day. The readings from January and June 2022 are compared in Fig. 4. A cross-section P3, representing the original undisturbed slope is shown there as well.

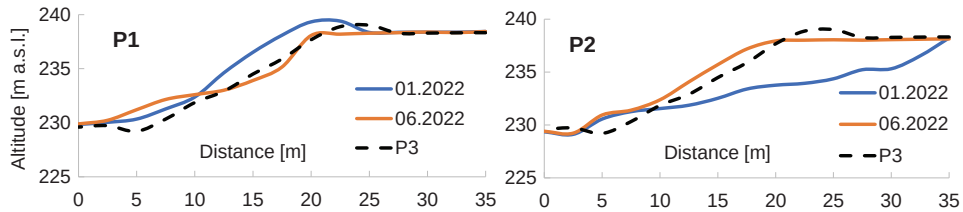
Fig. 4. Escarpment profiles: a) P1, b) P2

The original dump embankment (P3) was 8 m high with a slope 1:1.7, a ditch at the toe and a 1 m high ridge on the crown (compare with Fig. 3a). In the profile P1 in January 2022 only a minor mass movement was observed – a narrow gully was formed and some material from the upper part slid towards the ditch. The profile P2 from that day represents the effect of the slope failure at the zone of the largest observed depletion, reaching 11 meters into the embankment. The final shape of the damaged embankment suggests a compound type of slope failure: translational in the perpendicular cross-section and circular with almost vertical scarps in the longitudinal cross-section. Using the DEM, it was possible to calculate the volume of the lost material (the colluvium had been removed from the road pavement after the failure) – it was equal to about 1309.4 m<sup>3</sup>. It is worth noting that the main slopes of the upper surface of the dump, including the largest one (3.7%), were directed towards the place of the damage, which must have caused a constant inflow of water after the heavy rain to the analysed spot and was the most probable reason of the instability. After this failure, the void was filled with minestone, the escarpment was shaped to the original 1:1.7 slope and its surface was covered with the concrete slabs (see section P2 in Fig. 2). Additionally, a drainage canal was built (yellow dashed line in Fig. 3) with the inclination outwards the road. Unfortunately, these actions were not successful – in June 2022 the slope failures were not as deep as 6 months earlier, but they happened in several places (see also Fig. 2b). The forms of the failures were very similar to the largest one in January. As can be noticed from Fig. 3 the main slopes of the upper dump surface remained directed towards the road and between January and June 2022 the ridge was removed (the material was probably used for the refill) – it facilitated the access of rainwater to the escarpment.

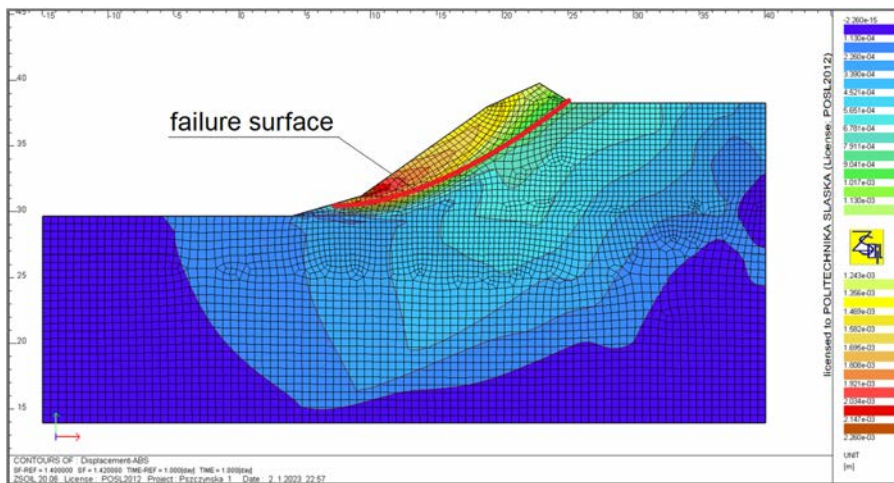
The results of the slope stability analysis at  $\Delta\text{GWT} = 8$  m and rainfall intensity (RI) of 0.04 m/d are shown in Fig. 6. The obtained factor of safety is equal to  $F_s = 1.42$ . This means that at the favourable atmospheric conditions (just light rainfall) the slope remains stable, even if the water table difference is relatively high. The shape of the failure surface is similar to the one observed in the photogrammetric measurements in June 2022 (relatively shallow, not reaching below the toe of the escarpment).

Fig. 6. Map of absolute displacements at the time of failure ( $F_s = 1.42$ )

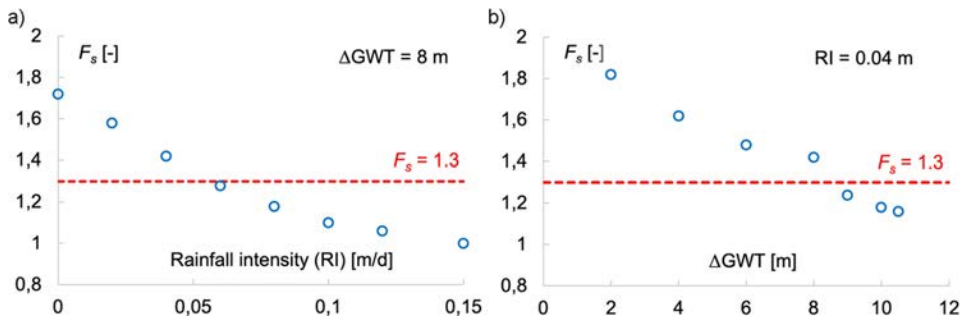
The influence of the ground water table difference (head) between the two sides of the model and the infiltration rate caused by rainfall on the  $F_s$  value are presented in Fig. 7. It is clear that the both factors are strongly correlated with the decrease of safety. At medium rain (RI above 0.06 m/d) or if the water accumulation at the higher side of the escarpment is greater than 8 m (expected after long-lasting intensive precipitation) the risk of slope instability is becoming high ( $F_s < 1.3$ ). In the assumed ground conditions, the rainfall intensity corresponding to heavy rain (RI above 0.18 m/d) means the inevitable occurrence of a landslide. As the observed failures occur practically after each heavy rain, these results confirm that the occurrence of water is the main factor responsible for the instabilities.

Fig. 7. Dependence of the factor of safety value on: a) rainfall intensity, b) water level difference

Photogrammetric measurements conducted with the use of UAV allowed to determine the most important geometrical data of the analysed post-mining dump at Pszczyńska Street in Gliwice, without the necessity to enter into the unstable zone. The FEM numerical model, using the ‘ $c - \tan \varphi$  reduction’ method and parameter values assessed on the basis of literature review confirmed that the main factor initiating the repeatable slope failures in the dump escarpment is the rain water. The seepage pressure decreases the shear strength of the material by lowering the effective confining stress and eventually resulting in the safety factor  $F_s < 1$  at even medium rainfall intensity. The flowing water is also obviously eroding the ground surface and flushing out the finest fractions (suffusion) which has an additional negative impact on the mechanical parameters of the material and on the slope stability. The 3D models, obtained from the post-processing of the digital images taken in two UAV missions with 6 months interval, revealed that the protective measures applied by the owner of the structure (covering the slope with concrete slabs and execution of one drainage canal in the vicinity of the industrial hall) were not successful. Removal of the ridge at the crown of the escarpment had also a detrimental effect on the slope safety. In the authors opinion, to prevent the future failures, the main slope of the upper surface of the dump along the whole length of the endangered road, should be inclined towards a new drainage canal constructed along the escarpment at large distance from it. A decrease of the embankment slope would be also helpful.
