# Expansive soils as the root cause of a historic underground potable water reservoir failure

Tomasz Godlewski<sup>1</sup>, Radosław Mieszkowski<sup>2</sup>

**Abstract:** The paper describes the root causes of damage to an underground potable water reservoir. It is made of reinforced concrete and consists of two chambers founded on subsoil diversified for its age and origin (folds of glacitectonically disturbed septarian clays and postglacial loams). The documented damage results from subsoil deformation caused by volumetric changes in the ground (shrinkage and swelling) due to the facility's exposure to various external factors determining the phenomenon's intensity for over one hundred years. The analysed example presents problems arising from founding the facility on expansive soils. It highlights the hazards resulting from negligence in landscape architecture development and emphasises the role of identifying the subsoil. Comprehensive geotechnical examination and geophysical measurements of the structure and subsoil, making the inventory and evaluating the nature of the damage helped identify the potential factor detrimental to the facility's technical condition. The conclus

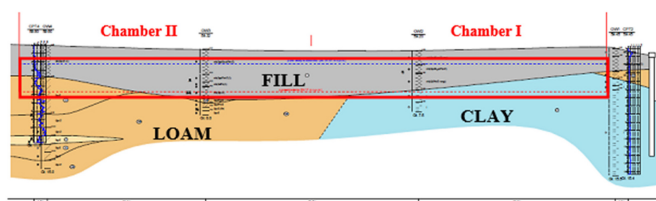
Fig. 3. Characteristic geotechnical cross-section of the reservoir, W-E direction [4]

The reservoir is located in a young glacial landform area within a moraine edge and documented glacetectonic uplifts. This determines the subsoil structure – a moraine hill of Pleistocene glacial deposits (loam and sand), within which folds, xenoliths and floats of Oligocene Septarian clays are present (results of glacetectonic displacements). The initially planned test numbers and locations (CPTU probing and drilling) were extended to cover additional drilling meant to precisely identify the course of glacetectonically displaced Septarian clays. They were completed with field tests using a flat dilatometer (DMT) and laboratory identification of the swelling pressure due to the need to determine the soil characteristics for its deformation range (potentially expansive soils). In order to determine the dampness of the made ground, shallow (1 m) drilling and trenching were made around the reservoir walls and on its ceiling. The geotechnical tests revealed that fine (cohesive) marginal soils represented by rigid-flexible Oligocene clays and postglacial soils in the form of rigid-flexible sandy loams and semi-cohesive clayey sands are the direct foundation of the analysed underground reservoir. Postglacial soils are deposited in the structure's western part. At the same time, Oligocene Septarian clays form the subsoil of the reservoir's eastern part (Fig. 3). Severely damped areas at the reservoir slope base were discovered within the fills.

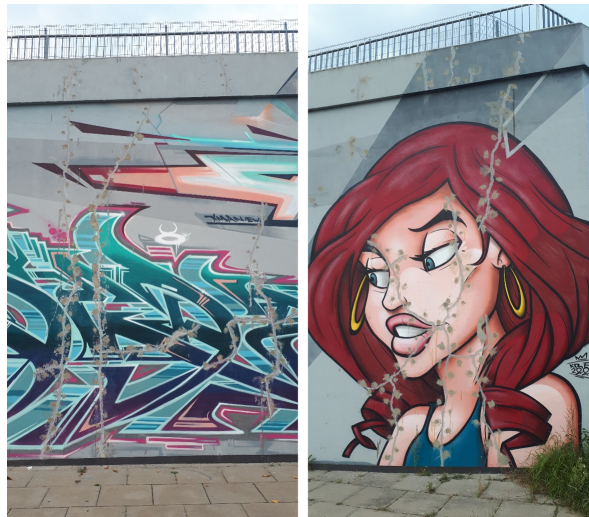
The direction and successive reported values of the benchmark replacement measurements for the retaining wall correspond to the expectations for such structures (bracket displacement). Linear displacements for the benchmarks located on the retaining wall reveal 1–6 mm differences and settling up to 6 mm. The analysis of the collected data suffered from a certain cognitive dissonance as the measurements were relative. It was impossible to refer the measurements to the construction period of the retaining wall, and hence the information was missing on the total displacement and the adopted acceptable values. Nevertheless, the currently observed traces of the retaining wall repairs (Fig. 4) testify to the structure's excessive strain (exceeding the acceptable values).

Fig. 4. Traces of repairing the retaining wall (ca. 5–6 m high) defects (vertical cracks); the wall is located along the reservoir's eastern part (photo by T. Godlewski)

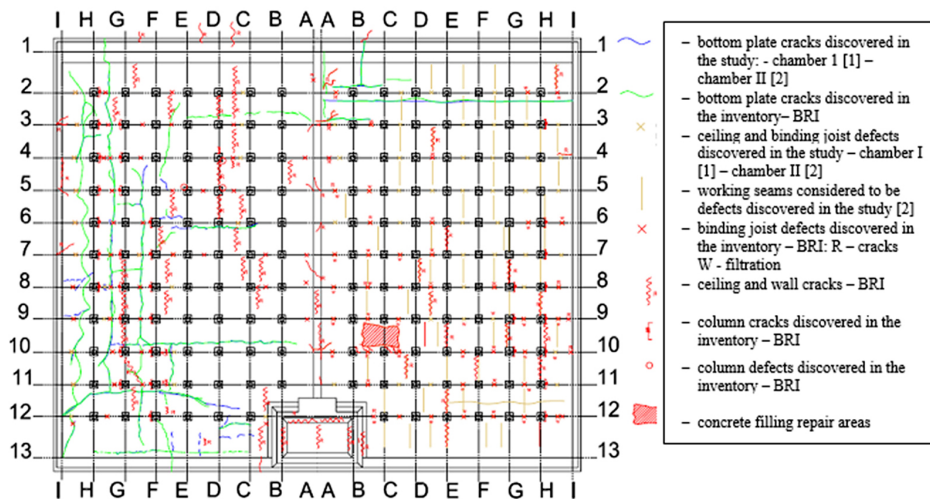
A detailed inventory of each chamber defects (made temporarily available after pumping out the water) was made before the geophysical measurements. Sketches were developed, openings measured and detailed photos taken [4]. Based on the above, the reservoir's technical condition was determined to be diversified. Referring the inventory results to the findings of 2004 (for chamber I, left) and 2016 (for chamber II, right), one can observe the progressing degradation of the reservoir's structure, though of various origins and intensity – Fig. 5. New fractures (not previously described) and cracks in the repair areas were discovered in chamber I. The cracks continue in the bottom plate along the reservoir's entire length in the eastern part (axes I, H, G to F) and crosswise on the axes 10–13 and between axes 2–3. The crack opening characteristic widths reach 1.5–2 mm (up to several mm locally) and are often filled with crushed material with numerous fine branches (Fig. 6a). Cracks on the binding joists, running towards the vault top, typically in the repair areas and often with intense lime efflorescence, up to 1.4 mm opening width, are characteristic of the chamber I (e.g. Fig. 6b).

Fig. 5. Inventory of the reservoir defects [4]

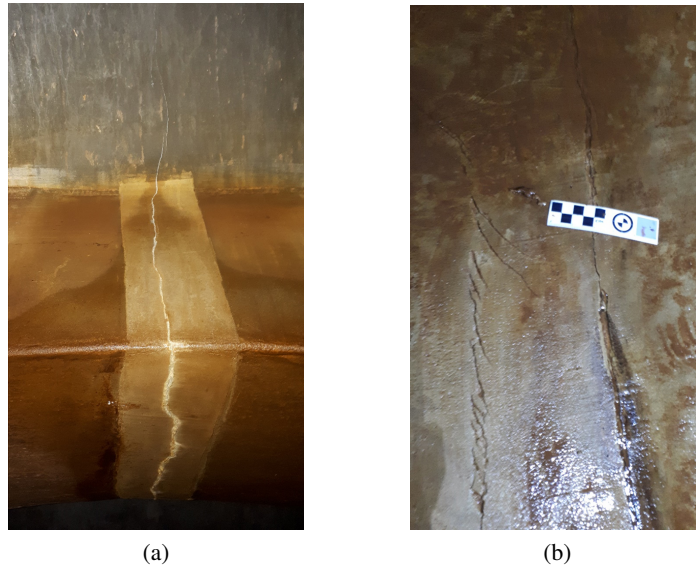
Fig. 6. (a) Bottom plate in chamber I, slanting cracks, locally with crushed material and branching, opening width ca. 0.9 mm; (b) binding joist in the H-G/8 axis in chamber I – a horizontal crack in the repair area, with efflorescence, opening < 0.3 mm, running vertically towards the vault (photo by T. Godlewski)

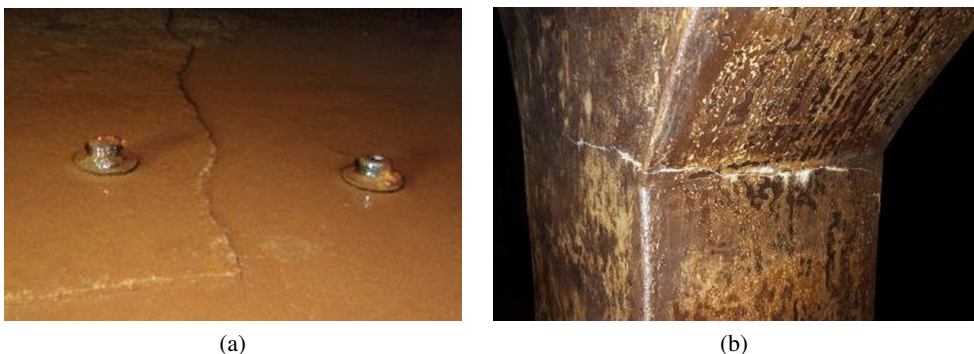
In some areas, mutual vertical displacement of the crack edges (offset) was visible – Fig. 7a. Characteristic tight cracks could be observed in the column areas at the column head widening; they reached no further than half the column width (Fig. 7b). The defects came in pairs on two adjacent columns in the direction of the numerical axes and applied to almost all columns in the H, G, and F axes (Fig. 5). Vault defects occurred all over column I, prevailing in the central part. In most cases, they are very fine cracks with lime efflorescence and in the repair areas.

Fig. 7. (a) Bottom plate in the G-F/9-10 axis in chamber I – monitored gap in the repair area, opening width > 2 mm, vertical displacement (offset) visible; (b) column in the H/2 axis (view from axis 3 side) in chamber I – a horizontal tight crack at the column widening area, reaching no further than half the column width (< 25 cm), crack opening ca. 4 mm wide with efflorescence (photo by T. Godlewski)

Cracks were also observed on the outer walls at the vault or pilaster edges. A significant number of cracks in the bottom plate, visible traces of shearing and vertical movements of the cracks, combined with the measurement results on the applied benchmarks and the nature of the column defects (compression?) suggest intense work of the structure in this part of the reservoir under stress with variable impact vectors.

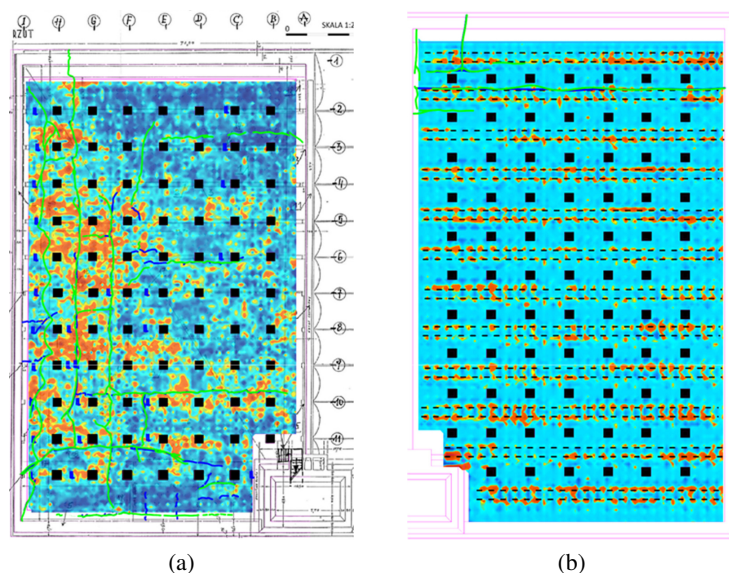
Numerous superficial areas of electromagnetic wave signal amplification were observed in the reservoir's bottom plate in chamber I, which is a testimony to the plate's non-homogeneity and cracking. It is confirmed by observations, whereby the GPR anomaly zone is much broader than the charted cracks – Fig. 9a.

This can suggest damping of the plate and material deterioration (concrete corrosion) much more advanced than expected based on observing visible cracks. The increased dampness zone in the bottom plate overlaps with the location of the prominent cracks identified in the reservoir structure. The GPR image shows linear, regular anomalies originating from the reinforcement. The echogram interpretation revealed that the reinforcing bars are not regularly spaced. The structure is reinforced but to a minimum extent. GPR measurements indicated the reinforcement

Fig. 9. View of the reservoir's bottom plate – map of GPR anomalies, 750 MHz antenna, against the cracks discovered on the surface: (a) image in chamber I, 0.25 m depth – visible irregular anomalies in the electromagnetic wave signal amplification (red), the effect of material cracking or non-homogeneity; (b) chamber II, 0.87 m depth – visible regular\* anomalies in the electromagnetic wave signal amplification (red), the result of an under-plate drainage system [4]

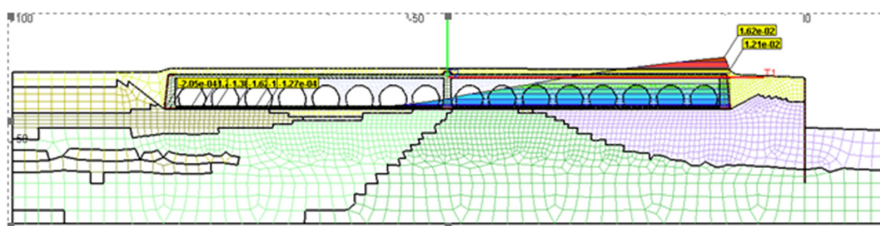
Fig. 11. Displacement distribution and values – visible impact of clay swelling (50 kPa swelling pressure) on the displacement of the reservoir and soil in its vicinity – soil uplift (max. 16 mm)

Based on the numerical analysis, it was concluded that the water level change in the reservoir related to the operating regime (the need to empty the chambers periodically for sanitary and maintenance purposes) has a limited impact on its replacement (max.  $\pm 5$  mm). Nevertheless, even minor displacement occurring when the reservoir is occasionally emptied and filled during regular use, when the structure is sensitive, poorly reinforced and impaired because of its age, can lead to the formation of new micro failures or contribute to the progressing degradation of the existing ones, compromising the reservoir's integrity with time. Consequently, swelling processes could and can be activated due to the possible migration of water into the subsoil.
