A. ZIEWIEC*, J. CZECH**, E. TASAK*

WELDED JOINT CRACKING IN MARTENSITIC STAINLESS STEEL PRECIPITATION-STRENGTHENED WITH COPPER**PEKANIE ZŁĄCZ SPAWANYCH STALI NIERDZEWNEJ MARTENZYTYCZNEJ UTWARDZANEJ WYDZIELENIOWO MIEDZIĄ**

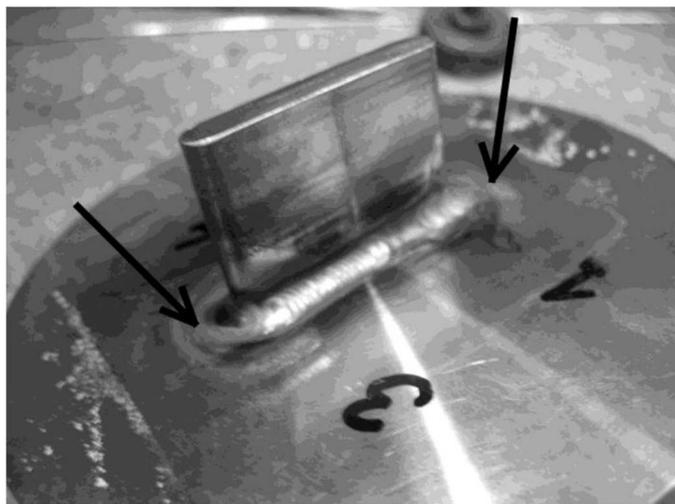
Fig. 1. Example of test weld joint configuration. Areas where cracking occurred most often (fillet weld curvatures around the member plate) are pointed with arrows

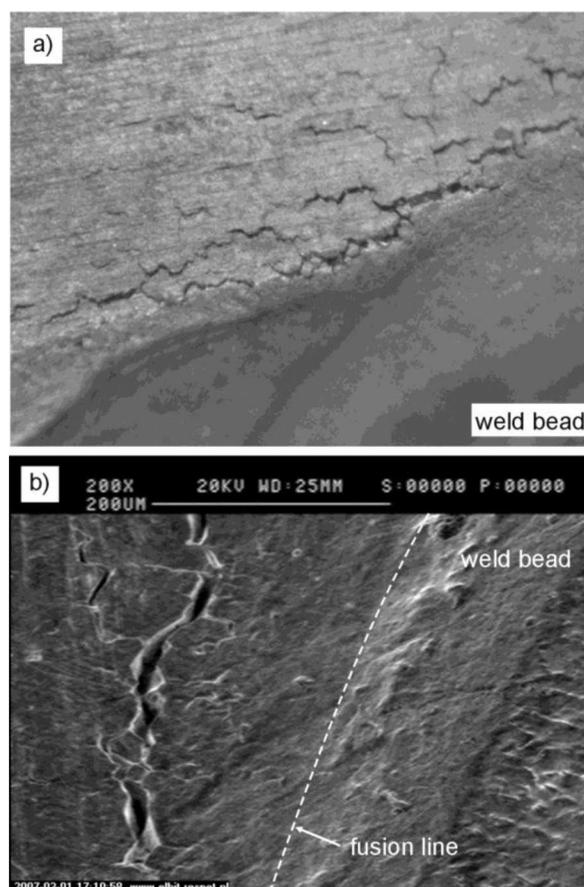
Metallographic evaluation of the provided test specimens extracted from welded parts and weld-test samples showed that the cracks do not exhibit typical features of hydrogen induced cracks. Typical cold cracks induced by a hydrogen embrittlement mechanism consistently initiate at the fusion line, their internal surfaces are free from oxidation and the bottom of the crack would have a relatively sharp appearance.

Fig. 2. Cracks in HAZ of 17-4PH steel welded with GTAW method a) cracks observed by stereoscope microscope, b) cracks observed by SEM

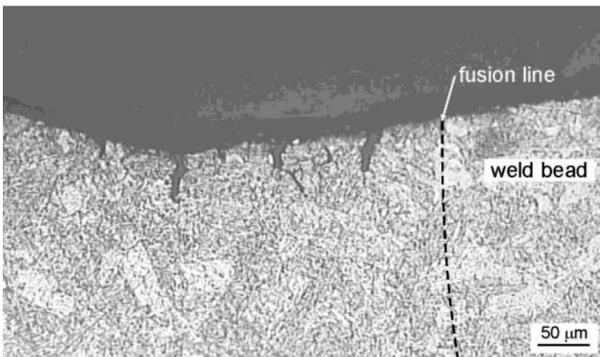
Figure 3 illustrates cracks on a metallographic section in the plane perpendicular to the base material surface and perpendicular to the fusion line. Cracks have an intergranular character (Fig. 4) and appear not only as adjacent to the fusion line but also at certain points in the HAZ away from the fusion line. They can be characterised by their significant width up to do 15 μm

and average depth of 50 μm . The internal surfaces of the cracks are oxidised and their bottom has form of a rounded wedge. The significant width and rounded bottom lead to the conclusion that the cracks originated as a result of large plastic deformations. These observations indicate that cracking was taking place when the value of temperature of the HAZ was high enough to promote oxidation by air in contact with the hot metal surface. At the same time, large deformations must have resulted from stresses induced by the welded joint constraints. This evidence has led to us to reject the hydrogen embrittlement hypothesis of the cracking mechanism and resulted in a new hypothesis stated that the observed defects are hot cracks. Chemical analysis of the base material showed a very low level of sulphur ($0.001 \div 0.003\%$), allowing us to eliminate sulphur as a factor in the hot cracking mechanism in the HAZ.

Fig. 3. Intergranular character of cracks in the HAZ

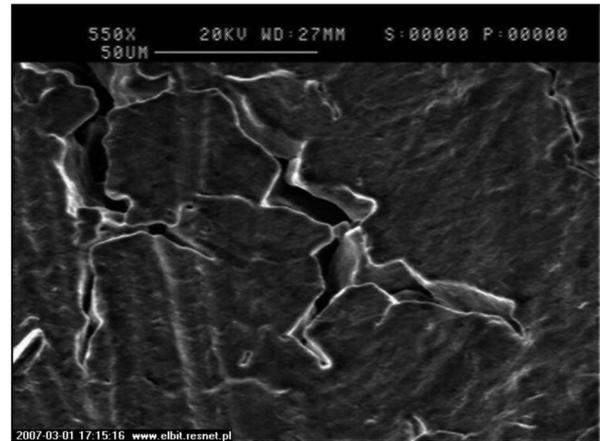
Fig. 4. Intergranular character of cracks in the HAZ. Significant width of the cracks is distinctive

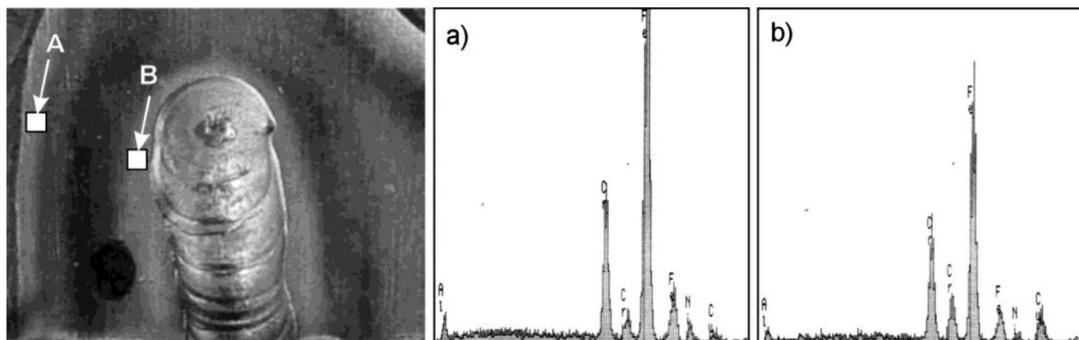
In spite of welding in a protective atmosphere of very high purity shielding argon in the so called “argon balloon”, the steel surface in the HAZ was discolored (Fig. 5). Titanium sample piece welded in the same conditions was not discolored in the HAZ. It demonstrates that the argon used as a protective atmosphere was of high purity and that the dark tarnish on the 17-4PH steel surface is not a result of oxidation processes resulting in oxide scale formation. Chemical microanalysis (using SEM Energy Dispersive X-Ray EDX) in the area of HAZ (Fig. 5b) and beyond the HAZ (Fig. 5a) has shown a distinct enrichment of copper in the HAZ area. Similar martensitic steels which do not contain copper (e.g. X3CrNiMo13-4) do not exhibit the susceptibility to the formation of micro cracks that is observed in the HAZ of 17-4PH steel, which contains $3 \div 5\%$ of Cu. These observations have led us to the hypothesis that the presence of Cu is a primary cause of the hot crack formation.

Fig. 5. Colored tarnish in HAZ along with depiction of chemical microanalysis areas: a) microanalysis deriving from area A, b) microanalysis deriving from area B

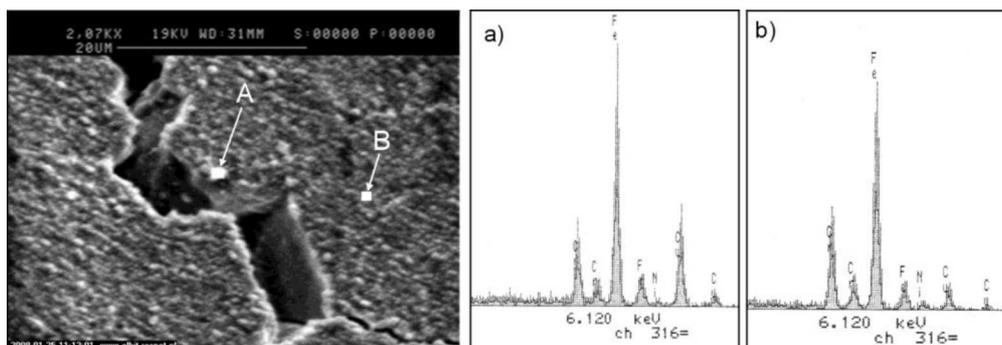
Fig. 6. Surface condition in the HAZ in the vicinity of the crack along with depiction of chemical microanalysis areas; a) microanalysis deriving from area A (crack edge), b) microanalysis deriving from area B (slightly off-set from crack edge)

Detailed analysis of the surface in the high temperature area of the HAZ has shown that the products deposited there have morphology typical of gas phase deposition (Fig. 6). The deposition products are enriched in Cu and depleted in Ni (Fig. 6b) when compared with the nominal chemical composition of the base material analyzed beyond the HAZ (Fig. 5a). Copper enrichment is especially pronounced at the edge of the crack (Fig. 6a).

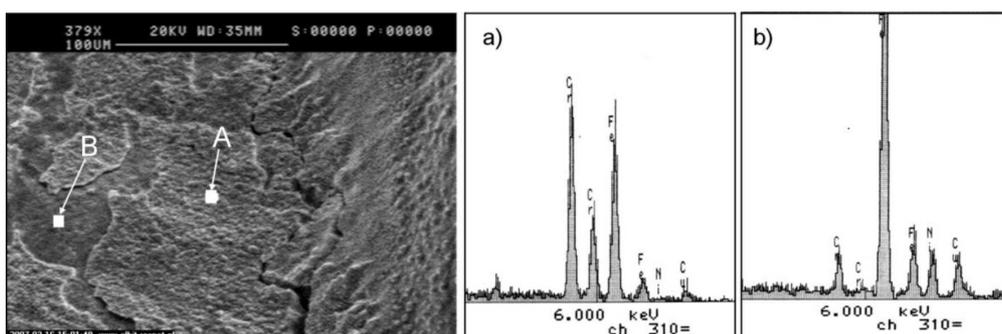
Fig. 7. Cracked and spalling oxide scale in the HAZ in the vicinity of the crack: a) microanalysis of the oxide scale (area A), b) microanalysis of the base metal surface where scale was removed (area B)

In case of imperfect positioning of the welding torch, insufficient shielding of the welded area may occur resulting in the formation of a thick oxide scale. Oxide scale tends to crack and spall during base metal cooling. Fig. 7 shows an example of a thick layer of oxides. Microanalysis of the oxide scale and of the steel surface beneath the scale is also presented in Fig. 7. Microanalysis suggests that selective oxidation has taken place and formed oxides containing mainly Cr and Fe with small amounts of Cu (Fig. 7a). The steel surface underneath the scale is distinctively enriched in Cu and Ni and noticeably depleted in Cr (Fig. 7b).

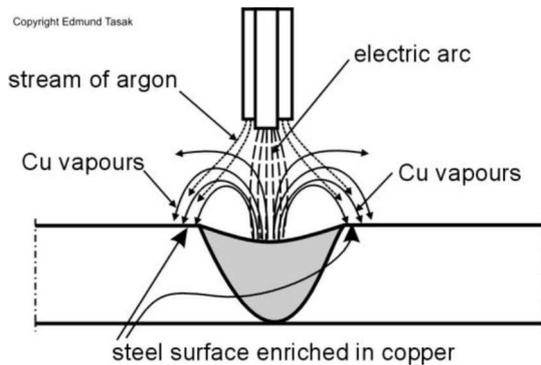
HAZ area. Cu vapor deposition mechanism scheme is illustrated in Fig. 8.

Fig. 8. Mechanism of surface enrichment in copper in the HAZ area. Copper and Cu oxides vapours deposit and condensate
