CAUSES AND CONSEQUENCES OF WATER FLUX ON THE EXAMPLE OF TRANSVERSE HEADING MINA IN THE SALT MINE “WIELICZKA”**PRZYCZYNY I SKUTKI DOPŁYWU WODY NA PRZYKŁADZIE POPRZECZNI MINA W KOPALNI SOLI „WIELICZKA”**

The causes of disastrous water flux in the historical Salt Mine “Wieliczka“ have been presented on the example of transverse heading Mina at the IV level at a depth of 175 m bsl. The complex geological setting of direct environment of the transverse heading Mina has been described paying attention to unfavorable hydrogeological conditions in the northern part of the salt deposit. The main activities oriented to limiting the water hazard in the Salt Mine “Wieliczka“ and the reconstruction of inner safety pillar, which had been seriously damaged by mining activities, have been analyzed. A selection of objects inside the mine, saved from flooding thanks to protection works has been visualized in photos.

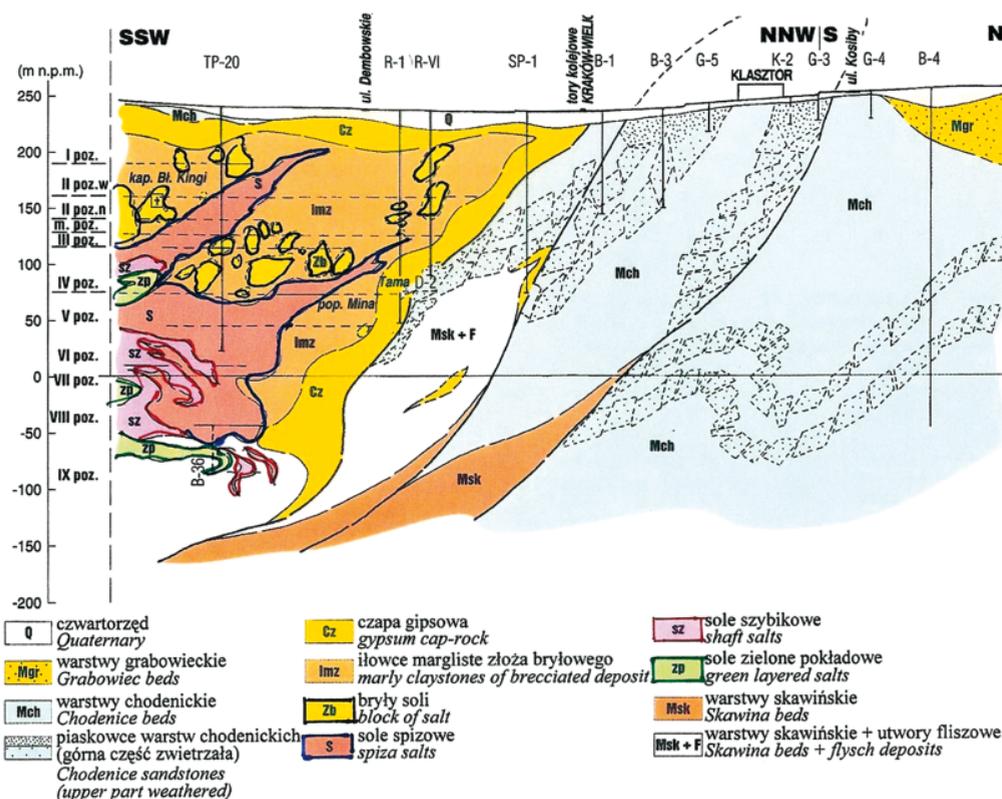
Geologically, the Wieliczka area is composed of the Jurassic, Cretaceous (Carpathian flysch), Tertiary (Miocene) and Quaternary strata. Figure 1 illustrates the complexity of geological setting of the deposit on the example of a cross section of the transverse heading Mina area, whereas cases of complex build of the deposit have been shown in photo 1.

Fig. 1. Cross-section through the northern part of the mine in the transverse heading Mina area

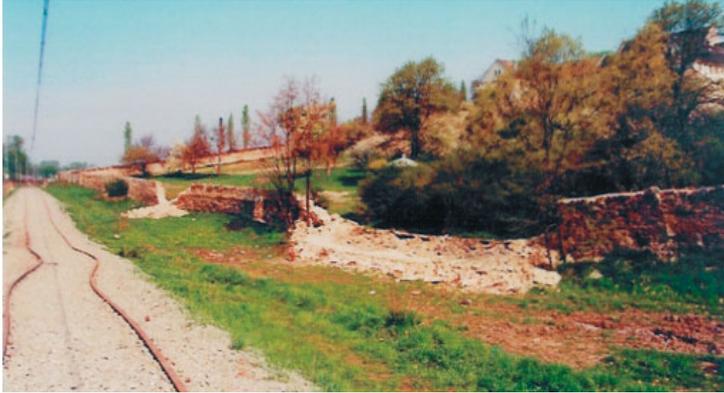
On 11 September 1992 a subsidence trough was observed on the surface. The maximum lowering of the terrain on that day was 0.3 m, to later increase to over 2 m. The railroad (Wieliczka-Wieliczka Marketplace section) became undulated and deformed (Photo 2), and part of the wall around the Reformati monastery collapsed. Dangerous cracks appeared on the walls and ceilings of the monastery (Photo 3) and the neighboring buildings, threatening their stability. Additional factor deteriorating the situation was the fractures (Photo 4) over 1 m in width and 5 m depth in the slope on which the monastery was sited, and cracking of the main collector in the area of the subsidence trough.

Photo 2. A view on the railroad and wall around the monastery

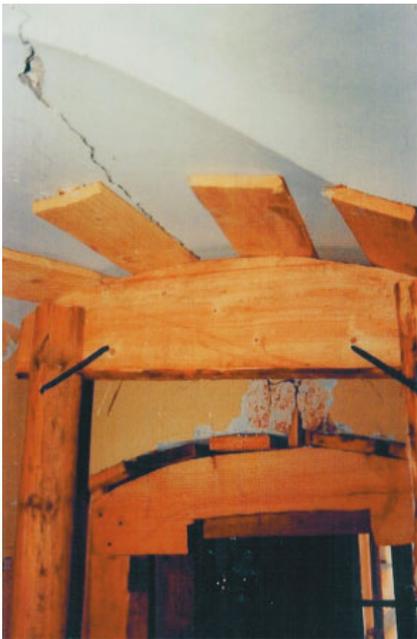
Photo 3. Fragment of supported roof of the monastery

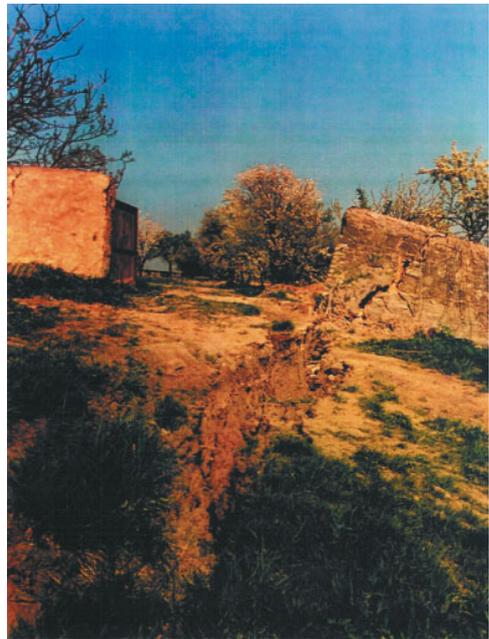
Photo 4. A view on the fractures and wall around the monastery

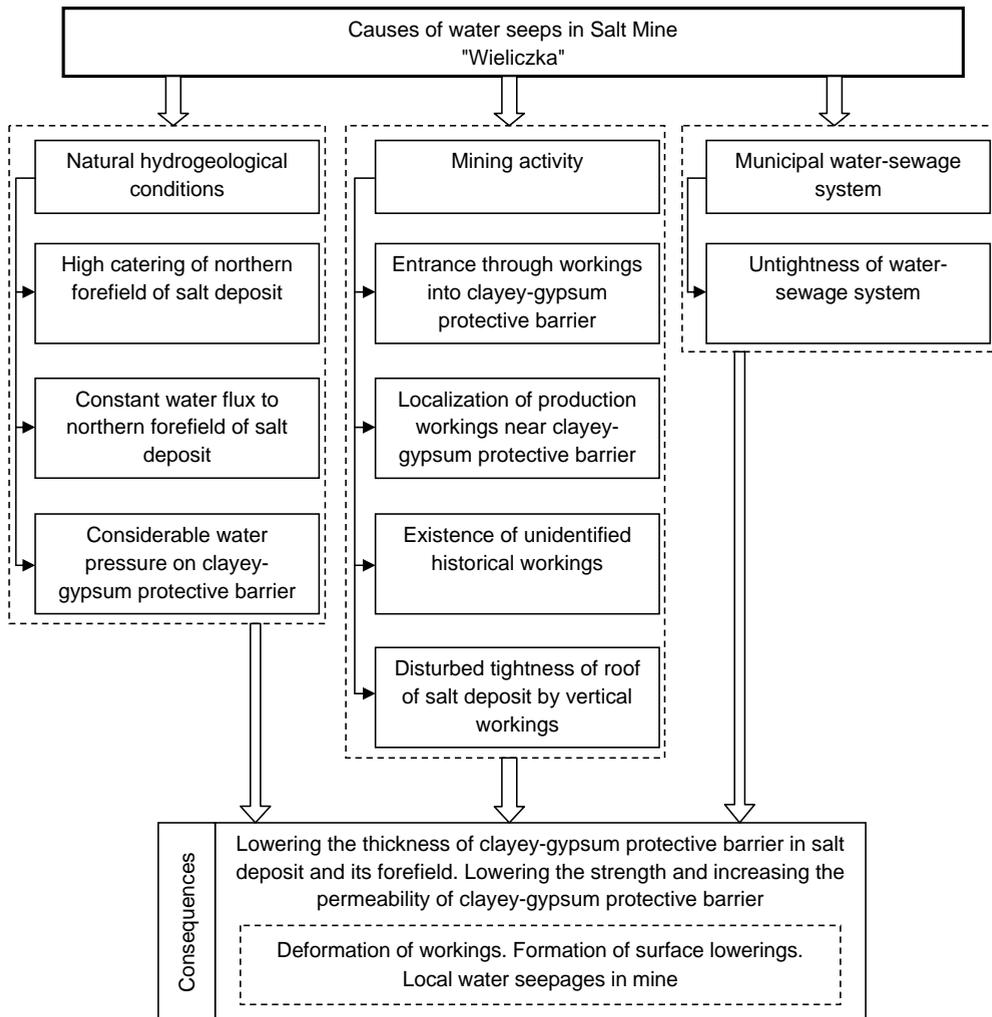
- disturbing of the northern clayey-gypsum screen around the deposit with workings,
- localization of production rooms, sited too close to the clayey-gypsum protective screen,
- existence of unidentified historical workings inside the mine and in the northern forefield of the deposit,
- disturbing the tightness of salt deposit roof with vertical workings, mainly in the form of shafts and backfilling boreholes.

All this resulted in weakening of the safety pillar (Fig. 2), which at a certain point in time could not withhold the pressure of water which rushed into the transverse heading Mina.

Fig. 2. Block diagram illustrating causes of water fluxes in the Salt Mine “Wieliczka”

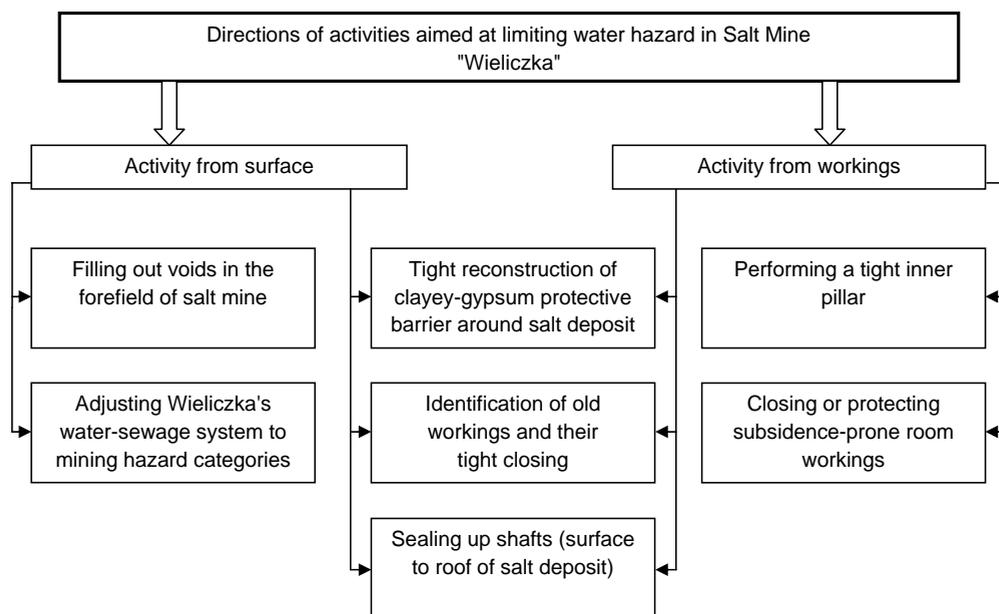
Fig. 3. Activities aimed at limiting water hazard in the Salt Mine “Wieliczka”

This however cannot be done to such outstanding historical object as the Salt Mine “Wieliczka”. There were undertaken multidirectional activities both from the surface and from accessible workings. The linking of hole injection and original pipeline injection methods turned out to be a success. Most of the operations have been presented in detail in numerous papers (Garlicki et al., 1994-95, Garlicki et al., 2004, Gonet & Stryczek, 1995, Stryczek & Gonet, 1992) therefore will not be discussed here. Figure 3 is their brief illustration.

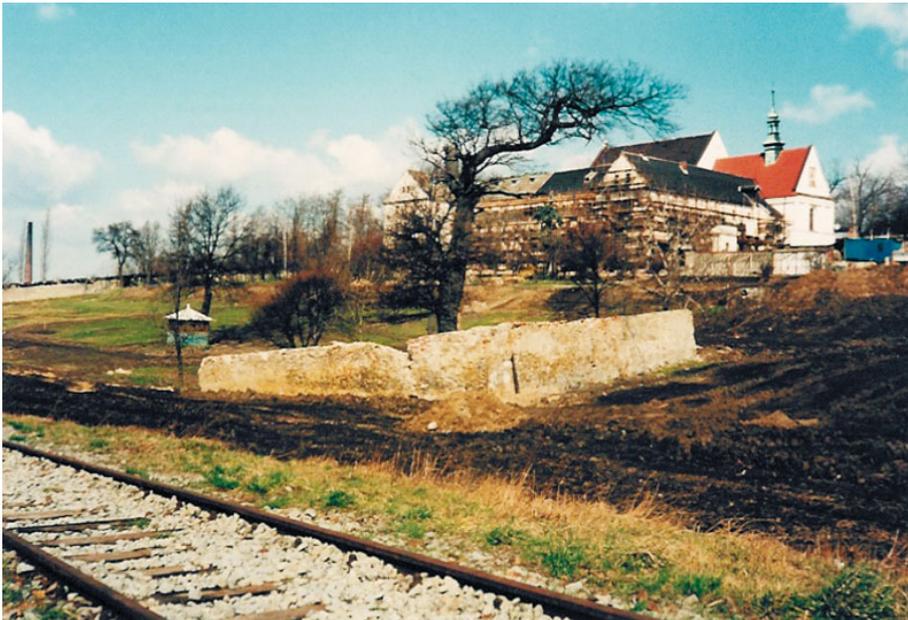
It is also worth noting that in a number of cases preventing potential water fluxes turned out to be far more advantageous than fighting with the consequences, administering very expensive rescue operations and renovation of damaged objects on surface as it was the case, e.g. in the monastery (Fig. 9).

Photo 9. View on the Reformati Monastery during its renovation after a disastrous water flux in the transverse heading Mina
