DOI: <https://doi.org/10.24425/amm.2023.141499>P. PAPLIŃSKI¹, H. ŚMIETANKA¹, P. RANACHOWSKI^{2*},
Z. RANACHOWSKI³, K. WIECZOREK³, S. KUDELA JR⁴

DEGRADATION PROCESSES IN SHIELD-CENTRING ELEMENTS OF SURGE ARRESTERS

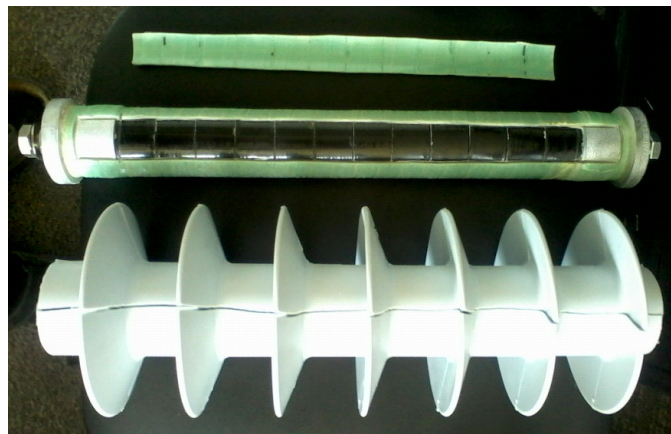
Fig. 1 shows not operated domestic (Polish) surge arrester whose shield-centring element has become a reference sample.

Fig. 1. Unexploited domestic MV surge arrester from 2018, after sectioning and removing the silicone elastomer cover – at the bottom. The cut-out fragment of the shield-centering element served as a reference sample – at the top. In the centre, the pile of varistors is visible

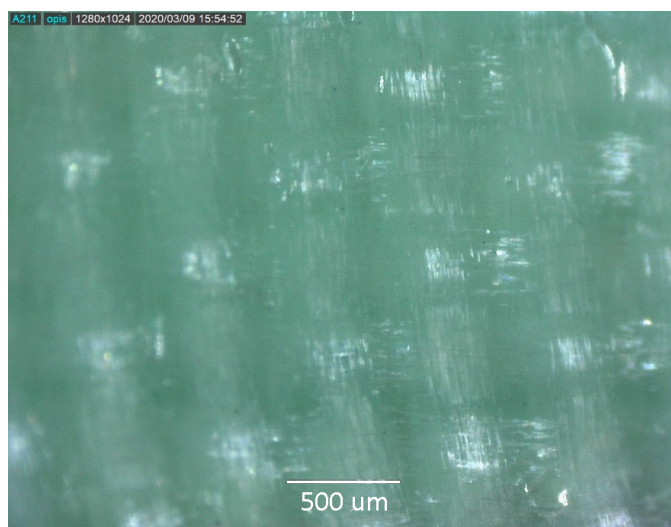
Fig. 2 shows the reference sample for the material under investigation. The fibres of the textile support were covered with a layer of transparent epoxy resin and were under the surface of the textolite. Fig. 3 shows the EDS test results of the surface of the initial material, for which the elemental composition was determined. The epoxy resin, the laminate binder present on the surface of the material, contained 76.6% carbon (C) and 23.4%

Fig. 2. OM image of the surface of textolite taken from an unexploited surge arrester, magnified 40 times. The textile weave made of fibreglass under the transparent resin layer can be seen

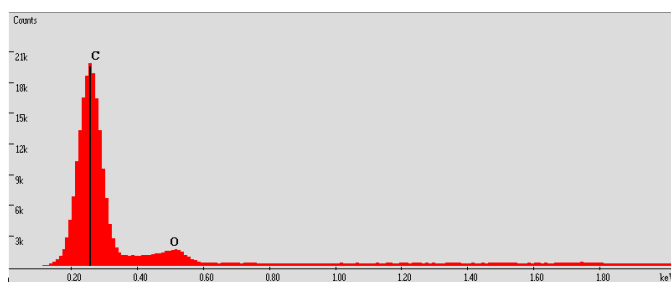
oxygen (O) by weight; the hydrogen (H) content was omitted – as it cannot be recorded using the EDS technique. The elements present in the fibreglass textile support – primarily silicon (Si) and calcium (Ca) – were not recorded, because they were covered with the organic resin layer.

Fig. 3. EDS spectrum obtained for the textolite surface from an unexploited surge arrester. Only carbon and oxygen, derived from the organic epoxy resin, were recorded

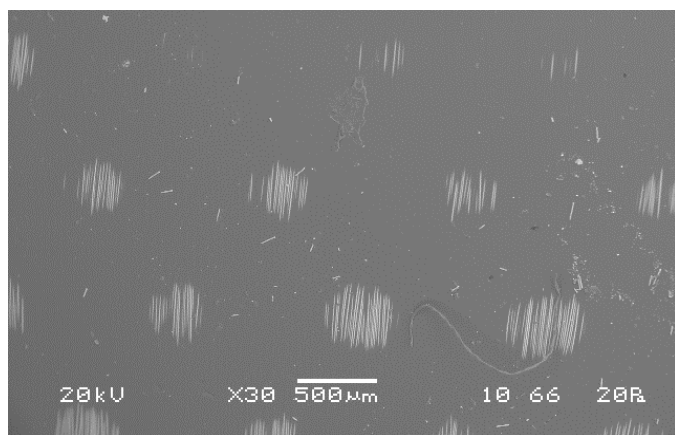
As a result of the flow of discharge currents and a local rise in temperature, the organic binder – epoxy resin – was melted and charred in some areas of the shield-centring elements. After the surface layer of resin has melted, fibre bundles from the textile support appeared on the surface of the material – Fig. 4. Fig. 5 presents the results of EDS analysis of the material surface in the area of slight degradation, with determined elementary composition. The surface of the material contained, besides carbon (78.0%) and oxygen (18.6%), also 1.6% of silicon and 1.0% of calcium, which came from these roving glass fibres on the surface of the laminate. Also minor admixtures of aluminium (Al) and magnesium (Mg) came from the glass. The degree of textolite degradation was not yet high and hence a small proportion of silicon and glass admixtures.

Fig. 4. SEM image of the textolite surface with weak degradation, magnified 30 times. Bundles of light-coloured roving fibres can be seen, which appeared on the surface of the laminate after the top layer of epoxy resin has melted

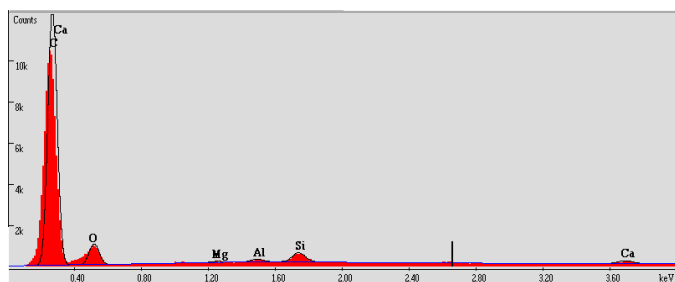
Fig. 5. EDS spectrum recorded for the textolite with slightly visible degradation in the form of a small content of elements present in the glass roving support (silicon, calcium, aluminium and magnesium)

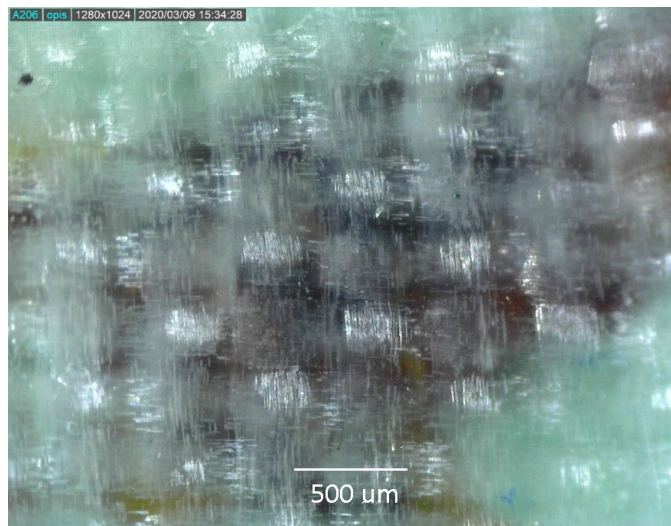
As the degradation effects progressed, more and more areas of charred epoxy resin were observed as a result of the discharge currents – Fig. 6. These areas kept increasing and the degree of charring of the organic phase intensified. Even where the resin was not yet heavily carbonised, its outer layer was melted to such an extent that the textile support was more and more noticeable on the surface. The fibre bundles can be seen particularly well in the SEM images – Fig. 7.

Fig. 6. OM image of the surface of the textolite with visible degradation, magnified 40 times. A part of the sample is clearly charred, and the shining fibre bundles of the roving support emerged on the surface after melting of the top resin layer

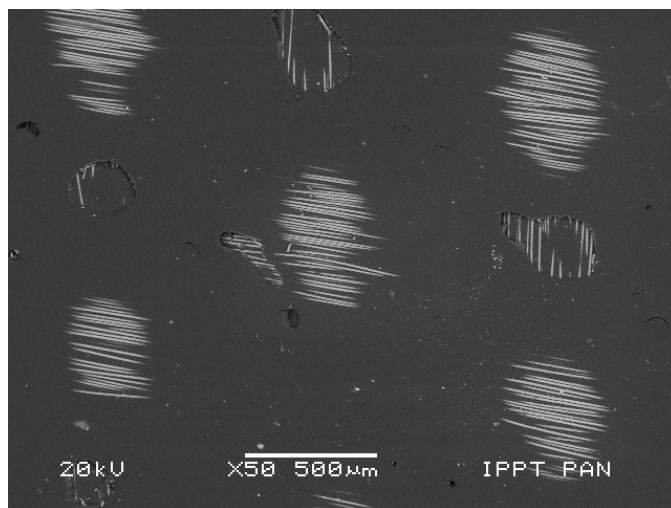
Fig. 7. SEM image of the textolite surface with advanced degradation, magnified 50 times. In the top layer of the material the resin is melted to a large extent. Bundles of bright roving fibres emerge from under it. There are also melted indentations in the resin

EDS analysis of the textolite with advanced degradation – Figs 6 and 7 – indicated an already pronounced content of the glass roving in the elemental composition of the material surface. The content of carbon (74.1%) and oxygen (16.9%) were reduced by several percent. This proves a significant loss of

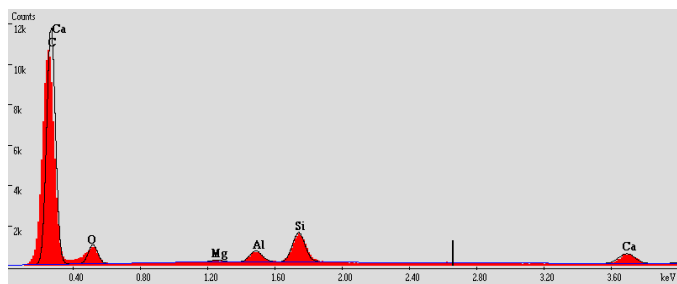
the organic phase – epoxy resin in the top layer of the textolite. At the same time, the amount of elements present in the glass increased: silicon to 4.6%, calcium to 2.9% and aluminium to 1.4% – Fig. 8. In total, they accounted for about 9% by weight of the laminate surface, excluding the oxygen part. The temperature rise resulting from the discharge currents, in some areas of the shield-centring elements, must therefore have been large, exceeding 200°C.

Fig. 8. EDS spectrum recorded for the textolite with advanced degradation effect. Significant proportion of elements present in the glass textile support: silicon, calcium and aluminium is visible

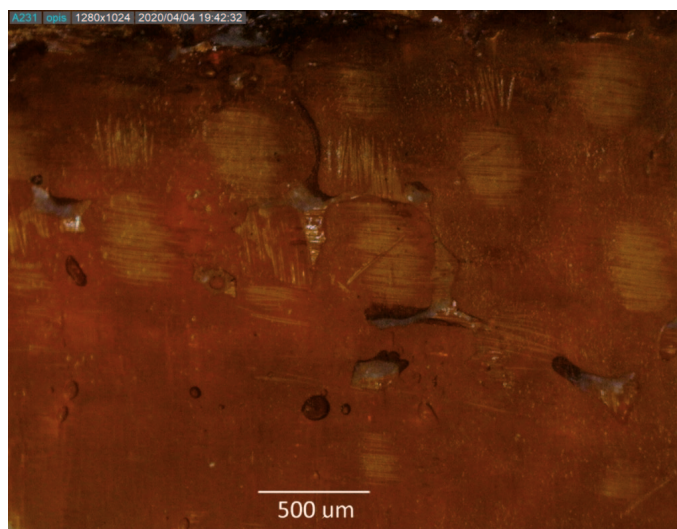
As a result of the flow, especially over a long period of time, of strong discharge currents, there must have been a large local growth in temperature – even reaching 300°C. As a consequence, the degradation of the organic epoxy resin increased in some areas of the shield-centring elements. Fig. 9 shows an OM image of the textolite from an operated surge arrester, where the charring of the resin has reached a high level. This is evidenced by the change in colour of the textolite to much darker. Fragments of the material showed a high variation in the degree of degradation. The temperature was then only high in specific areas of the shield-centring elements. In these areas, strong or even very strong degradation of the laminate effects were observed.

Fig. 9. OM image of the textolite surface with strong degradation, magnified 40 times. A fragment of the sample material has been considerably charred – the colour of the textolite has changed. Bright fibre bundles of the roving textile support can be seen. When the top layer of resin melted, these were found on the surface of the laminate

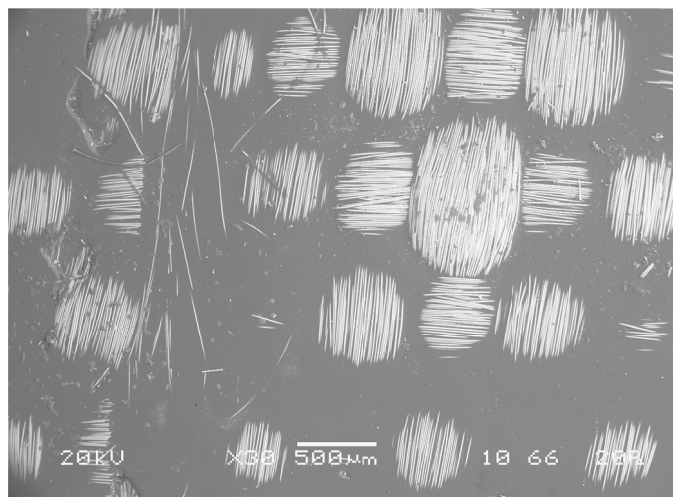
A number of flows of high discharge currents led to significant melting of the organic epoxy resin, especially of its top layer partial charring and even burning. As a result, numerous fibre bundles from the roving textile support are clearly visible in the SEM images – Fig. 10. Consequently, elements from the glass are a significant component in the elemental composition of the surface layer of the material.

Fig. 10. SEM image of the surface of the textolite with very strong degradation, magnified 30 times. The resin on the top layer has been considerably melted. Numerous bright bundles are visible on the surface, as well as individual glass fibres with areas of damaged roving

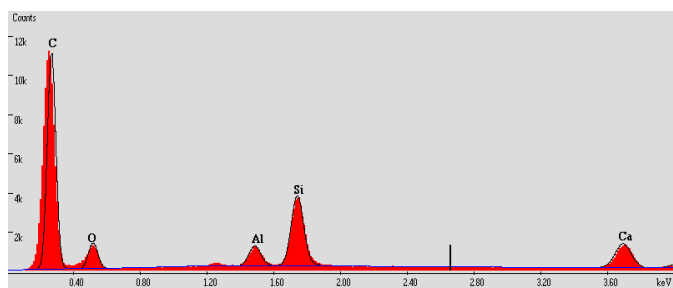
Fig. 11 shows EDS analysis of a very heavily degraded surface of the textolite. The carbon content remained at 68.0%, compared to the original value of 76.6%. The amount of elements present in the glass increased significantly: silicon to 8.4%, calcium to 5.5% and aluminium to 2.6% – a total of 16.5% (excluding oxygen). The epoxy resin from the surface layer of the laminate has melted and has been partially charred and burnt.

Fig. 11. EDS spectrum recorded for the textolite with very strong degradation. There is a significant proportion of elements present in the glass roving: silicon, calcium and aluminium. Oxygen is present in both – organic and inorganic phases

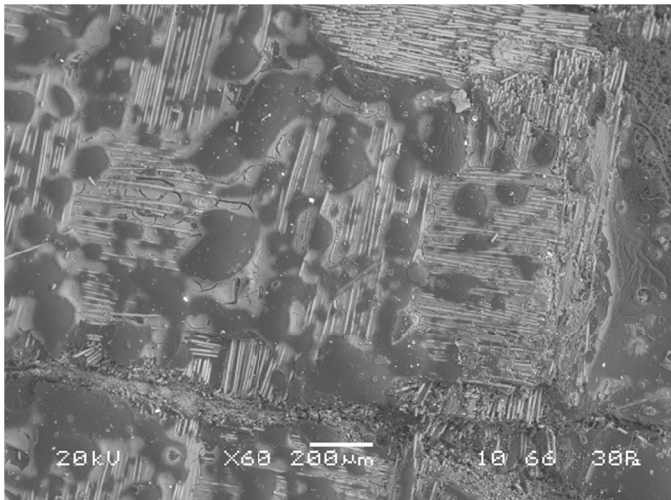
High local temperature rise led to very strong degradation of the laminate in some areas of the shield-centring elements of surge arresters. In extreme cases, the organic epoxy resin melted and was charred, cracked or even burnt out. An example of very

severe damage to the textolite structure and exposure of the textile roving support is shown in Fig. 12.

Fig. 12. SEM image of the textolite surface with very strong degradation, magnified 60 times. The resin on the top layer of the material has largely melted; it is charred and burnt. As a result, the roving support has become visible
