ŁAZIENKOWSKI BRIDGE FIRE IN WARSAW – STRUCTURAL DAMAGE AND RESTORATION METHOD

H. ZOBEL¹, W. KARWOWSKI², M. WRÓBEL³, P. MOSSAKOWSKI⁴

On the 14th of February, 2015, a huge fire broke out on Łazienkowski Bridge; a five span bridge, 423 m long and 28 m wide, built in the years 1972-74. It was a fully steel structure with four plate girders and orthotropic deck. The fire started under the first span during the replacement of wooden service decks. The next day, the Department of Bridges of the Warsaw University of Technology was designated to conduct an expertise material investigation, geometrical verification, and FEM model analysis. The subject of this paper concentrates on geometrical issues. The main difficulty of this task was the lack of full reference data regarding the bridge's original structure. The old design was incomplete and there was no actual surveying results for the undamaged structure. As a conclusion, some remarks focused on surveying measurements and on the final decision regarding this bridge are given. It was eventually exchanged into a brand new one and put into public use on the 28th of October, 2015.

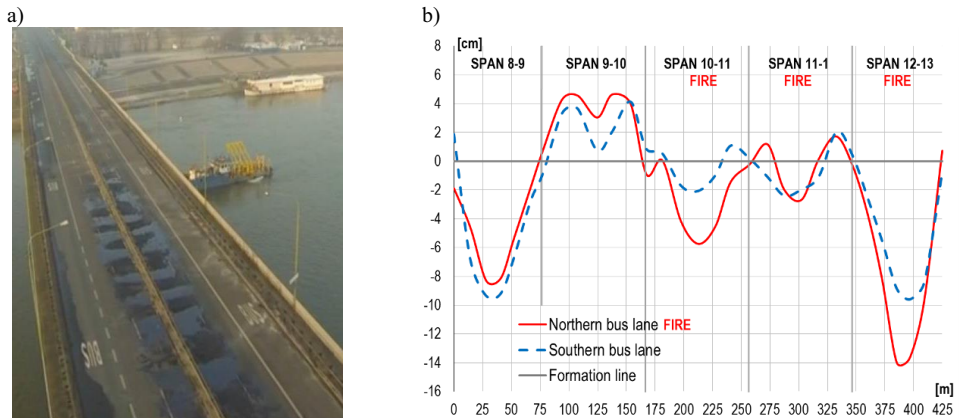
First, there was enormous noticeable damage to the deck; extensive, deep bulges of the plate of the orthotropic deck in the central part of the traffic lanes (Fig. 3 a). In the span 12-13, values of local differences were up to 30 cm, mostly around 15-20 cm. From the bottom view of the deck there was a visible loss of stability of the longitudinal ribs. This kind of damage was observed in the area of the deep bulges of the orthotropic deck as well as in the area without those bulges. The plate on the bus lanes was locally flat and no damage of insulation and asphalt pavement was observed. Only upon further surveying the measurements showed that this part of the structure was also deformed as noted by the shape of the strong deflected girders (Fig. 3 b).

Fig. 3. First view of the damaged structure: a) top view of destroyed central part of traffic lanes and deceptively undestroyed bus lanes [www.gazeta.pl], b) comparison of the bus lane formation lines

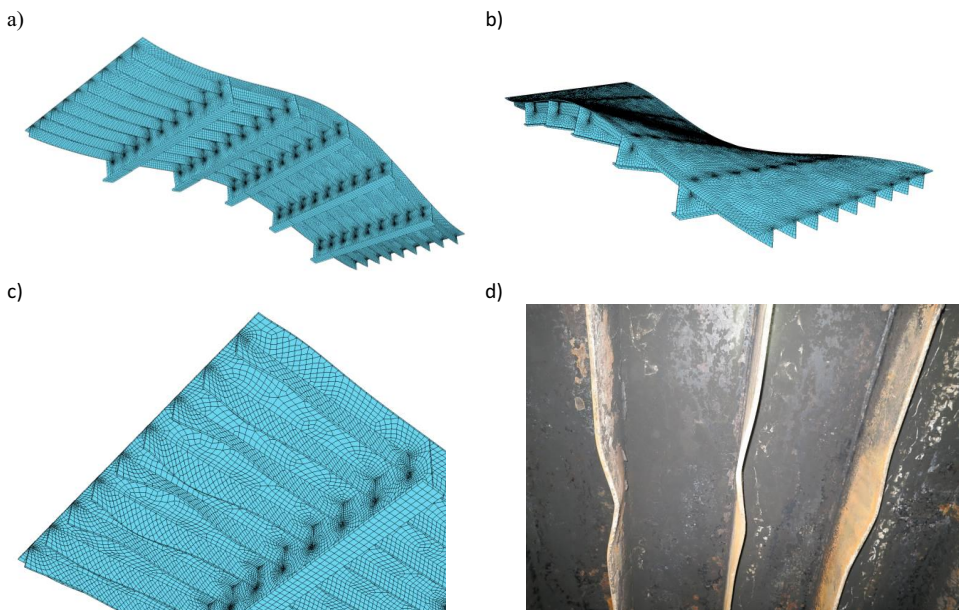
FEM analysis (with simplified boundary conditions – only local actions) was done to determine the internal forces which could cause observed displacements. The results showed different forms of local failure (Fig. 5 a, b c), which could be found on the real structure (Fig. 5 d).

Fig. 4. Loss of stability of the orthotropic deck: a) FEM analysis in temperature 100°C-115°C – bending form of loss of stability, b) FEM analysis in temperature 115°C-125°C – bending-torsion form of loss of stability, c) FEM analysis in temperature 150°C-175°C – warping of longitudinal ribs, d) real warping of longitudinal ribs of bus lane part

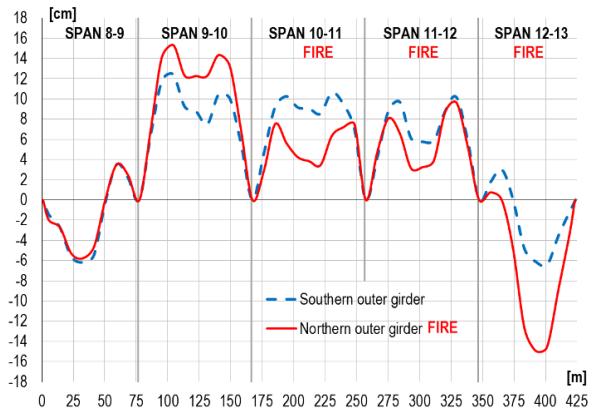
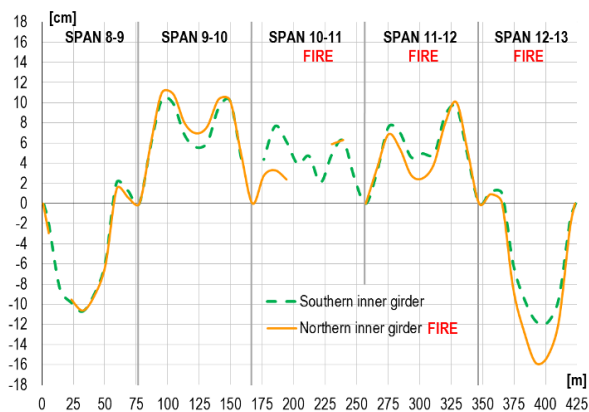
Excessive deflection of the two northern girders was observed. The northern external girder was lower comparing to the southern one by 58 mm, 32 mm, and 81 mm, for spans 10-11, 11-12, and 12-13, respectively (Fig. 5 a). The northern internal girder was lower comparing to the southern one by 46 mm, 22 mm, and 33 mm for spans 10-11, 11-12, and 12-13, respectively (Fig. 5 b).

Fig. 5. Comparison of girders deflection: a) external , b) internal (some data was impossible to collect because of impeded visibility of bottom flange)

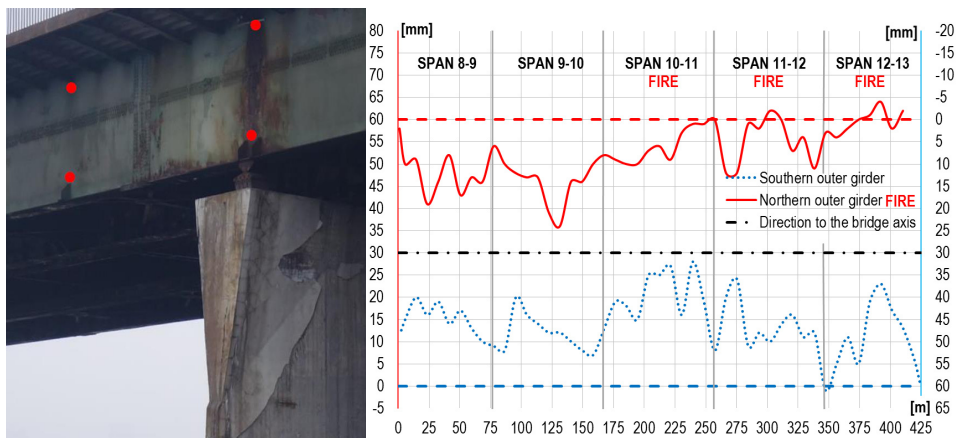
As a result of the fire there was a torsional deformation of the whole cross section of the bridge in spans 10-11, 11-12, and 12-13, a result of the shrinkage of the total steel structure in the transverse direction, and deflections or bulges of particular elements of the orthotropic deck. The initial shape of the cross-section was symmetrical, and both pairs of girders were slightly inclined to the longitudinal axis of the bridge (which showed the shape of two undamaged spans) after years of work. Surveying after the fire showed that the southern girders rotated in the direction toward the longitudinal axis of the bridge, and the northern girders rotated in the direction opposite to the longitudinal axis of the bridge. Finally, the northern girders in all three spans affected by the fire remained straight, with the southern more inclined (Fig. 6). The total cross-section of the bridge was asymmetrical – “skewed” in the northern direction – and as a consequence the loss of stability of the whole structure was very possible.

Fig. 6. Verticality checking of outer girders: a) example of the measurements points, b) results for the whole structure

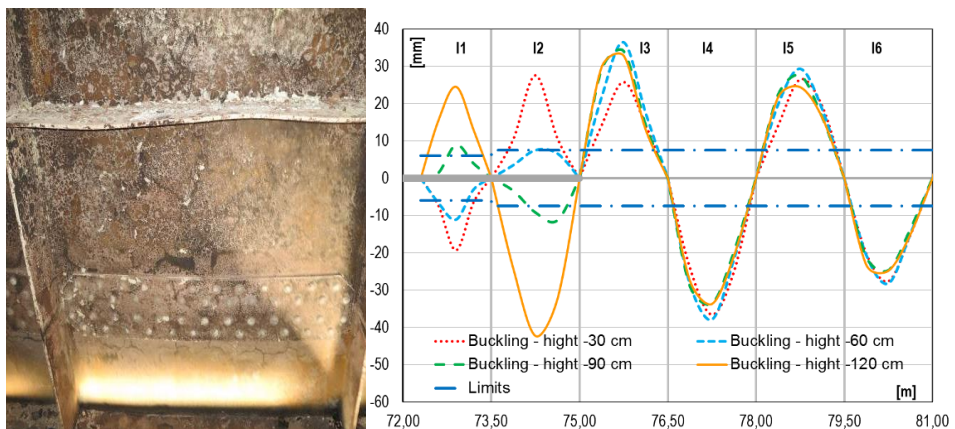
More serious damage to the girders was discovered when it was possible to go under the deck in the close proximity of the girder web. Extensive local bulges of the webs in the internal girders were noticed and later measured. For the northern one (which was most exposed to fire), the curvature was bigger than 40 mm at a distance of 1500 mm (Fig. 7 b). The maximal measured bulges of the northern internal girder were 43,1 mm at span 10-11 and 41,2 mm at span 11-12.

longitudinal ribs was also not linear. The web of the girder lost stability for more than 1500 mm of distance. A comparison of values of standard permissible deformations against measured ones showed that the steel structure was in a state of emergency. Large deformations („waving”) of horizontal ribs stiffening in the upper part of the webs of the internal girders (Fig. 7 a) were also observed.

Horizontal and vertical ribs did not prevent a change of the geometry of the web. High temperatures caused „waving”, thereby losing stability. The damage was much more extensive in the northern girder. An adjacent cold water pipeline secured the southern girder, consuming quite an amount of heat generated by the fire.

Fig. 7. Failure mode of the girders webs: a) picture of local bulges of the web and deformations of the horizontal ribs, b) local bulges of the 9 m long part of the girder 10-11 – values for level of measurements 30/60/90/120 cm below the deck

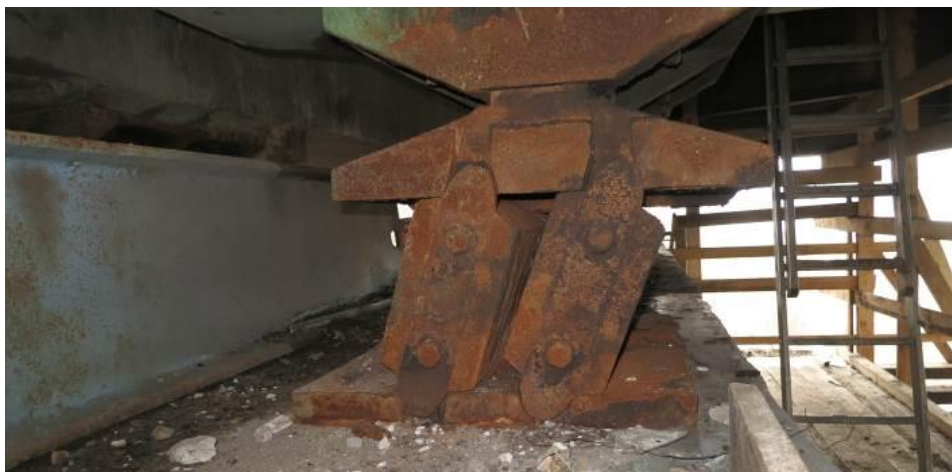
The bearings on pier 13 reached the maximal permissible angle of rotation (Fig. 8) caused by elevated temperatures, which changed the geometry of the steel superstructure. In the case of extreme low temperatures, there was a risk that span 12-13 could fall down. It was winter and the probability of occurrence of temperatures of -25°C is high.

Fig. 8. Maximum permissible rotation of the bearing on the pier 13

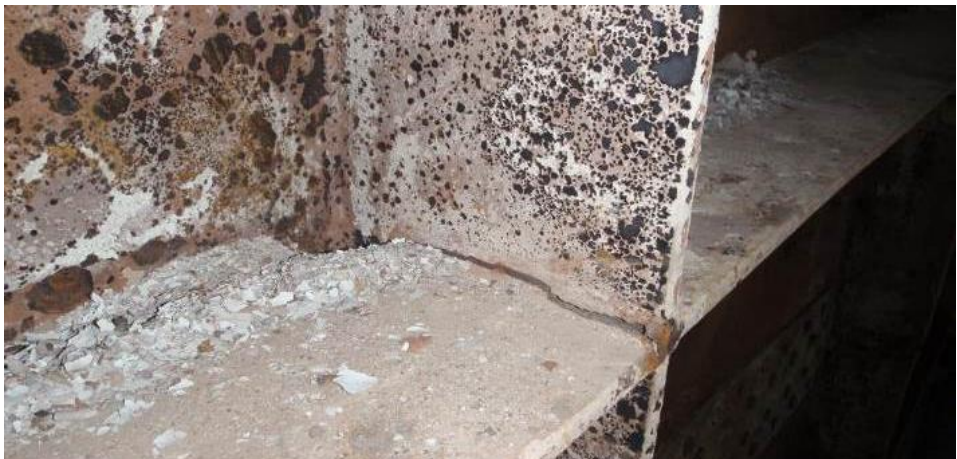
There was a lot of other damage observed, mostly damage of equipment. But there was also very local structural damage such as cracks of welds or shearing of rivets. For example, the investigation found several cracks of welds connected to the vertical ribs with cross-beams of the orthotropic deck (Fig. 9) and with the horizontal rib stiffening web of the internal girders. Many of the rivets were sheared in assembly joints between the cross-beams and the internal girders and in the joints of secondary elements in all three spans. Inventorying all this damage was impossible in reasonable time. Fortunately it would be necessary only in the case of maintenance, which was finally rejected.

Fig. 9. Typical crack of weld

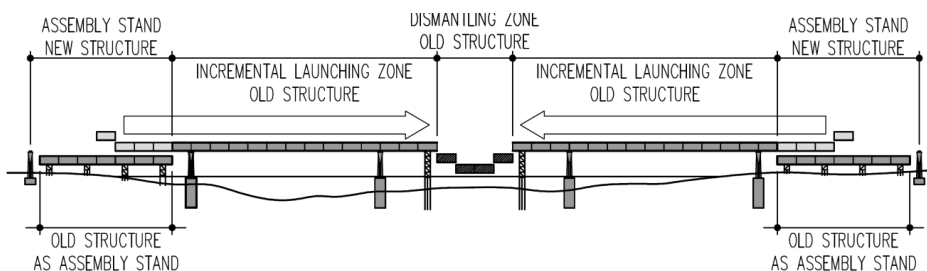
Fig. 10. Replacement method of steel part of Łazienkowski Bridge. During the operation additional temporary support in the middle of right part of the structure was added

The contractor decided to use the modified incremental launching method to construct the new superstructure (Fig. 10). Because of the use of some parts of the old structure in the process of launching, it was possible to avoid temporary supports (except for two) and disassemble the old structure while assembling the new one. This modification required cutting and lowering the outer spans (they consisted of assembly stands) and cutting the rest of the structure in the middle of the middle span. The bridge was divided into two parts. In the beginning, both were one-span, simply supported beams with cantilevers. In such a moment it was easy to compare the deflections of each part. Results of this comparison confirmed the poor condition of the burnt part: it had 10 cm of deflection, comparing to the non-burnt, 22 cm (Fig. 11). Finally, additional temporary support in the middle of span 4 was used.

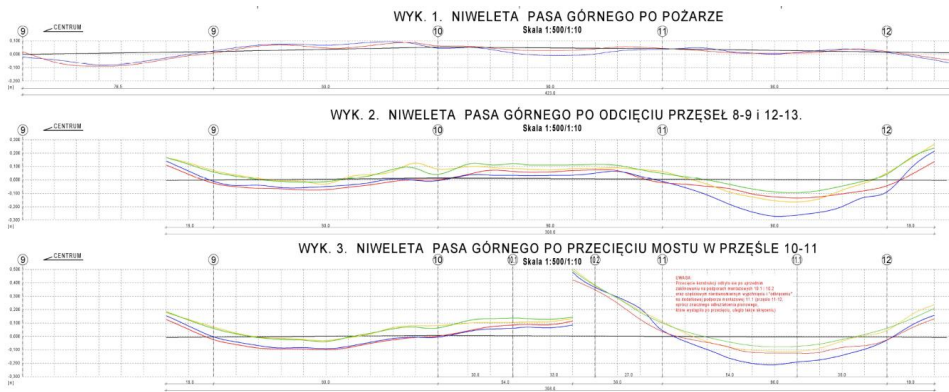
Fig. 11. Original surveying report from contractor of replacement of Łazienkowski Bridge. The third graph shows the huge difference between deflection of burnt and non-burnt spans of the bridge
