CAUSES OF THE CRACKS IN THE PIPELINE MADE OF THE 15HM STEEL

Issues referring to cracks in the pipelines made of the 15HM steel are described. Metallographic specimen of welded joints are provided. The results of impact strength tests, hardness tests and static tensile tests are given. Tests results as well as direct and indirect causes of the pipeline cracks are shown.

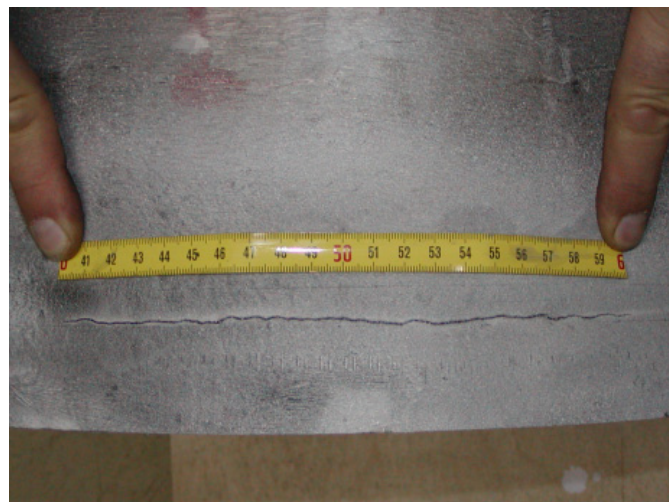
- Crack length of about 210 mm was created from the pipeline's side in the heat affected zone;
- The main crack extends through the entire thickness of the material along the outer border (from the material side) of the heat affected zone. HAZ from the crack's side is much wider than on the side of the collector (Fig. 1);
- The cross-section shows the final phase of the crack. Initiation occurred in the upper part of the weld (the face of the weld) and moves along the outer border of the heat affected zone and then into the zone. Definitely a wider lower part of the HAZ (Fig. 2);

Fig. 1. The main crack - a view from the outer side in the place of the welded joint

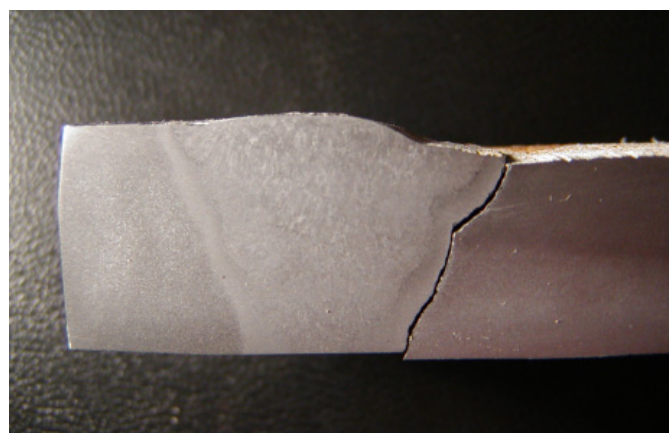
Fig. 2. The main crack from the pipeline's side extending through the HAZ – a cross section

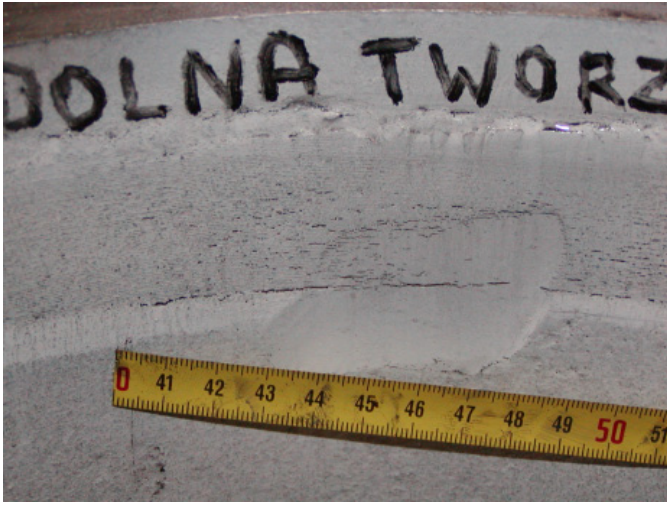
- In the lower generatrix of the pipeline at the place of the change of the thickness of the material are thermal shock cracks with a more visible crack of approximately 70 mm in length (Fig. 3);

Fig. 3. Thermal shock cracks on the inside of the lower generatrix at a distance of 40 mm from an axis of the weld

- In addition to the above-mentioned defects there are also fatigue cracks (thermal shock cracks). These are typical cracks for this type of areas of communication pipelines

located in the area of the collector of the lower generatrix of the pipeline probably caused by an improper operation of the nozzles or cracked protective T-shirts. The scale of observed fatigue cracks, however, is disproportionately smaller than the cracks that caused damages.

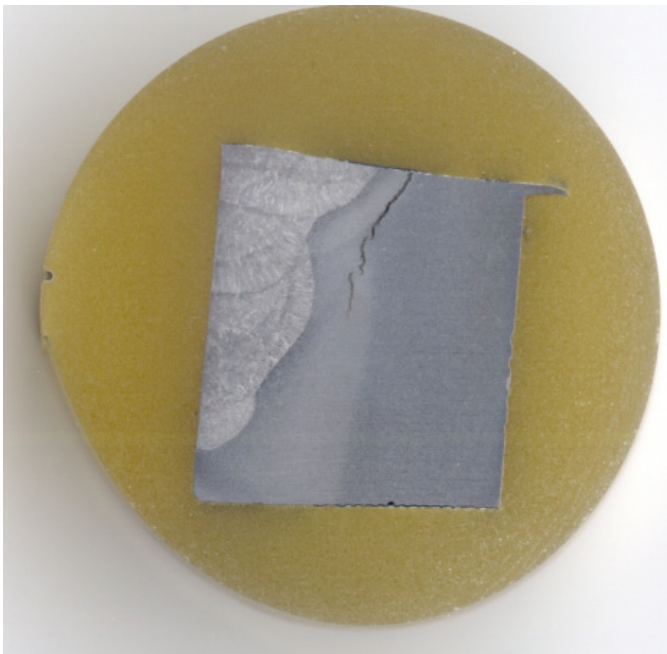
- On the surface of the outer wall is visible the final phase of the crack in the HAZ from the pipeline's side (Fig. 4);

Fig. 4. The main crack from the pipeline's side in the HAZ – a cross section

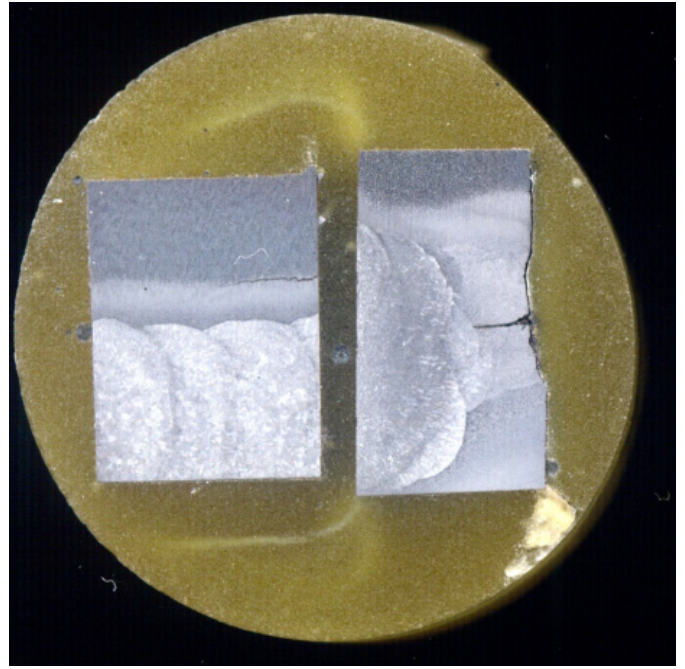
- In the lower generatrix of the pipeline there is a crack of the weld from the root side of the weld in the root pass (Fig. 5);
- In the fusion line there are not any visible cracks. Heat affected zone in the grain layer is much narrower than in the lower part of the joint (Fig. 6)

Fig. 5. The view from the face of the weld, an outer surface – a crack in the HAZ and a cross section – a crack in the weld from the root side of the weld

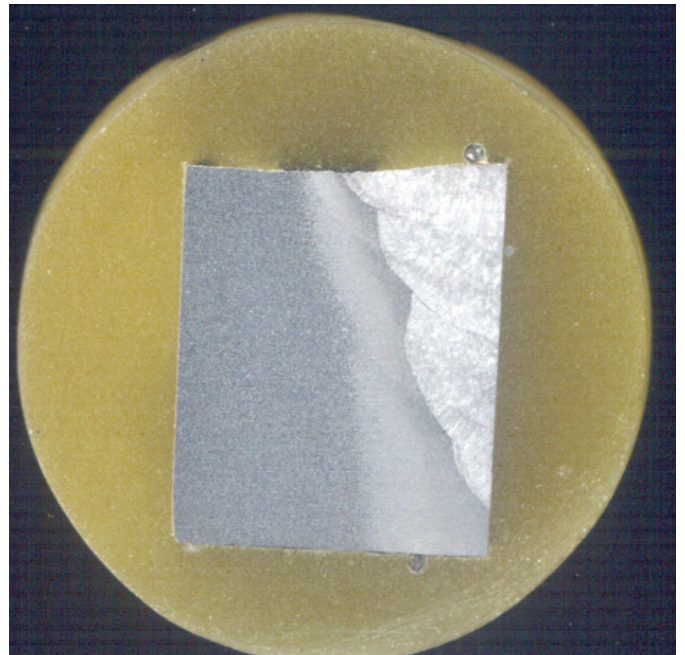
Fig. 6. A fusion line of the weld on the side of the collector – cross-section.

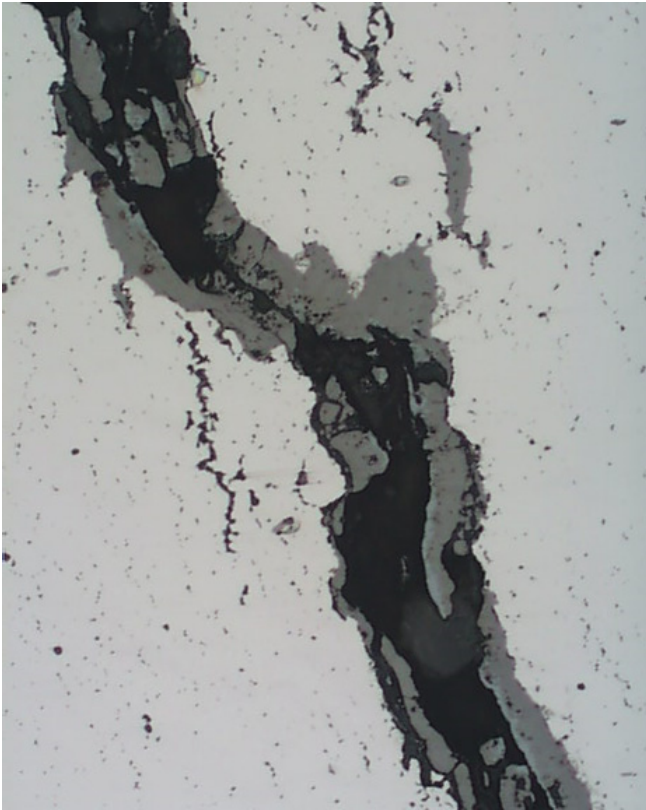
Fig. 7. Material / HAZ – the main crack (on the transition line of the HAZ – pipeline’s material, parallel to an axis of the welded joint) with the grid of oriented microcracks partially filled with oxidation products. Unetched metallographic specimen. Zoom 200×

- HAZ from the pipeline's side directly on the main crack corresponds to the structural changes SIII and physical degradation DV class. A degree of exhaustion was determined at 100%;
- base material in the vicinity of the main crack of the pipeline corresponds to the structural changes class SIII and physical degradation DIV. A degree of exhaustion was determined at 85%;
- base material of the pipeline (bottom generatrix) corresponds to the structural changes SII / SIII and physical degradation DI class. A degree of exhaustion was determined at 45%;
- a weld corresponds to structural changes SII and physical degradation DII class. A degree of exhaustion was determined at 45%

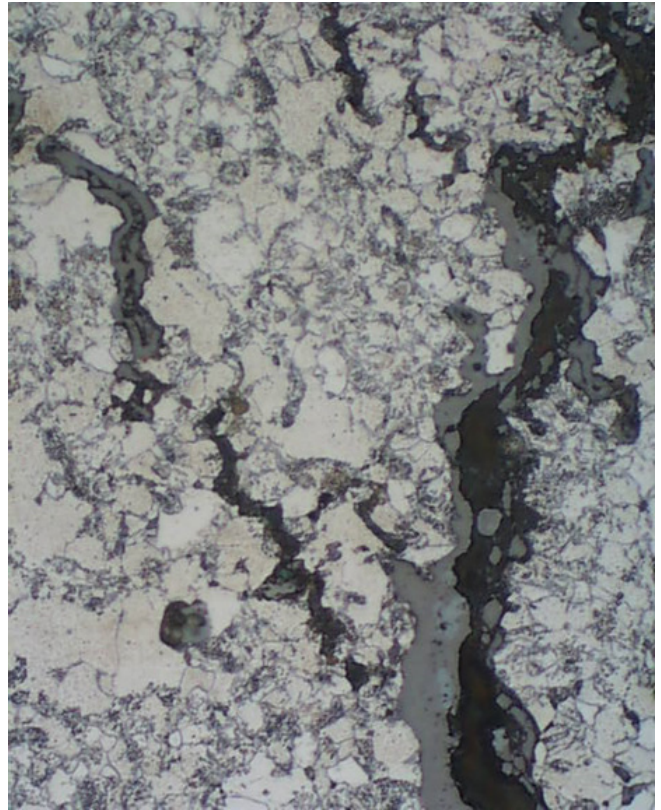
Fig. 8. HAZ – the bainite type of a structure. The disintegration of the primary structure, grids of intercrystalline macro and microcracks, and the chains of creeping micropores on the grain boundaries. Zoom 500×

- An indirect reason of a damage of the welded joint was a process of creeping caused by a long-term influence of elevated stresses and a high temperature on the material of the welded joint. Creeping effects in the form of micro- and macro-cracks are visible especially in the transition from the HAZ into the base material in the pipeline.

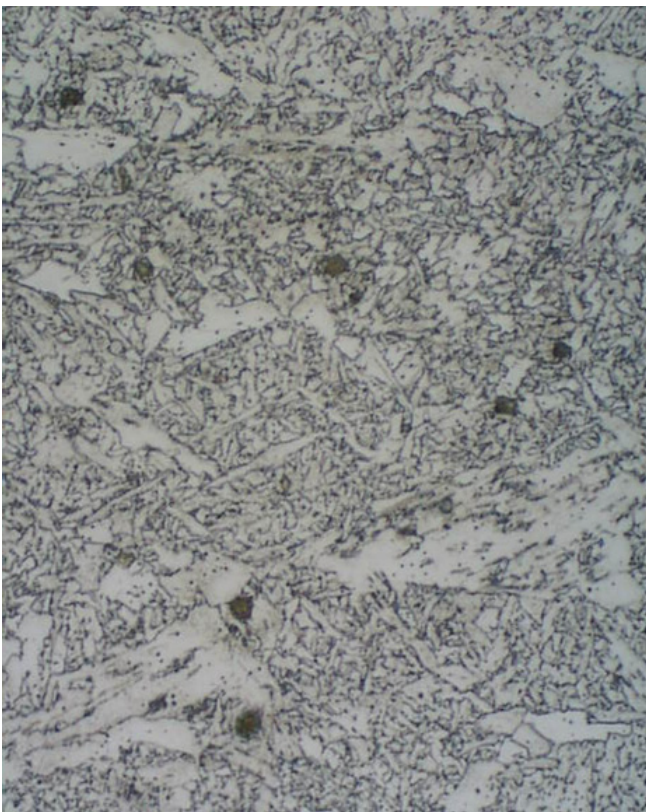
Fig. 9. The weld – a bainite type of a structure with a ferrite grid on the borders of a former austenite. There are visible single creeping micropores. A partial disintegration of the primary structure. Zoom 500×

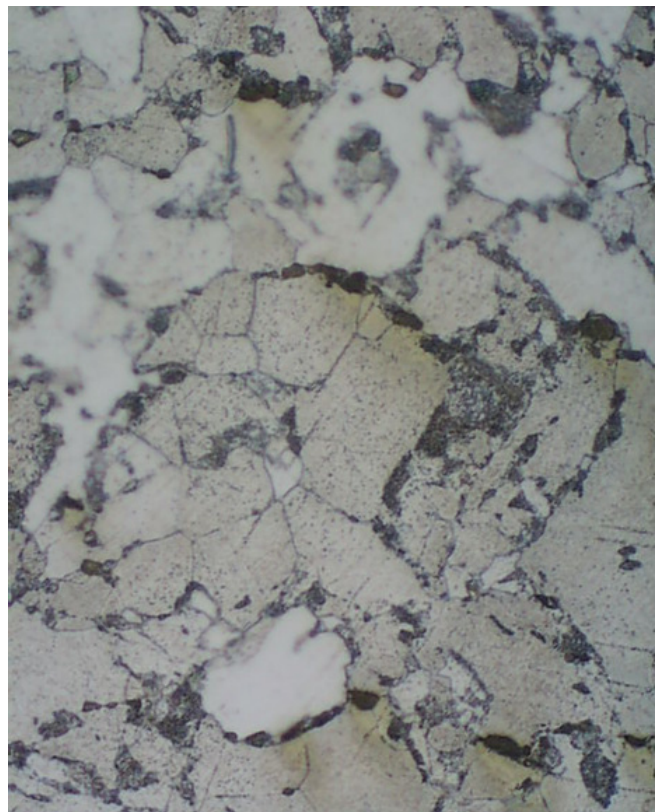
Fig. 10. A base material of the pipeline – a disintegration of the primary structure, grids of intercrystalline macro and microcracks, and the chains of creeping micropores on the grain boundaries. Zoom 500×

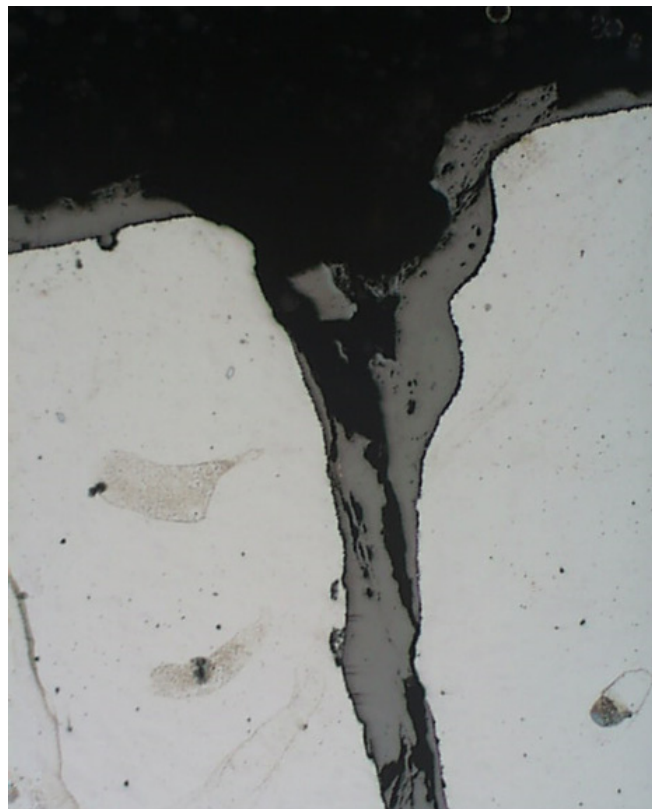
Fig. 11. A material of a welded joint (bottom generatrix – the root of the weld). A visible thermal shock crack with a distinctive wedge shape with the rest of the corrosion products. Unetched metallographic specimen. Zoom 50×
