M. HAWRYLUK^{*#}, Z. GRONOSTAJSKI^{*}, M. KASZUBA^{*}, J. KRAWCZYK^{*},
P. WIDOMSKI^{*}, J. ZIEMBA^{*}, M. ZWIERSZCHOWSKI^{*}, M. JANIK^{**}

WEAR MECHANISMS ANALYSIS OF DIES USED IN THE PROCESS OF HOT FORGING A VALVE MADE OF HIGH NICKEL STEEL

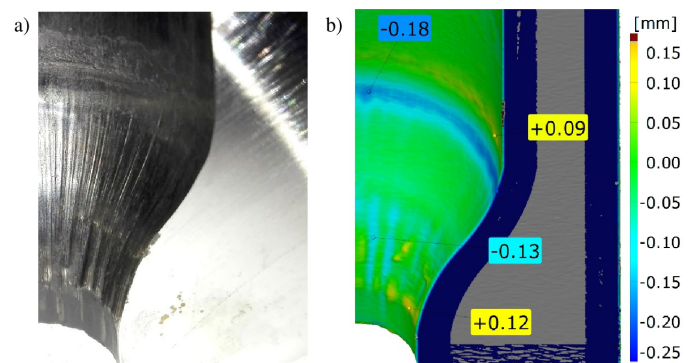
Fig. 3 shows a view and the scan of ¼ working surface of a tool which has operated through 900 forging cycles. On the tool surface, we can observe traces of abrasive wear – abrasive

Fig. 3. The tool surface after 900 working cycles: a) macro view, b) comparison of laser scan image with CAD model

grooves, about 0,1 mm deep, formed along the direction of the forging material shift on the tool surface (area II). The biggest loss (−0.18 mm) is observed in the area of the tool's contact with the sharp edge of the charge material cut from bars (area II, point 1).

Also, we can observe locally present material allowances reaching 0.12 mm, which probably represent the areas of plastically deformed tool surface. The allowances may also mean the high nickel steel charge material being stuck to the die surface.

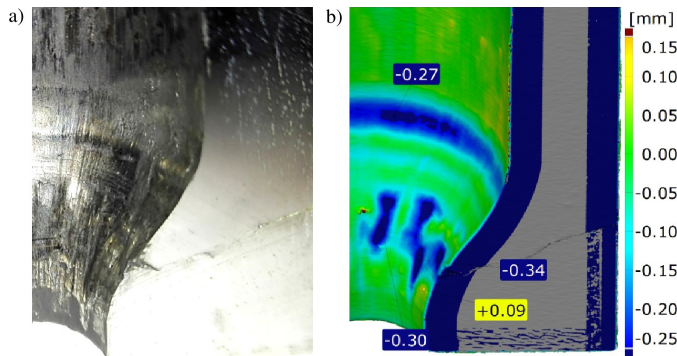
Fig. 4. The tool surface after 1900 working cycles: a) macro view, b) comparison of laser scan image with CAD model

The highest wear was observed on the surface of the tool which worked through the biggest number of forging cycles, i.e. 1900 (Fig. 4). The material losses reach 0.30–0.34 mm and are extensive. On the surface, we can also notice cracks and traces of plastic deformation in the surface layer, visible on the surface in the form of deformed cracks as well as protruding fragments constituting the allowance whose values reach over 0.15 mm.

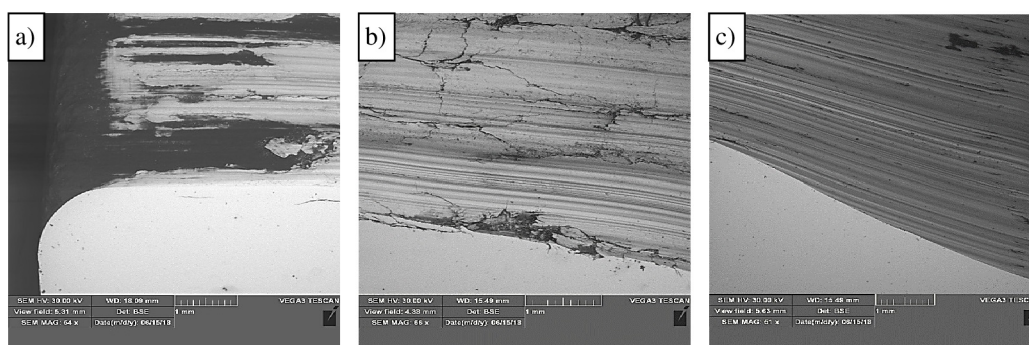
On the tool's surface (Fig. 11), after it has produced 900 forgings, we can observe oxide layers in the area of the radius and the throat (Fig. 11a-b). Layers of this type characterize in a different shade of grey during the analysis performed with the use of a BSE detector on a scanning electron microscope. In Figures 11a-b, they are visible as the darker zones in the areas between the thermal fatigue crack networks. It is also possible to notice production impurities on the surface (in the crack area). Fig. 11b shows deep grooves originating from abrasion wear. The direction of the grooves is in accordance with the direction of the forging material flow. Grooves of the same direction are visible in the other analyzed areas (Fig. 11c). Fig. 12 shows the results of the SEM analysis for 3 main selected tool areas for the first operation of forging an engine valve, after 1900 forgings.

Fig. 11. View of the analyzed die surfaces after producing 900 forgings: a) zone I, b) zone II, c) zone III

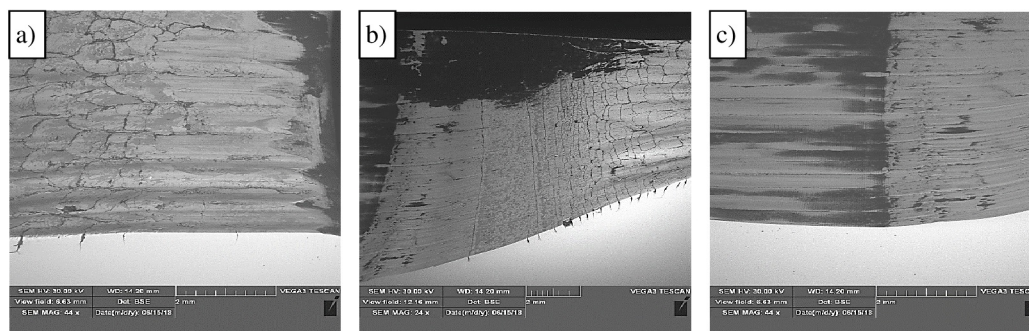
For the analyzed die, which produced 1900 forgings, we can observe the presence of a small layer of oxides in the area of the radius and the throat (Fig. 12a-b) – there are some darker areas visible during the tests with the use of a BSE detector. The EDS analysis confirmed those areas to contain iron oxides. What is more, Fig. 12a and Fig. 12b show deep grooves originating from abrasion wear. The direction of the grooves is in accordance with the direction of the forging material flow. In this area, we can observe a large number of cracks originating from thermal fatigue, which, in some areas, are plastically deformed. This may prove a loss of stability of the surface layer and its tempering. A result of this phenomenon is a drop of hardness in this area. Grooves of the same direction are visible in the other analyzed

Fig. 12. View of the analyzed die surfaces after producing 1900 forgings: a) zone I, b) zone II, c) zone III

areas (Fig. 12c), while, in this zone, it is possible to observe an almost complete removal of the surface layer (scale and worn tool material), which was not observed for the die after 900 forgings.

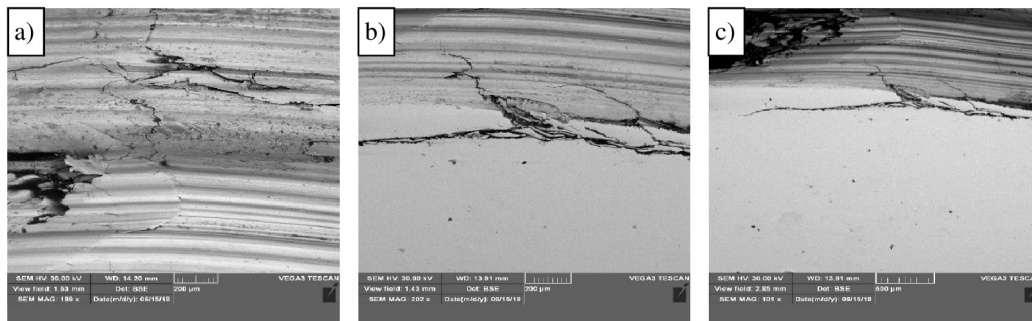
The analyzed area (Fig. 13) contains numerous grooves and scratches. In the groove pits, we can see impurities and, in some of them, a small amount of oxides. In the groove area, we can also see plastic deformations. In the thermal fatigue crack areas,

it is possible to notice zones of tool material plastic deformation as well as subsurface cracks at the depth of about 150 μm .

Fig. 13. Analysis of zone I for a tool which produced 900 forgings

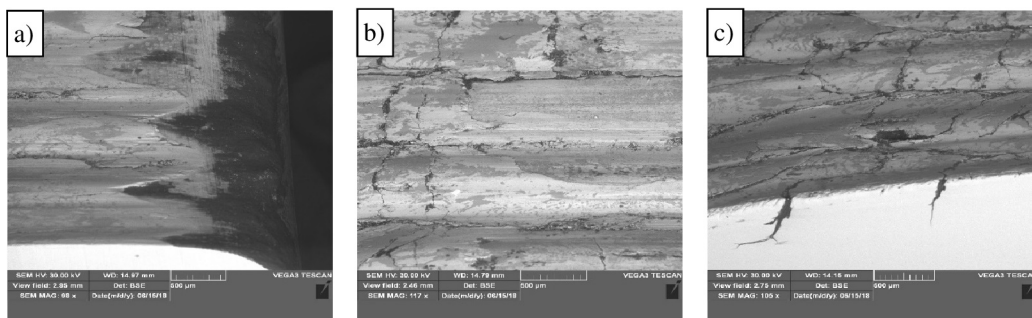
The analyzed area (Fig. 14) contains numerous grooves and scratches. In the groove pits, it is possible to see impurities and iron oxides (which was confirmed by the EDX analysis – Fig. 14c). In the groove areas, we can notice plastic deformations, numerous cracks and tool material spallings (Fig. 14b).

In the thermal fatigue crack areas, tool material plastic deformation areas are visible (Fig. 14c) as well as subsurface cracks at the depth of about 500 μm . In the deformed material areas, we can see the presence of an additional material (Fig. 14b), which probably comes from the material of the forging. Fig. 15 shows another microstructural image, for which, additionally, the chemical composition was provided.

Fig. 14. Analysis of zone I for a tool which has produced 1900 forgings

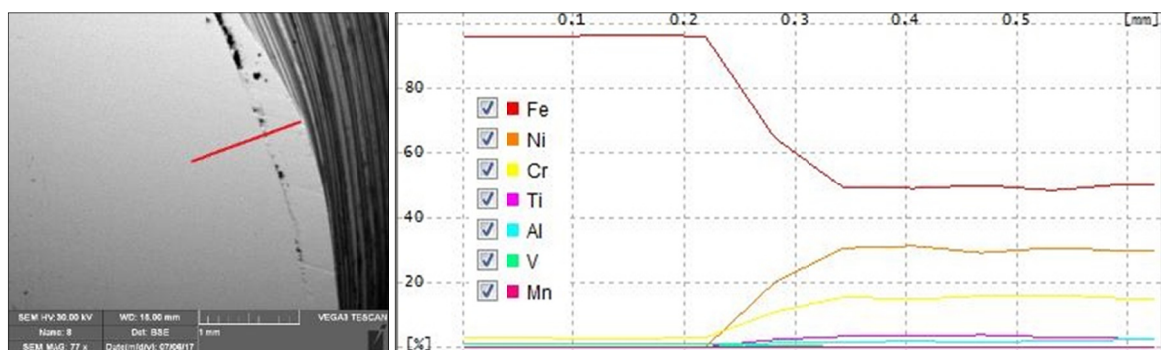
The analysis presented demonstrated a varying element content along the vector marked in yellow in Fig. 15. While in the diagram, the values on the left correspond to the chemical content of the tool steel for hot operations, which, beside cast

Fig. 15. Results of the chemical composition tests in the forging section for a tool which has produced 1900 forgings in zone I

steel, also contains alloy additions, such as Cr, V, Mn. A clear change in the chemical composition signifies the beginning of the forging material area, which adheres to the die surface. This material characterizes in the following contents: about 30% nickel, 15% chromium and 2% titanium in an iron matrix. This result is in accordance with the assumed chemical composition of tool steel W360 ISOBLOC and the composition of the forging material – high nickel steel. The obtained results (Fig. 15) confirm the previous observations of the forging material being stuck to the tool surface in the analyzed area. An additional material is distributed on the surface, forming a layer of a varying thickness, reaching even 0.5 mm, which forms a new working surface. An effect of the sticking (adhesion) of the shaped material to the tool is a change in the geometry of the tool section through the narrowing of the die opening, a low quality of the forging surface, excessive friction of the shaped material with the formed layer, as well as blocking of the forging during the process of its extrusion.

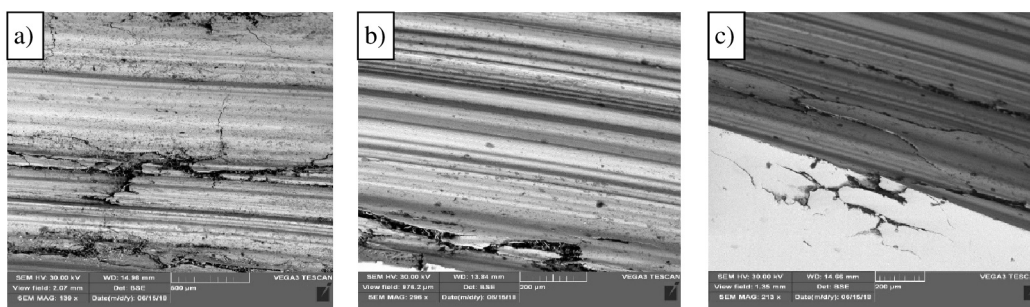
The analyzed area (Fig. 16) contains numerous grooves of different widths 25-100 μm and depths 5-25 μm . We can also notice cracks originating from thermal fatigue. The cracks propagate to the depth of about 300 μm from the surface. On the surface, it is possible to see sticking of the plastically deformed material (Fig. 16c).

Fig. 16. Analysis of selected areas in zone II for a tool which has produced 900 forgings

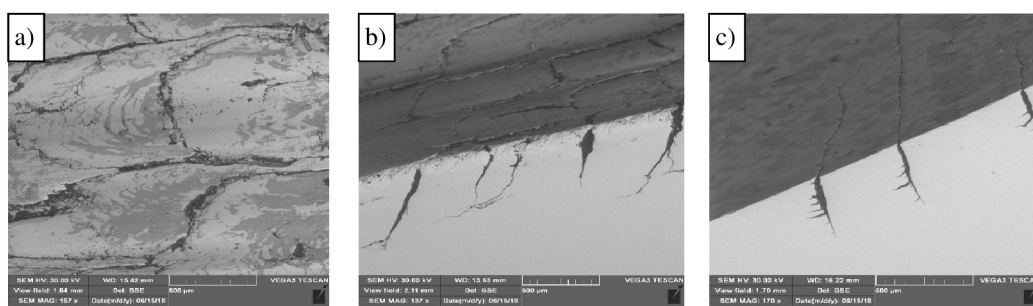
The analyzed area (Fig. 17) contains numerous grooves of different widths 500-750 μm and depths 25-50 μm . We can also notice cracks originating from thermal fatigue. The cracks propagate to the depth of about 500 μm from the surface. On the surface, it is possible to see sticking of the plastically deformed material (Fig. 17a-b). In the groove and crack areas, we can observe a material in the form of oxides and impurities from the production process. The cracks filled with iron oxides originating from the tool material were confirmed by the EDX analysis. In the area of transition into the arc section, cracks without plastic deformation are visible (Fig. 17c). Their depth is about 350-500 μm . They are also filled with iron oxides coming from the tool material. This proves a relatively high temperature of the tool in these areas.

Fig. 17. Analysis of zone II for a tool which has produced 1900 forgings

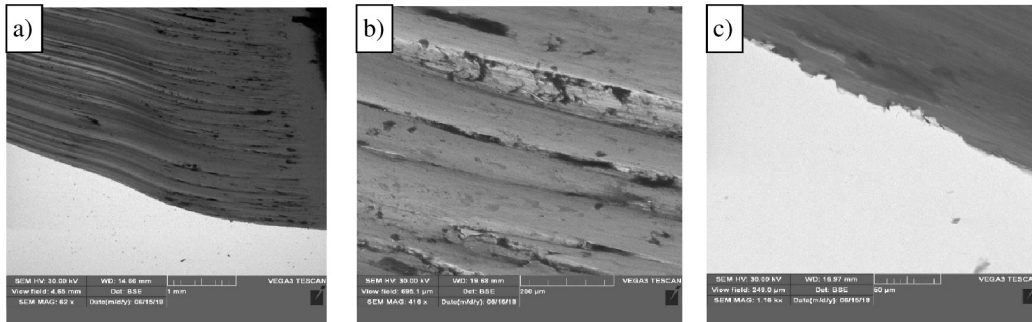
The analyzed area (Fig. 18) contains numerous grooves in the radial area, which fade in the further section of the tool. In the groove areas, we can see the lack of material cohesion (Fig. 18b). In the radial area (Fig. 18a), no thermal fatigue cracks were detected. Beyond the radius, no wear was observed, as well as no grooves, fatigue cracks or other traces of wear.

Fig. 18. Analysis of zone III for a tool which has produced 900 forgings

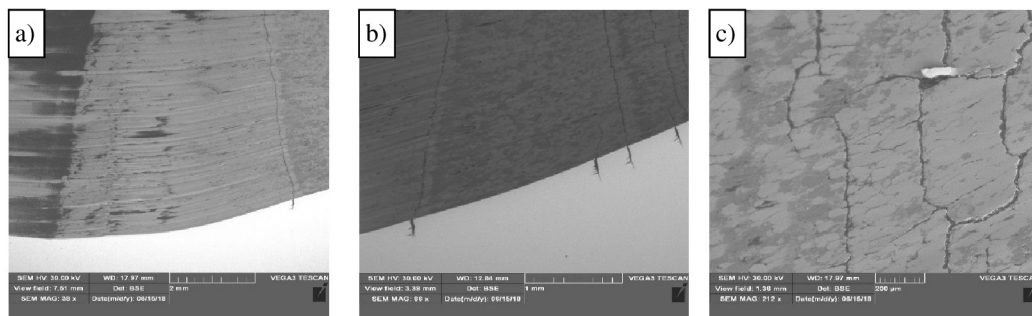
The analyzed area (Fig. 19) contains numerous grooves in the radial area, which fade in the further section of the tool (Fig. 19a). In the transition zone, we can notice material cracks originating from thermal fatigue (Fig. 19b). Cracks of this type

Fig. 19. Analysis of zone III for a tool which has produced 1900 forgings

were not visible for the tool which had produced 900 forgings. Also, it is possible to notice a network of primary and secondary cracks (Fig. 19c) in the transition area, covered with a small amount of oxides.

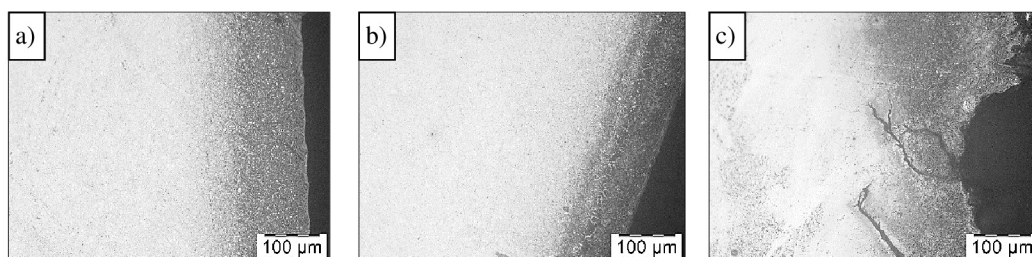
The performed light microscopic tests confirm the fact that the tool which has produced 1900 forgings exhibits a much higher degree of wear. The previously presented SEM investigations for the tool which has produced 900 forgings point to the presence of only a few deep cracks.

Fig. 20. Exemplary microstructural images with a visible nitrided layer and a few cracks. The tool has produced 900 forgings: a) in zone I, b) in zone II, c) in zone III

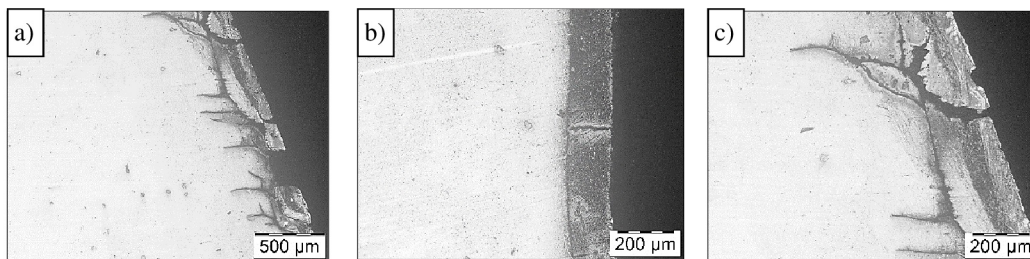
For the tools after a larger number of forgings, the cracks are much deeper; also, as it can be observed in Fig. 21a and

Fig. 21c, material losses as well as a strongly deformed material in the surface layer are present. We can also notice a tendency for spalling of the diffusive nitrided layer for the tools which have produced a larger number of forgings.

Fig. 21. Exemplary microstructural images with a visible nitrided layer and numerous cracks. The tool has produced 1900 forgings: a) in zone I, b) in zone II, c) in zone III

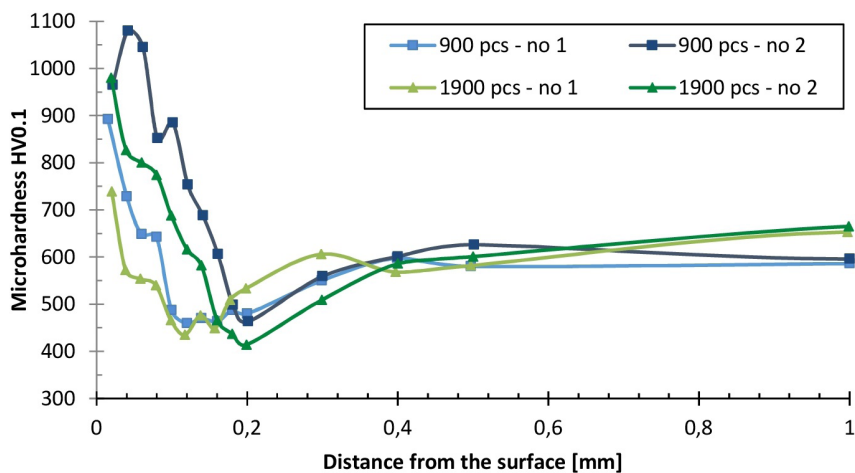
layer, the hardness is lowered to about 900 HV at the surface after 900 forging cycles and to about 740 HV after 1900 forging cycles. This proves a gradual removal of the nitrided surface layer in the surface of the die. At the same time, the hardness analysis in point 2 (Fig. 2) showed that the tool, through the whole operation time, remains in this area without a loss of its mechanical properties. This is confirmed by the lack of abrasive loss in this region and the presence of only a few fatigue cracks on its surface. The performed analysis confirms that the stability of the nitrided layer in this area is still high.

Fig. 22 shows visible effects of a loss of stability of the nitrided layers of the tools to the depth of about 0,2 mm after

900 forging cycles and to about 0.4 mm after 1900 forging cycles. This may prove the presence of high temperatures in the vicinity of point no. 4, caused by the highest deformation of the forging material and the highest pressures. The tempering and plastic deformation of the tool in the region are confirmed by the light microscopic analysis – Fig. 23, where one can see deformed cracks down to the depth of about 0.5 mm from the surface.

Fig. 22. Microhardness measurement results in point no. 1 and no. 2

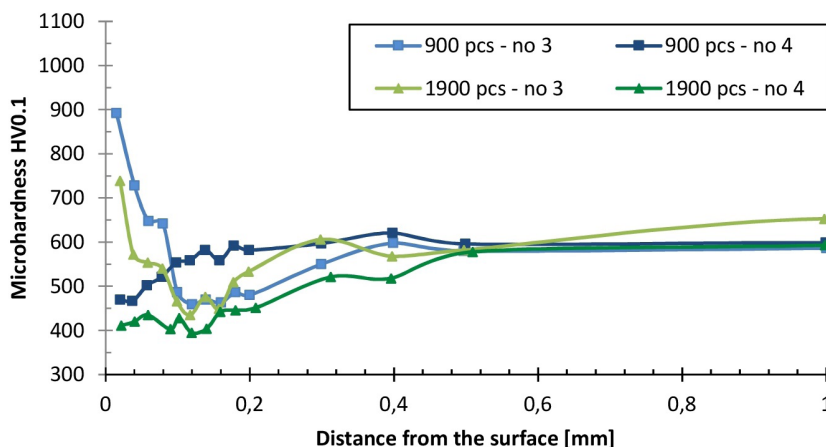
The presented results prove the occurrence of local overheating of the shaping tools' surface layer, which results in their total tempering in such a short operation time. As it has been discussed above, the large number of losses and cracks, their

Fig. 23. Microhardness test results in points no. 3 and no. 4
