PANSI XIE^{*,**}, YONGPING WU^{*,**}**DEFORMATION AND FAILURE MECHANISMS AND SUPPORT STRUCTURE TECHNOLOGIES FOR GOAF-SIDE ENTRIES IN STEEP MULTIPLE SEAM MINING DISTURBANCES****MECHANIZMY POWSTAWANIA ODKSZTAŁCEN I PEKANIA ORAZ TECHNOLOGIE WZMACNIANIA I ZABEZPIECZANIA ŚCIAN CHODNIKÓW W WYROBISKACH NACHYLONYCH**

Entries in steeply pitching seams have a more complex stress environment than those in flat seams. This study targets techniques for maintaining the surrounding rock mass stability of entries in steep seams through a case study of a steep-seam entry at a mine in southern China. An in-depth study of the deformation and instability mechanisms of the entry is conducted, employing field measurement, physical simulation experiment, numerical simulation, and theoretical analysis. The study results show that the surrounding rock mass of the entry is characterised by asymmetrical stress distribution, deformation, and failure. Specifically, 1) the entry deformation is characterised by a pattern of floor heaving and roof subsidence; 2) broken rock zones in the two entry walls are larger than those in the roof and floor, and the broken rock zone in the seam-floor side wall is larger tha

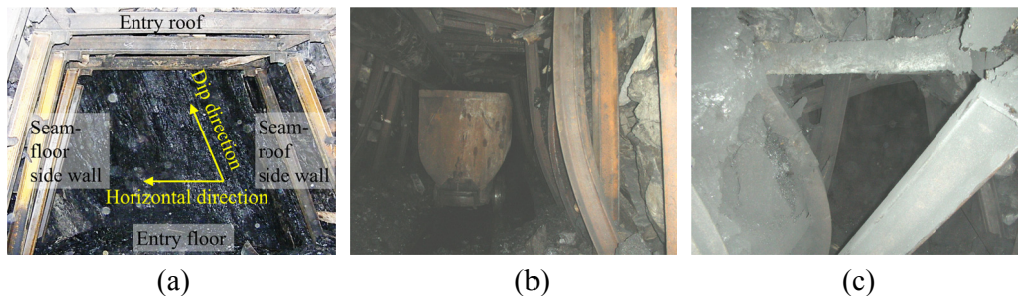
As shown in Fig. 2b, the entry of panel No. 3964 was severely deformed during entry driving and panel production. As observed on-site, the deformation began at the floor, manifesting as floor heaving, then induced wall-feet instability, and finally caused roof subsidence; the I-beam feet of the shed support at the seam-floor side was severely bent, twisted, and deeply penetrating the floor. The deformation was asymmetrical and characterised by floor heaving and roof subsidence, and the entry cross-sectional shape changed from a trapezoid to an irregular quadrangle. The local convergence in some areas of the roof was up to approximately 1 m when mining panel No. 3966, as shown in Fig. 2c. The deformed entry necessitated multiple and highly frequent repairs to maintain the minimum stability level; this incurred high maintenance costs and severely affected the normal production operations of the panel (Zhang, 2014).

Fig. 2. Deformation and failure characteristics of panel No. 3964 entry during different stages of mining operation: (a) Initial stage of entry driving, (b) mined-out panel No. 3964, and (c) mined-out panel No. 3966 (adjacent to No. 3964)

(1) The entry was special in terms of its half-coal-half-rock structure, complex stress distributions in the surrounding rock mass, and multiple mining disturbances. The entry deformation was characterised by an asymmetrical pattern. The floor heaved, and the roof subsided; as a result, the seam-floor side feet of the shed support structure were severely bent and twisted, and deeply penetrated the floor.

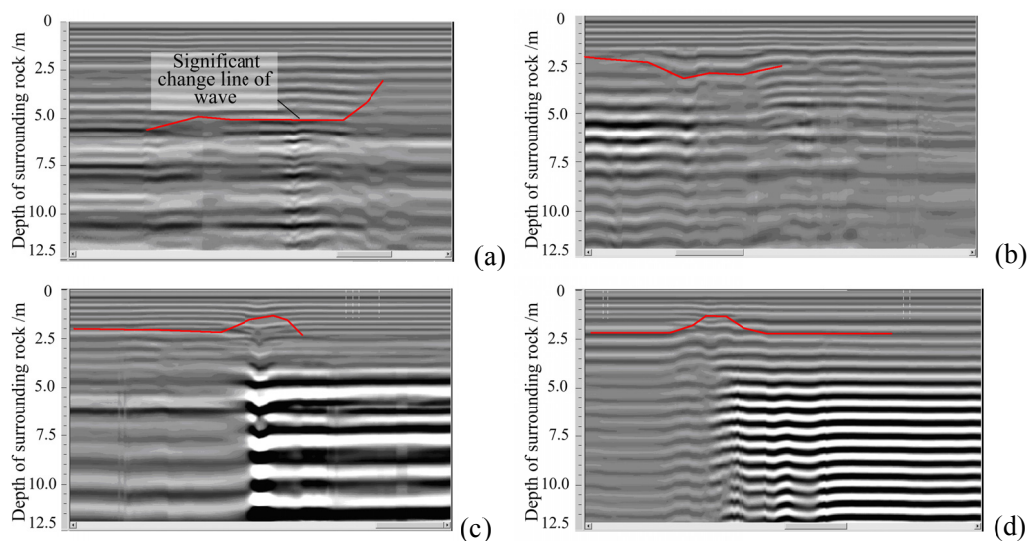
The resulting waveforms generated by the radar device were then analysed. A clear bend in the waveform indicates a broken rock zone in the surrounding rock mass, whereas an irregularity in the vertical waveform pattern indicates cracking or manifestation of a structural failure (Wang et al., 2013). Based on an on-site investigation and analysis of the obtained measurement data, the broken rock zones were found to differ at different measurement points and at different locations near the same measurement point. Fig. 3 shows the results obtained from measurement point No. 7, which is located 40 m away from the panel face. A clear bend at a depth of 5.2 m in the waveforms of the entry floor (Fig. 3a) is apparent, indicating a stable rock-broken rock interface in the surrounding rock mass. A bend at a depth of approximately 2.5 m is apparent in the waveforms obtained by each of the other three test leads (Figs. 3b-d).

Fig. 3. Waveforms obtained from measurement point No. 7 using ground-penetrating radar, for entry (a) floor, (b) seam-floor side wall, (c) roof, and (d) seam-roof side wall

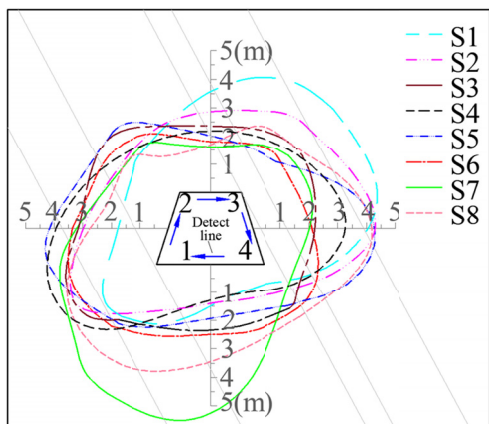
Based on the broken rock zones in the surrounding rock mass of panel No. 3964 entry identified through measurement, as well as the occurrence conditions and convergence of the surrounding rock mass observed on-site, the breaking characteristics of the surrounding rock mass were graphically represented as a broken contour, as shown in Fig. 4. This figure shows six broken rock zones greater than 4.0 m in size. The size of the broken-rock-zone showed ranges of 1.4-5.2 m in the entry floor (test lead No. 1), 1.8-4.5 m in the seam-floor side wall (test lead No. 2); 1.5-4.0 m in the roof (test lead No. 3), and 1.8-4.1 m in the seam-roof side wall (test lead No. 4). Generally, the broken contour of the surrounding rock mass is asymmetrical, with larger broken rock zones in the two entry walls than in the roof and floor, and a larger broken rock zone in the seam-floor side wall than in the seam-roof side wall. In addition, the broken rock zones identified through measurement are consistent with the convergence characteristics of the surrounding rock mass observed on-site. Based on the theory of broken rock zones in the surrounding rock proposed by Dong et al. (1994), the majority of the surrounding rock mass

can be classified as type-V unstable surrounding rock with a large broken rock zone. However, the surrounding rock near the seam-floor side wall can be classified as type-VI very unstable surrounding rock with a large broken rock zone. Based on the above classifications as well as the tested lithological properties of the surrounding rock mass (Table 1), the surrounding rock of the entry can be classified as fractured soft rock.

Fig. 4. Broken contour of surrounding-rocks

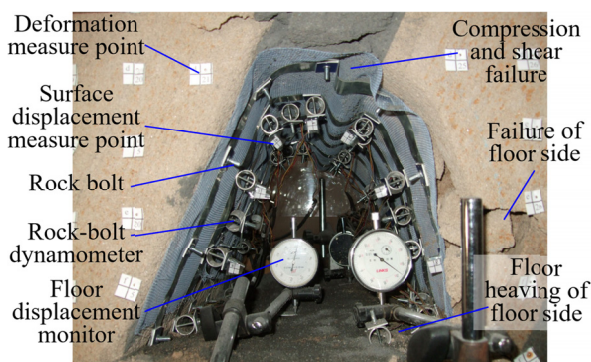
Vertical and lateral loads were simultaneously applied to the model. At 5-MPa pressure, the deformation rate of the surrounding rock began to increase, with relatively large deformation in the entry floor and seam-floor side wall. The deformation and failure of the surrounding rock that developed along the direction of the seam dip angle was monitored. At 15-MPa pressure, failure of the coal seam occurred in the entry roof and floor as well as in the seam-floor side wall; specifically, transpression failure occurred in the entry roof owing to slipping and squeezing of the rock strata on both sides, as well clear heaving in the seam-floor side of the floor, as shown in Fig. 7.

Fig. 7. Physical simulation experiment results of panel No. 3964 entry

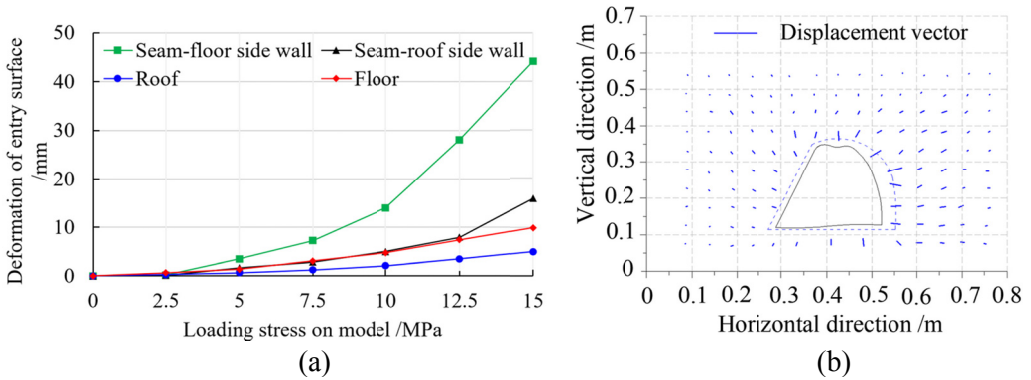
Throughout the experiment, the model was monitored for entry surface displacement using an optical total station and dial gauges. The entry surface displacement gradually increased with an increase in the confining pressure, as shown in Fig. 8a. The order of monitoring entry deformation rate and its magnitude was undertaken with respect to the seam as follows, from high to low: the seam-floor side wall, floor and seam-roof side wall, and roof. The maximum accumulative convergence in the roof and floor was 0.15 m and 0.6 m in the two entry walls. In addition, the monitored displacement of the surrounding rock exceeded 2 m, with the largest

displacement occurring for the seam-floor side wall, at 3-4 m (Fig. 8b). The rock displacement in the roof was approximately 2-3 m, which was basically consistent with the broken-rock-zone measurement results.

Fig. 8. Deformation and failure characteristics of entry surrounding rock mass: (a) Surface deformation and (b) displacement characteristics

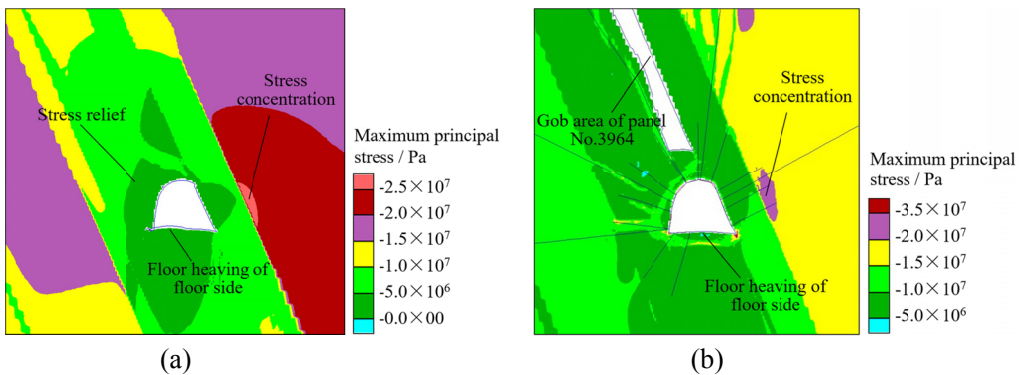
bility is threatened by multiple disturbances in both the temporal and spatial dimensions. The stress distribution in the surrounding rock mass is uneven owing to the attitude and lithological properties of the surrounding rock mass. Furthermore, the numerical simulation results showed that the initial stress in the entry roof exceeded that in the entry floor, as the roof was a siltstone mass with good structural integrity, high strength, and good anti-deformation capacity, whereas the floor is an argillaceous siltstone mass with well-developed joints and low strength. As a result, in the initial stage of entry driving, the entry floor heaved, and large deformation occurred in the seam-floor side wall of the entry, whereas relatively small deformations occurred in the other areas of the surrounding rock mass. Thus, an overall asymmetrical deformation was clearly established, as shown in Fig. 10a.

When seam No. 8 was mined out (see Fig. 1), the entry experienced a second disturbance. Meanwhile, the initial stress in the roof of seam No. 9 (the floor of seam No. 8) released, or the entry simultaneously experienced the disturbance resulting from the stress release, thereby aggravating the asymmetrical deformation in the two entry walls. The mining of panel No. 3964 (the third mining disturbance) caused a release of the stress around the working face, thereby alleviating the deformation in the entry roof. This phenomenon was consistent with the physical simulation experiment results, but the stress field in the surrounding rock mass was still clearly characterised by an asymmetrical distribution, as shown in Fig. 10b.

Fig. 10. Asymmetrical mechanical characteristics of entry at different mining stages: (a) entry driving and (b) panel No. 3964 mined out

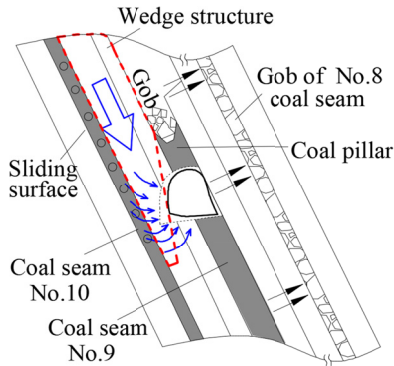
While panel No. 3964 was being mined out, the roof and floor of the mined-out area were displaced towards the stopped-out space, yielding reduced cohesion between the entry floor and seam No. 10. Consequently, the siltstone stratum became a long, large, inclined, wedge-shaped body, which slipped downward along seam No. 10 under the effect of gravity, exerting pressure on the seam-floor side wall of the entry and causing local deformation. There was greater deformation in the area nearer to the bottom of the wedge-shaped body, as shown in Fig. 11.

Fig. 11. Wedging effect on entry instability due to mining operations in upstream panel

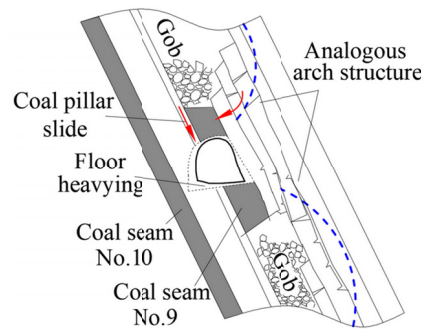
While the panels upstream and downstream of the panel No. 3964 entry were being mined out, the roof of the mined-out area caved in, yielding an arch-shaped cross-section for the gob roof. The surrounding rock at the upstream and downstream entries serve as the two feet of these

arches and the caved-in roof of the mined-out area constitutes the arch body (Shi, 1999). This was the fourth mining disturbance, which induced transpression and slipping of the entry roof and floor and finally caused the small coal body at the entry roof to break, as shown in Fig. 12.

Fig. 12. Arching effect on entry instability due to mining operations in downstream panel

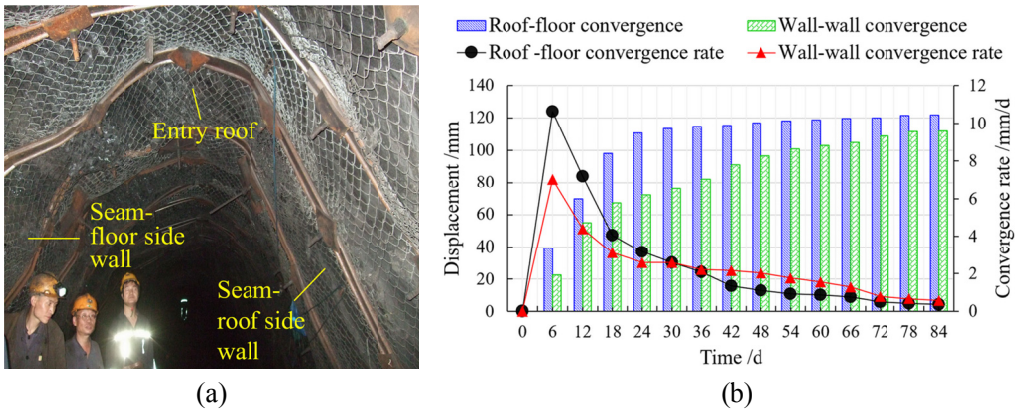
A field test of the improved support structure design for the entry was conducted, as shown in Fig. 13a. The monitored field results show that the entry remained stable, as demonstrated by the magnitude of the convergence of the two walls, roof, and floor measured on the 30th (experiencing the second mining disturbance) and 48th day (experiencing the third mining disturbance) after implementation. The maximum rib-rib and floor-roof convergences were 112 and 122 mm, respectively; the maximum convergence rates were 7.02 and 10.63 mm/d, respectively, and the minimum convergence rate was 0.35 mm/d, as shown in Fig. 13b. The deformation in the walls was clearly reduced, demonstrating a clear effect of the improved design, and the deformation in the roof and floor was also reduced to some degree, thereby providing a basic guarantee of entry stability. With the implemented rock bolt-wire mesh-anchor cable asymmetrical support system, the deformation rate was increased in the initial stage. When the upstream and downstream panels were being mined out, the rib-rib convergence rate gradually decreased and severe deformation of the surrounding rock was effectively curtailed. Therefore, repair was no longer needed to maintain the entry stability level during the multiple mining disturbances; furthermore, the maintenance cost of the entry was largely reduced, thereby ensuring that normal mining operations could be performed.

Fig. 13. (a) Improved support structure design for entry of panel No. 3964 and (b) monitored results of entry deformation after implementation of the improved design

Based on the above analysis of the entry instability mechanism under the impact of multiple disturbances, the root cause of the instability of the softrock gob-side entry is believed to be the asymmetrical load of the surrounding rock mass on the support structure. Therefore, it was necessary to fully utilise the support capacity of a rock bolt-wired mesh-anchor cable support structure in accordance with the uneven load distribution in the surrounding rock of the entry. This allowed a more even stress distribution in the surrounding rock mass, with more harmonious deformation of the support structure and surrounding rock mass. In addition, it ensured the stability of the latter. Considering the above, the following principles for controlling the stability of the surrounding rock mass of the entry were proposed: active support, additional reinforcement at critical points, and coupled support. Improvement of the existing support structure by an asymmetrical support structure design coupling high-strength rock bolts, long anchor cables, W-steel straps, and steel-bar meshes was proposed. The design parameters are detailed below.

(1) Rock bolts: spaced at $800\text{ mm} \times 800\text{ mm}$ 12 bolts per grille (four in the roof, all perpendicular to the roof, three in each wall, with the middle bolt perpendicular to the wall; two on the seam-floor side of the floor). Material specifications: $\Phi 20\text{ mm} \times 2500\text{ mm}$ (2200 mm for the two bolts on the seam-floor side of the floor), high-strength screw-thread steel, left-turning thread, equal strength along the total length, initial compression exceeding 50 kN . Rock-bolt supporting plate: $200\text{ mm} \times 200\text{ mm} \times 20\text{ mm}$ (length \times width \times thickness). Each bolt grille was reinforced with three high-strength W-steel straps and joined with a lap length exceeding 200 mm .

(2) Anchor cables: material specifications: $\Phi 17.8\text{ mm} \times 7000\text{ mm}$, twin wire, cage type; one in the middle of the roof; one in the middle of the seam-roof side wall; one each in the top, middle, and bottom of the seam-floor side wall; spaced $1000\text{ mm} \times 3200\text{ mm}$.

(3) Wire mesh: material specifications: #10 galvanised wire; dimensions: 2000 mm × 1000 mm for the two walls, 4100 mm × 1000 mm for the roof; mesh size: 80 mm × 80 mm; joined mesh-by-mesh with a lap length of 200 mm.
