NON-DESTRUCTIVE TESTING AND ANALYSIS OF A XIX-CENTURY BRICK MASONRY BUILDING

A. HOŁA¹, Ł. SADOWSKI², J. SZYMANOWSKI³

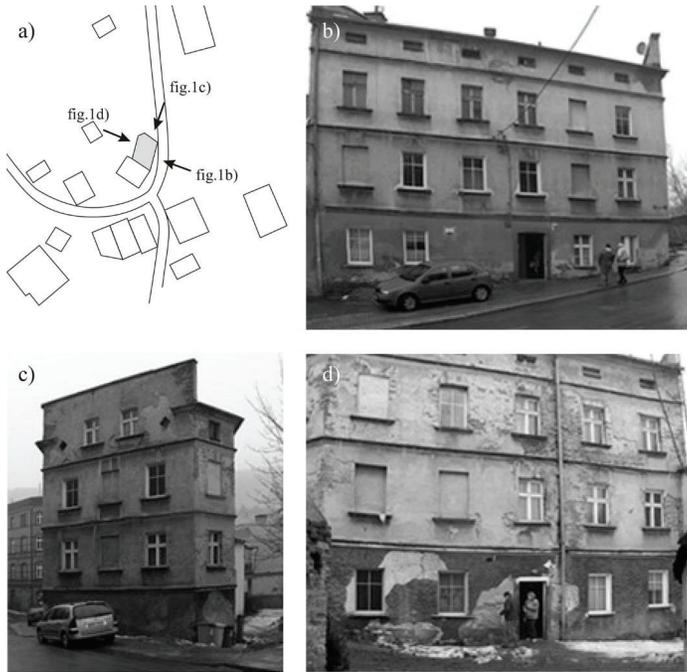
Fig. 1. View of: a) building location, b) facade with the main entrance to the building, c) gable wall of the building, d) facade from the yard

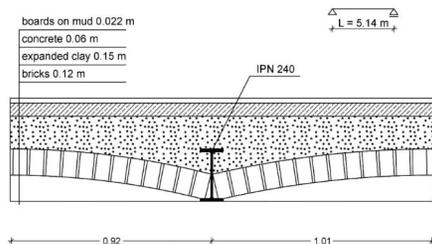
Fig. 2. Cross-section of: a) the segmental ceiling above the basement, b) the wooden ceiling above the first floor

Figure 2b shows cross-section of the wooden ceiling above the first floor. The beam rested on both sides on the walls, therefore a free-supported beam was adopted as the static diagram. The arrangement of layers in Figure 9 is presented on the basis of thickness measurements of individual layers in the ceiling. The volumetric weights of the materials in table 3 were adopted on the basis of standards [34, 35].

| Element | Ultimate limit state | | | Serviceability limit state | | |
|---|---|---|---|---|---|---|
| Beam of the wooden ceiling | 23.8 | 13.5 | 75.8 | 77.7 | 26.1 | 197.5 |

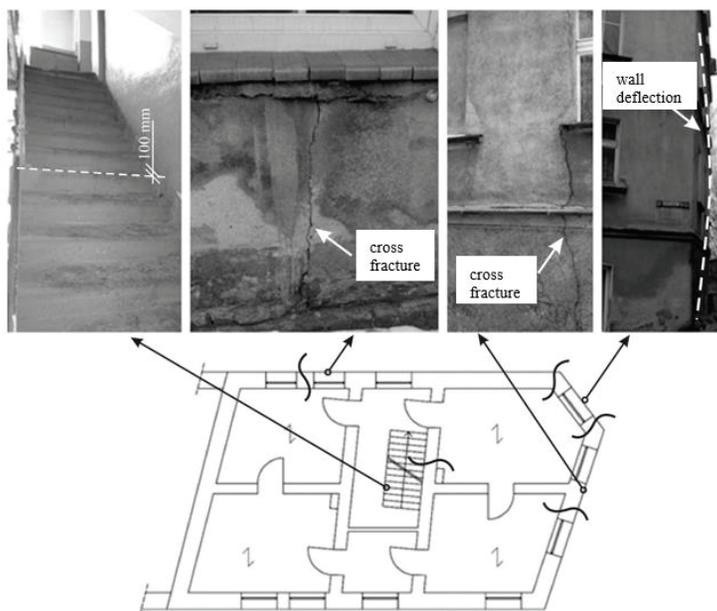
- numerous vertical cracks and bulging towards the outside of one of the gable walls of the brick masonry building. Deep cracks were also noticed in one longitudinal outer wall. There was also local deformation and a deep crack along the entire height of the internal transverse wall, as a result of which the brick lintel that is based on it is distorted above the entrance to the basement, with the bricks being loose in the zone above the lintel. The locations of the wall cracks are shown in Figure 1,

- significant deflections of wooden ceilings over all the above-ground floors,
- a significant deviation regarding the level of the stone stairs that run from the ground floor to the first floor, and which are based on the deformed and cracked transverse wall,

Figure 3 presents the wall cracks and deformed stone stairs, as well as a sketch of the second floor of the brick masonry building, on which the direction of the support of the wooden ceilings is marked. In the photo of the stairs, a dashed line shows a significant deviation of the stone treads from the original level.

Fig. 3. Sketch of the second floor of the analysed brick masonry building, with photos documenting the cracks of masonry walls and deformation of the stone stairs that run from the ground floor to the first floor.

- repair (stitching with steel rods placed in the wall joints) cracks occurring in external and internal walls,
- replacement of internal stairs with new reinforced concrete

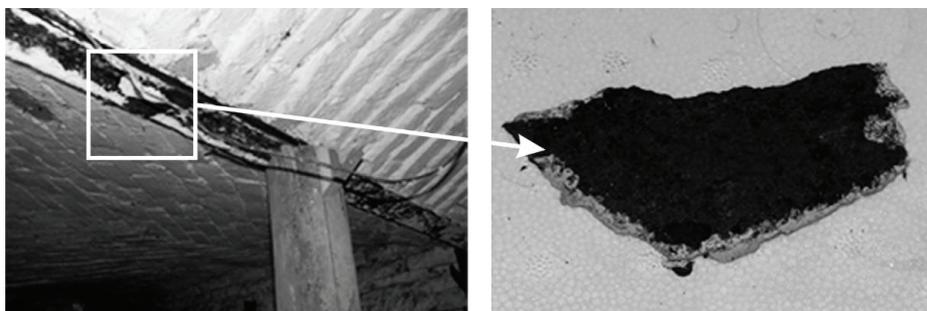
- strong corrosion of the I-section steel beam in the sectional ceiling in the basement. Rust layers of 2 mm thick were easily detached from the bottom flange of this beam, and as a result of which the cross-section of the beam was reduced by about 40%. In addition, a significant deflection of the beam and its rotation in the plan were found. Therefore, it was recommended to support it with a wooden support in order to prevent the ceiling above the basement from collapsing,

Figure 4 shows a bent and supported heavily corroded I-beam in the ceiling above the basement, while Figure 5 presents an exemplary view of the heavily damp ground floor walls, which are covered with salt efflorescence and mould fungi.

Fig. 4. View of a highly corroded steel beam in the ceiling above the basement.

| Element | Ultimate limit state | | | Serviceability limit state | | |
|---|---|---|---|---|---|---|
| Steel beam of the sectional ceiling above the basement | 329.0 | 212.4 | 54.9 | 19.5 | 11.0 | 77.5 |

- many years of ignoring the progressive cracking of the building's walls and the bending of the ceilings, including the bending of the corrosive steel beam in the ceiling above the basement. As a consequence, the ultimate limit state of the wooden ceiling beams was exceeded by 75.8%, and the serviceability limit state by 197.5%. Moreover, the ultimate limit state of the steel beam was exceeded by 54.9%, and the serviceability limit state by 77.5%.

- replacement of all ceilings with new, massive ones. The ceiling on steel beams with reinforced concrete slab and expanded clay block is recommended in this case. Steel beams at the support points must be absolutely anchored to the walls and with each other and, moreover, connected with perpendicular stiffening steel ribs, so that the creation of rigid horizontal discs by individual floors. The gable walls should be anchored with such ceilings,

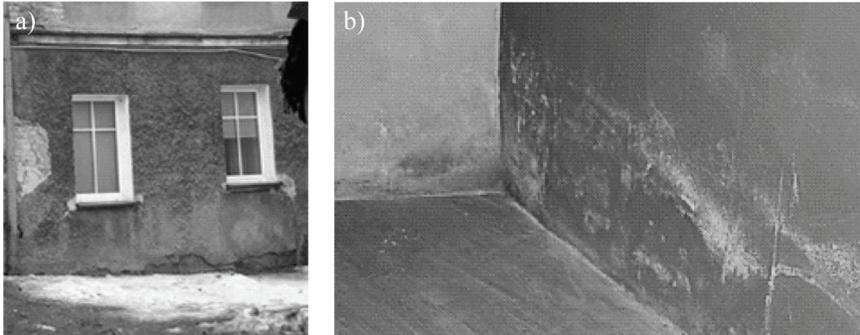
- strong dampness of the walls at the ground floor level, with salt efflorescence and mould fungi on their surfaces.

Fig. 5. View of the damp walls of the ground floor covered with salt efflorescence and mould fungi: a) from the outside; b) from the inside.

Qualitative and semi-quantitative tests of the type and concentration of salts showed that in the external and internal brick walls of the building there are mainly chlorides and nitrates, and to a lesser extent sulphates. Table 2 presents the average values of the concentration of individual salts in relation to the permissible concentration limits according to [32, 33].

Despite the fact that the foundation walls of the brick masonry building are made of stone, it is not surprising that the concentration of chlorides is exceeded in most of the tested places of the brick walls. The building is located in the close vicinity of the road and pavement, which are sprinkled with salt in winter.

- vertical insulation of foundation walls, unblocking the band drainage system that had functioned in the past, and the horizontal floor in the basement and on the ground floor in the basement,

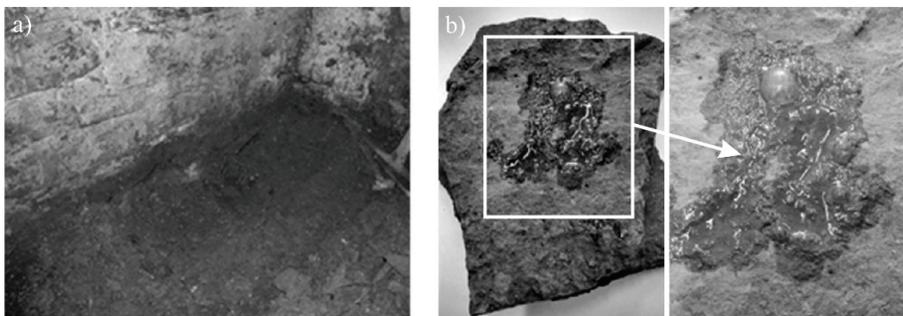
In order to determine the causes of the numerous cracks in the walls of the brick masonry building, it was decided to carry out a soil test. For this purpose, an excavation in the vicinity of the foundation was made, which confirmed that the building has no foundation benches, and that the basement walls are laid directly on the rock ground beneath the building. In the opencast excavation under the basement, groundwater was found in marl rock at a level similar to the floor level.

An interview with residents showed that the water level in the basement is higher than the floor level after rainfall, and that the first cracks in the walls of the brick masonry building appeared several years ago, after the existing perimeter drain around the building ceased to operate as a result of breaking its continuity during the construction works conducted in its vicinity. It was concluded that the reason for the uneven settlement of the walls, and therefore the cause of their cracking, may be the loosening of the rock due to the gradual dissolution of the calcium carbonate (CaCO_3) that is in it, and also due to dynamic vibrations caused by traffic.

Fig. 6. View of: a) exposure of foundations, b) samples of marl rock taken from the excavation, which react when in contact with hydrochloric acid by producing foam.

Laboratory tests showed that the ground under the brick masonry building is mudstone with a high marl content. This was also confirmed by tests with the use of hydrochloric acid. Figure 6 shows the foundations that were uncovered in the basement in the corner of the outer walls, a view of the rock sample taken for laboratory testing, and the reaction of the mudstone to contact with hydrochloric acid (foam).

- not repairing the damaged perimeter drain around the building. This caused the groundwater table to rise above the foundation level for a long time, and in turn it weakened the soil that is made from the marble mudstone by leaching calcium carbonate (CaCO_3) from it. This contributed to uneven settlement of the building walls and their cracking, and also to a significant deviation regarding the level of the stone stair runs leaning on a cracked wall,

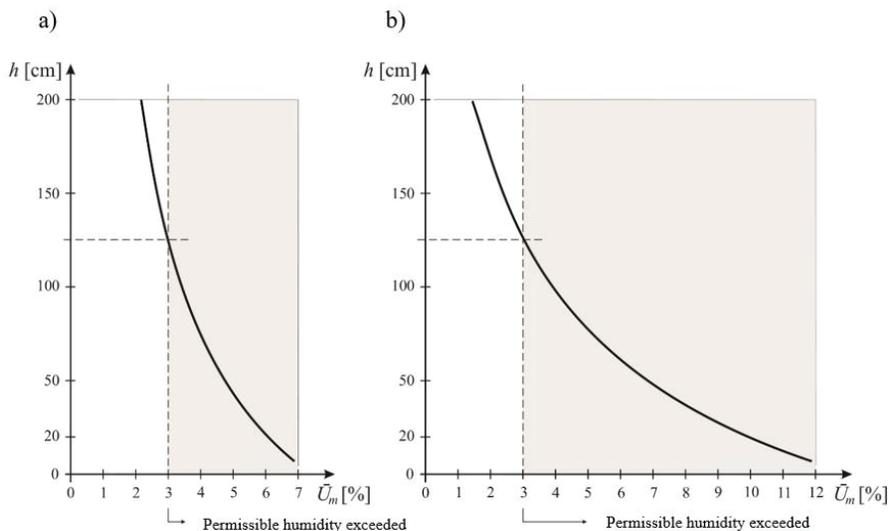
The average values of the moisture content in the subsurface zone, determined at heights of 20 cm, 50 cm, 100 cm and 150 cm above the floor level, were equal to 6.40% (SD = 3,50), 4.70% (SD = 2,38), 3.50% (SD = 0,55) and 2.60% (SD = 1,11) respectively for the internal walls, and for the external walls they were equal to 10.20% (SD = 3,37), 6.80% (SD = 1,33), 3.80% (SD = 0,64) and 2.35% (SD = 0,59), respectively. This state is illustrated in Figure 9. Table 1 presents the classification of the moisture content adopted from literature [29-31], and the determined degree of dampness of particular batches of the tested walls. The measurement results clearly show that the building's walls are excessively damp up to a height of about 130 cm above floor level.

Fig. 9. Averaged mass moisture content distributions \bar{U}_m in the masonry walls of the ground floor: a) at the height of the internal walls, obtained using the dielectric method; b) at the height of the outer walls, obtained using the resistance method.
