# The role of structural analyses and queries in recognizing damage causes and selecting remedies in historic buildings: case of the Dominican monastery in Lublin

Anna Halicka<sup>1</sup>, Anna Ostańska<sup>2</sup>

**Abstract:** The article presents the process of structural diagnostics of the Dominican monastery in Lublin. In order to establish the underlying cause of cracks, not only *in situ* investigations but also detailed analyses of documents were executed. Inventory drawings were examined in order to identify the building's structural system. The query of historical documents and city archives was carried out to understand the structure's performance. Conclusions were confronted with the crack pattern. It was established that the damage resulted from the original conditions of the structural system in place. These conditions were created in past, when the monastery incorporated sections of the medieval town wall into its structure.

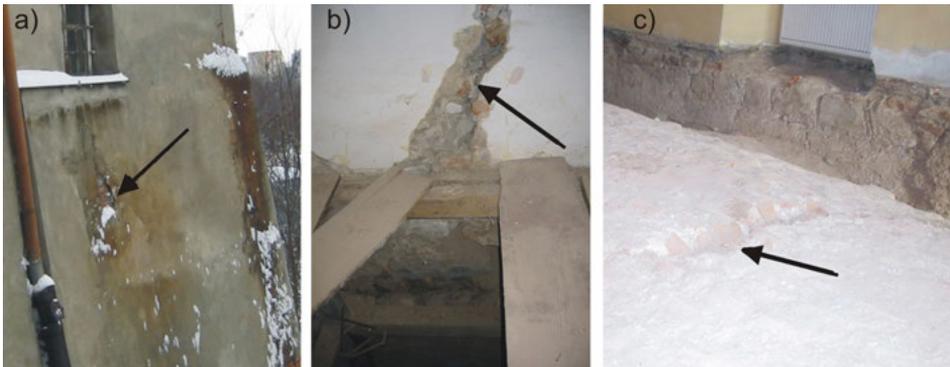
Strong damage emerged in the monastery's south-east corner: several wide cracks crossing the whole masonry width (the example is shown in Fig. 3a and Fig. 3b) as well as bursting and cracking of the vaults above the ground and first floors which were the continuation of wall cracks (Fig. 3c).

Fig. 3. Examples of cracks in the south-east corner of the monastery: a) and b) the same crack in the south wall photographed from the outside and inside, c) burst of the barrel vault above the ground floor

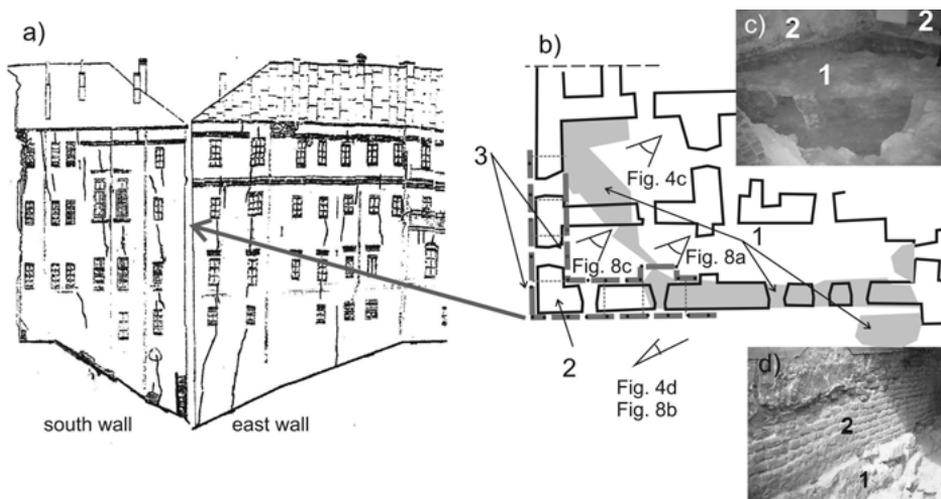
During the works aimed to strengthen the building's foundation zone, medieval limestone masonry was uncovered. This medieval masonry constitutes the foundation in the long section of the building (Fig. 4b, Fig. 4d). Its character varies in different sections: beginning with rubble work, *via* a layered wall (outer layers from regularly placed limestone elements and rubble work inside) up to uniform limestone masonry. In the corner, the course of the wall from the 17<sup>th</sup> century and the course of the medieval masonry do not overlap. The medieval masonry is located inside the building. It is probably the "missing" part of the town wall (Fig. 4b, Fig. 4c).

Fig. 4. South-east corner of the monastery: a) crack pattern of the corner, b) course of the medieval walls uncovered during structural restoration works and the course of the applied supporting structures, c) uncovered medieval wall inside the building, d) uncovered medieval outer wall. Numbers indicate the following: 1 – medieval wall, 2 – wall from the 17<sup>th</sup> century, 3 – course of the underground micropiled structure strengthening the foundation, introduced during structural restoration works

To conclude, the outer wall was founded in a non-uniform manner – virtually the full length of the wall stands on the medieval wall, whereas the corner of the structure was founded directly on the subsoil. It should be emphasized that the corner was founded 3.0–4.0 meters deeper than the medieval wall. It stands on the top of a loess layer. Above the loess layer, up to the level of the ground floor, outside and inside of the building, a layer of uncompacted embankment was revealed. The characteristic feature of loess is that after soaking its strength drops and strain rapidly grows. Water infiltrated to the loess under the corner wall via the embankment, which resulted in the corner's settlement. This in turn caused the shear of the wall above the zone where of the foundation's condition varied (Fig. 3, Fig. 4a). This entailed the bursting and cracking of vaults.

The south-east corner (Sec. 3.1) was supported on the reinforced concrete micropiled structure, hidden in the soil. The decision was motivated by the fact that the repeated measurement of the cracks' width proved that they were not stabilized. The corner and the zone where walls take course outside the town wall were connected by two reinforced concrete underground beams joined via the historic wall with tensioned tendons [25]. The beams were supported with micropiles (Fig. 4b, Fig. 8a, Fig. 8b).

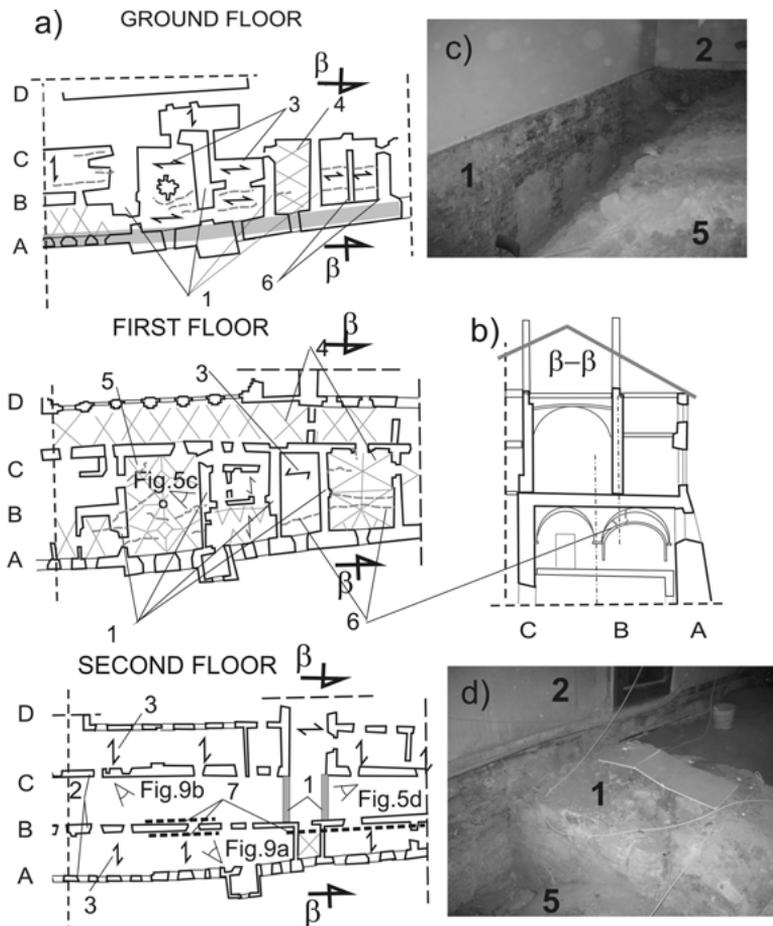
Fig. 5. Analysis of the load-carrying system of the monastery's east wing: a) horizontal projections of the ground, first and second floors with crack pattern b) cross-section of the building, c) wall with openings uncovered during the ground floor vault restoration, d) upper edge of the transverse wall uncovered during the restoration of vaults above the first floor. Numbers indicate the following: 1 – transverse load-carrying walls in the basement and first floor and their upper edge uncovered in the second floor, 2 – parallel load-carrying wall from the 17th century, 3–arrows indicating the direction of barrel vaults load bearing, 4 – cross vault, 5 – lierne vaults, 6 – cracks of the vault loaded with longitudinal wall, 7 – course of steel frames supporting the ceiling introduced during structural restoration works

This may suggest that the transverse walls between “A” and “C” axes in the ground and first floor (see Fig. 5) are remnants of older buildings adjacent to the town wall, which were incorporated into the monastery in the 17<sup>th</sup> century. It should be emphasized that the existence of these buildings was unclear earlier and only the rehabilitation works confirmed their presence. They were uncovered during a temporary removal of backfill from vaults.

Fig. 5c shows the remnants of the building (a transverse wall with openings) uncovered during the basement vault’s restoration. Fig. 5d shows the upper edge of the transverse wall uncovered in the second floor. These remnants were recognized by the researcher of architectural heritage to be the walls of a medieval tower [26].

In Fig. 5, the pattern of cracks in vaults above the ground and first floor is shown with a broken gray line. The cracks are parallel to the longitudinal walls. This allows to deduce that the differential settlement of longitudinal and transverse (loaded with heavy vaults) walls was the cause of cracking of vaults and walls.

The analysis of projections shown in Fig. 5 indicates that the builders not only incorporated the older buildings between “A” and “C” axes into the structure, but also added a new part between “C” and “D” axes. In this location, they arranged the vaults supported on the longitudinal walls. The ceilings above the second and third floor are supported on the longitudinal walls as well. What is more, the wall in “B” axis runs above certain vaults and is supported on flat arches arranged on its bottom edge. However, with the passage of time, one of the arches settled and loaded the vault. This resulted in vault cracking right below the wall (the cracks are marked in Fig. 5 with number 6).

The rehabilitation design scheduled a change in timber ceilings above the second and third floor into fire-resistant ones, replacement of the roof's steel sheets with ceramic tiles, and the adaptation of the unused space under the roof for dwelling purposes. All these changes were connected with the increase of the load exerted onto the load-carrying wall in "B" axis and the vault under it (Sec. 3.2). It was decided that the increase in the load should be avoided by the arrangement of new two-storied steel frames, which transfer the excess load onto the transverse walls again and prevent the propagation of cracks in the vault (Fig. 5a, Fig. 9).

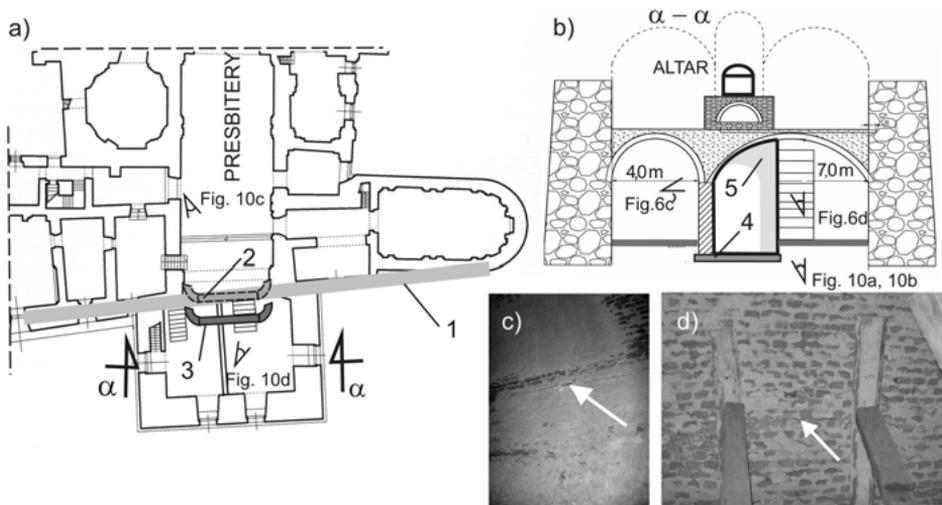
However, during structural diagnostics, it was found that the cause of the vaults’ destruction is much more complex. Two crypts directly abutting on the town wall from the outside, supported on one internal wall (Fig. 6c, Fig. 6b), are of a different width. Therefore, the vaults’ spans are also different (the vault of the seven meter span is flat, whereas the vault of the four meter span is elevated). The calculations of vaults were executed assuming the “arch” scheme of vaults, their loading with the weight of the altar, stone floor, backfill and self-weight, as well as the tested stress-strain parameters of masonry, treated as the elastic material. These calculations confirmed that the thrust of the wide vault is

twice the thrust of the narrow one. Such differential thrusts induced the horizontal force to be exerted on the internal load-carrying wall towards the narrow crypt, which resulted in a non-uniform stress distribution in the wall section as well as under its foundation. The wall was founded in the weak uncompacted embankment. Therefore, the overloading in the zone of the maximum stress and wall rotation occurred. This explained the observed horizontal cracks running virtually along the whole length of crypts: in the brick joint of the internal wall in the level of the wide vault's support (visible from the side of the narrow crypt Fig. 6c), and in the top section of the wide vault (Fig. 6d).

Fig. 6. Structural system of the crypts of the Tyszkiewicz Chapel: a) projection of a part of the basilica with the course of the town wall (1) and locations of the altar: the presumed initial position (2) and present position (3), b) cross-section of crypts with the location of the altar and strengthening structures: widening the foundation of internal wall (4) and concrete structure supporting the vault (5), c) horizontal crack in the internal wall in the level of the wide vault support visible from the narrow crypt, d) wide vault supported by wooden shores and the crack in its top section

The unexpected factor increased the load and consequently, the unbalanced thrust. As mentioned above, the Tyszkiewicz Chapel was built outside of the town wall and outside the front wall of the initial church. It may be supposed that the high altar was then put on the town wall (Fig. 6c). However, during the structural restoration works it was found that the altar is placed not on this wall, but inside the layout of the chapel and crypts. It was moved from the town wall into the chapel. Timber beams were put under the altar. However, with the passage of time, due to their deflection and biological corrosion, the altar's dead load (assessed to be more than 15 tons) was exerted onto the backfill and consequently onto the vaults.

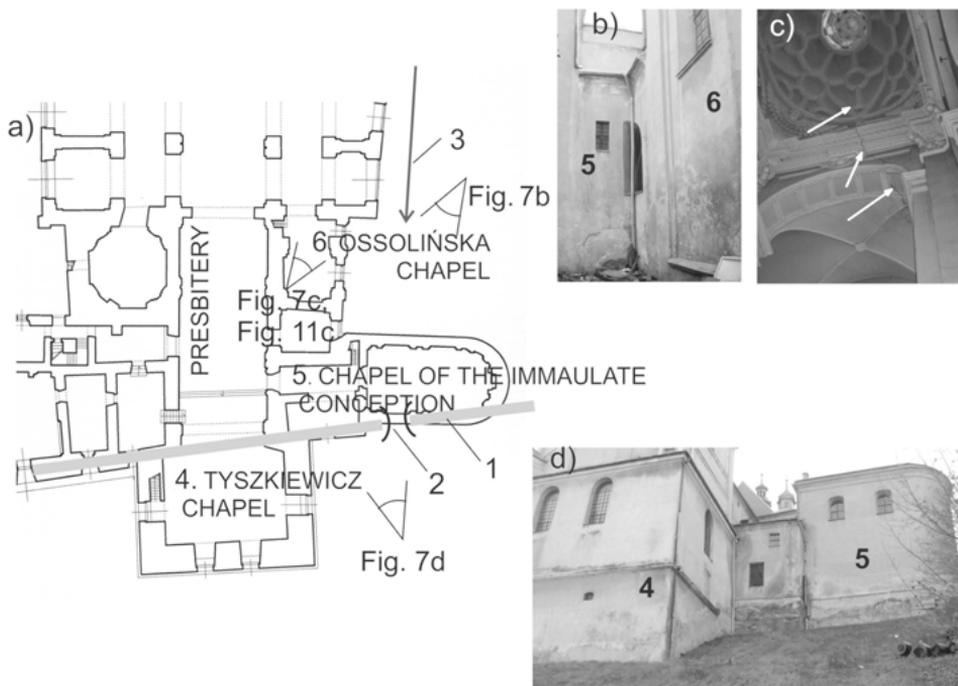
Originally, the town gate, the so-called "Butcher's Gate" existed in the location where the chapel is at present (Fig. 2b, Fig. 7a). It was a part of the path running next to the basilica leading from the Town Market away from the city. It also performed as the drain of liquid waste from the town's butcheries. The chapel crossed the path, putting a stop to this unpleasant neighborhood (Fig. 7b, Fig. 7c). However, the chapel began to act as a dam for rainwater and sewage flowing from the Old Town Hill. The loess which constitutes the subsoil in the corner between the basilica and the chapel soaked. This resulted in the settlement of chapels adjacent to the path, particularly the Ossolińska Chapel, and emergence of cracks in walls, vaults and the dome (Fig. 8).

Fig. 7. Location of the Chapel of the Immaculate Conception of the Blessed Virgin Mary: a) projection of the basilica, b) view from the inside of the Old Town, c) view from the outside of the Old Town Hill. Numbers indicate the following: 1 – town wall, 2 – Butcher's Gate, 3 – direction of water and sewage flow, 4 – Tyszkiewicz Chapel, 5 – Chapel of the Immaculate Conception of the Blessed Virgin Mary, 6 – Ossolińska Chapel

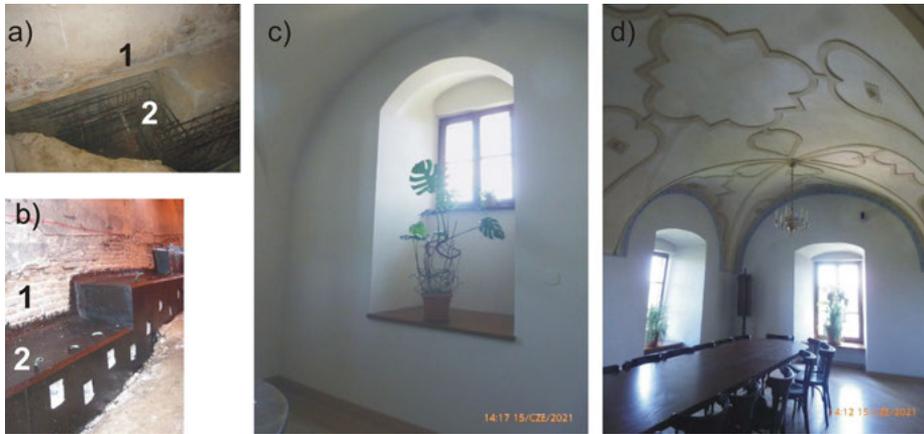
Fig. 8. South-east corner of the east wing in the Dominican monastery: a) and b) the micropiled structure supporting the corner – the internal and external grid beams photographed under construction (1 – east wall, 2 – micropiled structure), c) present view of the restored corner room in the ground floor (the wall shown in Fig. 3b), d) present view of the restored corner room in the first floor

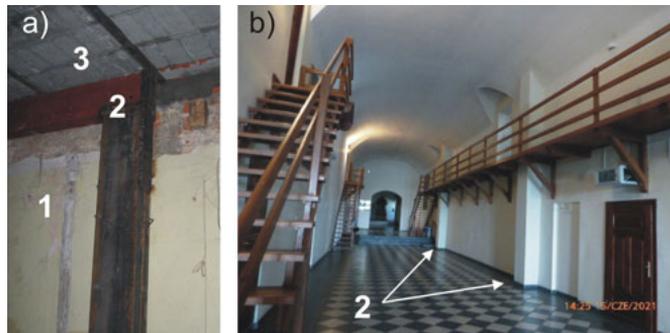
Fig. 9. Steel structures unloading the vaults in the east wing of the Dominican monastery founded on the transverse first floor wall: a) one of steel frames under construction, b) present view of the corridor in the second floor lined with the steel frame (1 – longitudinal wall standing on the vault, 2 – steel frame, 3 – ceiling above the second floor)

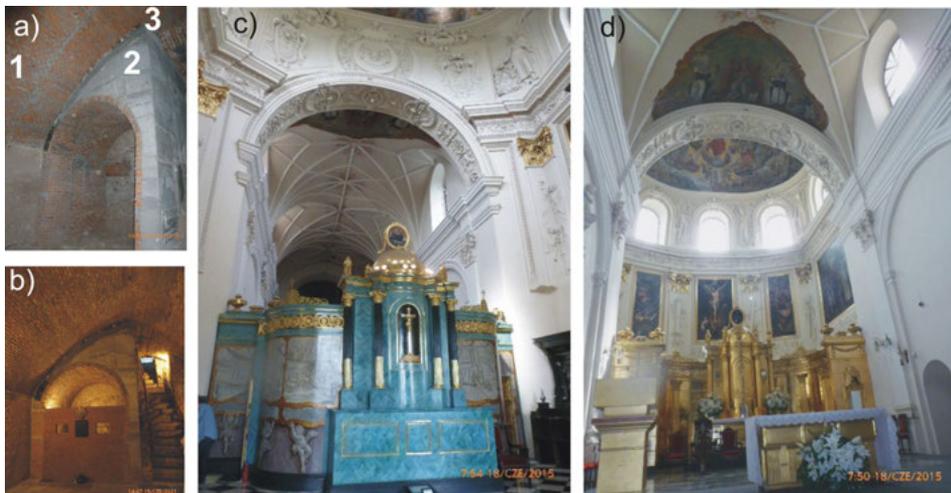
Fig. 10. The Tyszkiewicz chapel: a) and b) concrete structure in the crypt supporting the wide vault under the high altar, under construction and now (1 – rebuilt part of the vault, 2 – supporting concrete arch, 3 – original part of the vault), c) present view of the Tyszkiewicz Chapel's interior with the reverse of the high altar, d) present view of the high altar and the Tyszkiewicz Chapel behind it

The damaged wide vault in the crypt under the Tyszkiewicz chapel (Sec. 3.4) was partially rebuilt or strengthened in the zone outside the altar's location. Calculations mentioned in Sec. 3.3 proved that the section of the vault supporting the altar has insufficient bearing capacity for the fulfilment of the ultimate limit states conditions. Unfortunately, the temporary unloading of the vault by removing the altar for the restoration time was impossible, would allow the introduction of effective strengthening. Therefore, the supporting structure was introduced under the altar (Fig. 6b, Fig. 10). The strengthening of the crypt's structure was supplemented with widening the foundation of the internal wall.

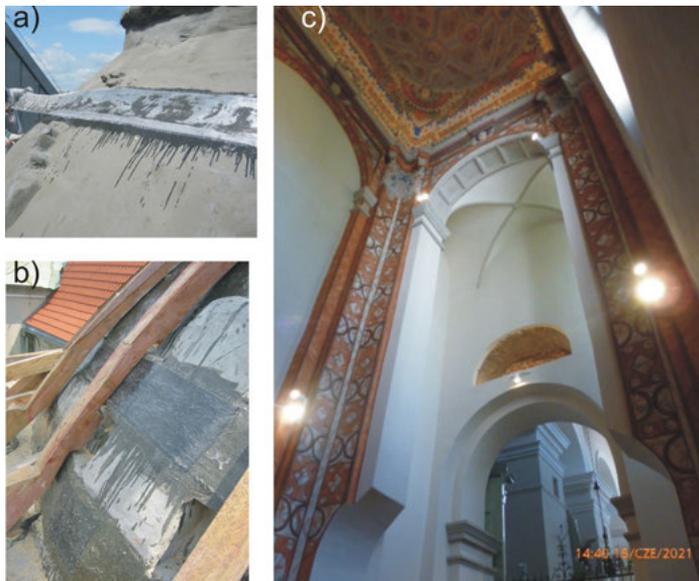
Fig. 11. The Ossolińska Chapel restoration: a) application of GFRP composite as the first layer, b) CFRP composites after strengthening, c) present view of repaired and restored arch and vault

The remedy applied in order to eliminate the cause of the damage in north side chapels (Sec. 3.4) was a new drainage system in the area adjacent to the basilica. The structural restoration, besides the injection and sewing of the cracks in walls, vaults and the dome, included the application of GFRP and CFRP composites in order to strengthen the hoop of the dome of the Ossolińska Chapel (Fig. 11). The effectiveness of GFRP and CFRP composite strengthening was proved for historic masonry, particularly for arches and vaults, based on several studies, e.g. compiled in [29]. This solution gives good results, also in comparison with today's widely developing TRM systems [30]. Nevertheless, due to the recognition of the disadvantages of CFRP composites gluing to historic masonry (difference of stress-strain characteristics and creating a barrier for moisture evaporation), only the lower half of the dome and, what is more, only strips of surface were covered with composites. The solution allowed the steam permeability. Before the composites' application, the whole surface was covered with trass-lime-based material. In order to "soften" the difference between masonry and CFRP moduli of elasticity, the first composite layer constitutes GFRP (Fig. 11a), which was the basis for CFRP (Fig. 11b).
