THE PHENOMENON OF HYDROGEN EMBRITTLEMENT IN HIGH-STRENGTH BOLTS

The article proposes a method for assessing the risk of hydrogen embrittlement for high-strength bolts in class 12.9. For this purpose, bolts made of material grade 32CrB4 were prepared and in a controlled manner the grain flow inconsistency was made, leading in extreme cases to the production of the forging lap. To perform the study, the device proposed by the European Assessment Document (EAD) was adapted to the testing of hydrogen embrittlement of threaded fasteners in concrete. The concrete substrate was replaced with metal spacers that were preloaded with a bolt. The use of the wedge distance under the bolt head led to the generation of two stress states – tensile and compressive, which translated into an increased risk of hydrogen embrittlement. After being tested, the bolts were visually and microscopically inspected to assess potential locations for cracks and hydrogen propagation. As a result of the conducted tests, it was found that the prepared test method allows to assess the resistance or susceptibility of the bolt to threats related to hydrogen embrittlement.

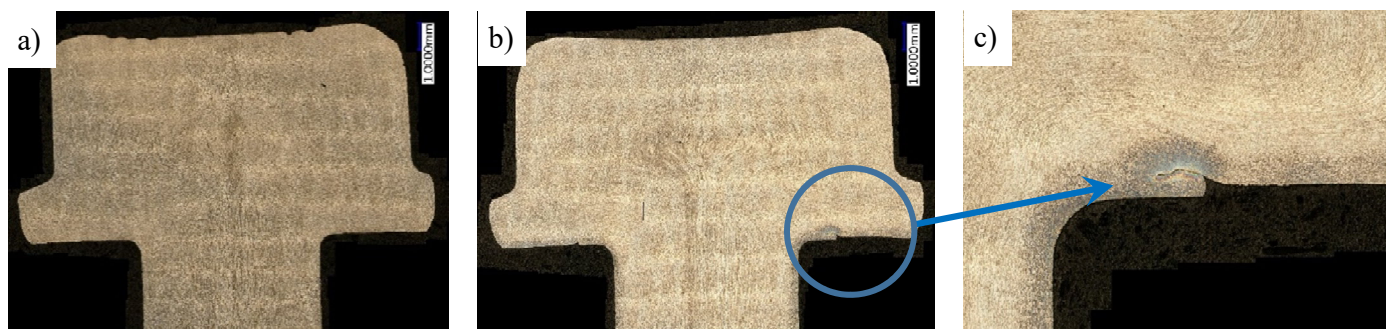
The variations of the samples differed by the change of the constant volume principle for one of them, and thus by the change of the pattern of the fiber arrangement in the part of the bolt head (Fig. 1). In one variant, in the first forging operation, the material was upset from a too small part of the volume of the prepared wire semi-product. More material was left in the bolt pin. As a consequence, in the following operations, the bolt material was forced into the bolt head, leading to the phenomenon of lap forging on the bearing surface of the bolt flange (Fig. 1c).

Fig. 1. Samples of polished longitudinal sections of DIN 6921 M6x20 bolts after the forging process with the grain flow pattern. a) variant compatible with the technology used, b) variant with a deliberate defect of lap forging the bearing surface, c) the lap forging of the bearing surface

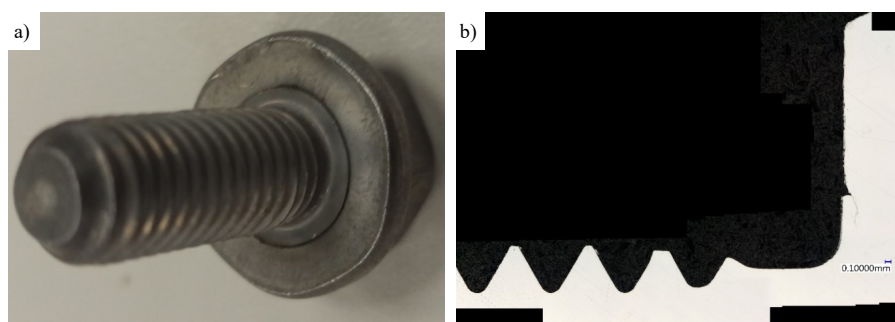
to cracks. The bolt threads, the first thread (thread starting from the bolt pin with a larger radius at the bottom than the rest of the thread) and the radius between the bearing surface and the pin were checked. In samples 1 and 3, no additional cracks were found, apart from the lap forging defects generated intentionally in the forging process (Fig. 6). Longitudinal sections of the bolts for metallographic evaluation were prepared. The analysis showed no new crack nuclei. The lap forging length of the bolt was measured and compared with the samples immediately after the forging process (Fig. 7). The measurement was to show whether the lap forging defect propagated, the end of which can be defined as a notch during the HE test. There was no significant increase in the length of the defect. The difference obtained in favor of the samples after the test could have resulted from

Fig. 6. Evaluation of sample 1 of variant 1 after the test. a) assessment of surface discontinuities, b) assessment of the bolt longitudinal section

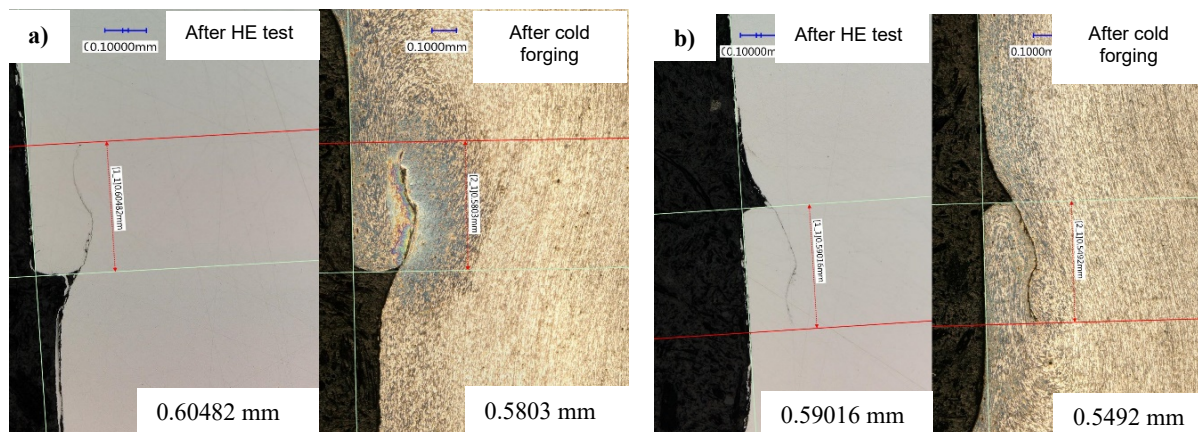
chance and depended on the variability of the forging process, high strain rates, tool heating, and production speed reaching 180 pcs/min. In the future, for the remaining samples prepared for HE tests, it is planned to extend the test to 200 hours to assess the potential increase in the length of the lap forging defect due to the diffusion action of hydrogen atoms.

Fig. 7. List of the clamping length for the bolt after the HE test and after the forging process (before heat treatment), a) right side of the bolt, b) left side of the bolt

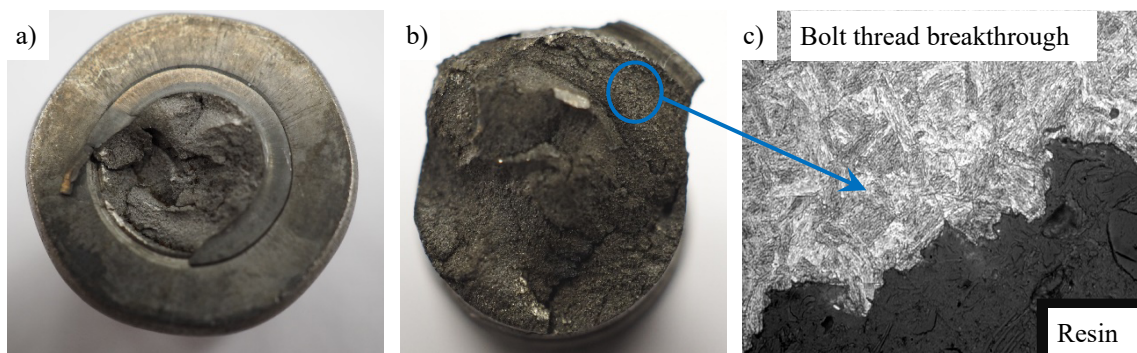
A breakthrough was made in sample 2 of variant one (Fig. 8). Macroscopic and microscopic analysis allowed us to classify the type of scrap as brittle. The crack after evaluating the polished sample of the bolt thread was defined as an intercrystalline crack. There are no places where plastic scrap occurs, this is due to the fact that the tension in the bolt dropped after the crack had occurred. The clamping force was reduced by increasing the clamping length on the bolt due to a break.

Fig. 8. Assessment of breakthrough of the bolt after failure, a) bolt head, b) threaded bolt pin, c) cross cut from the threaded bolt pin

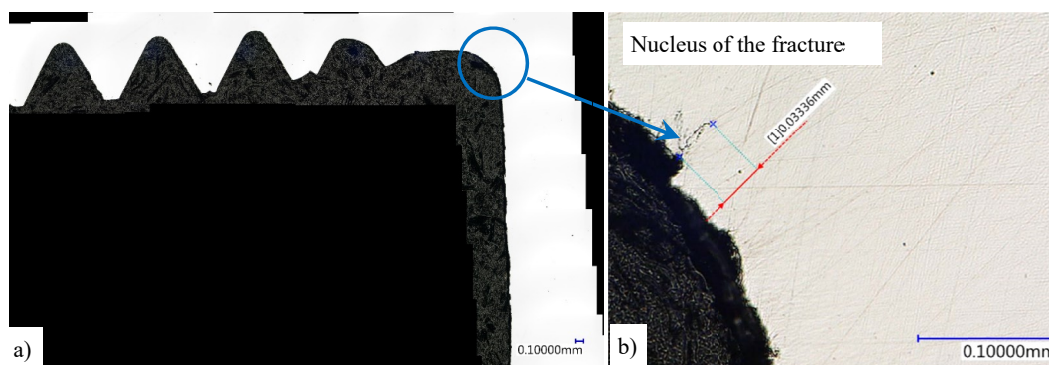
exposed to the wedge, of increased tensile stress. The nucleus of the crack was located in the radius between the bearing surface and the bolt pin. The stress point in the loaded bolt. The first microscopic assessment did not give a clear answer as to whether the image shows a crack germ, there was a risk of confusion with a defect in the sample polishing process. The sample was polished again, which confirmed the presence of a defect in the same place. The length of the crack nucleus (Fig. 9b) is 0.03336 mm, it was created as a result of a notch on the surface. The notch could have resulted from the random sticking of semi-product material particles to the die.

Fig. 9. Microscopic evaluation of a polished longitudinal sample, a) evaluation of surface discontinuities in places exposed to cracking, and b) crack nucleus on the radius
