Settlement of a historic building due to seepage-induced soil deformation

3. Soil seepage-induced deformations within the area of the St. Nicholas basilica in Gdańsk – case study

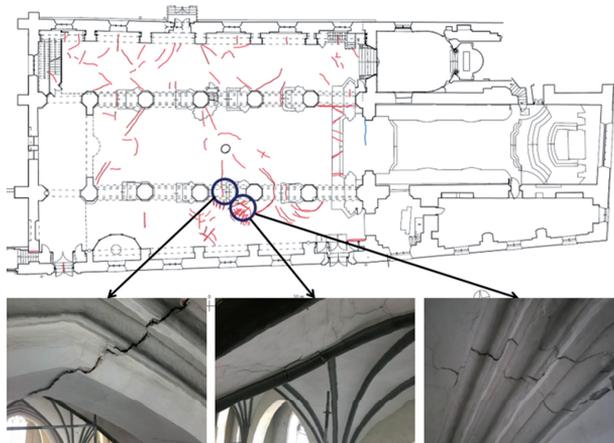
Disturbing damage to the vault over the southern aisle was observed in autumn of 2018, at the end of October. Intense (in terms of number and opening width) scratches of the squinches and deformations (buckling relative to the vault plane) of the ribs were identified during a thorough inspection.

Vault ribs were cracked with a displacement and detached from the squinch surface, and the opening width reached 6–8 mm. Arch wall crack (crevice with a mutual edge shift) between the second and third pillar of the southern aisle, with a maximum opening width of 28 mm was identified. Fig. 3 shows damage concentration in the southern aisle pillar area and the cracks of wall elements.

Fig. 3. Simplified stock-taking of Basilica southern aisle damage [43]

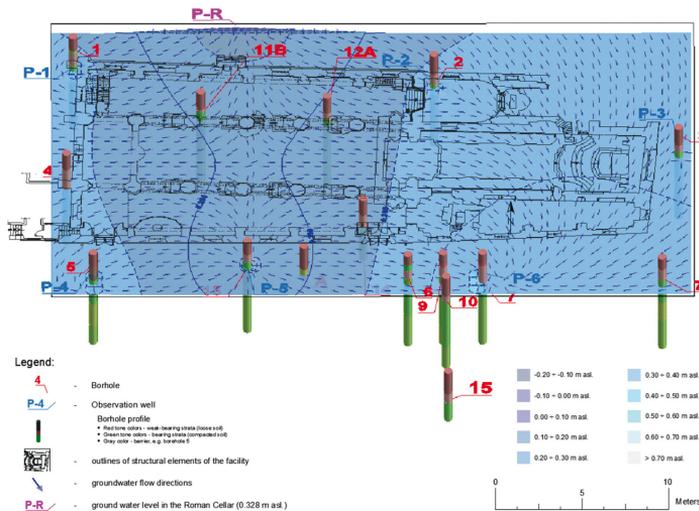
Fig. 5. Groundwater table level map with marked soil profiles at the borehole and piezometer location, with seepage directions for 31/7/2019, against the background of the Basilica basement level plan

31/7/2019, against the background of the Basilica basement level plan, with marked soil profiles in test boreholes and piezometers. Fig. 5 also shows water seepage directions resulting from piezometer groundwater levels. The analysis covered changing water levels on individual piezometers, as well as varying water seepage directions and seepage gradient values. Gradient values were analysed both along the entire length between the piezometers and locally, e.g., in the area of the pillars that experienced the greatest settlement.

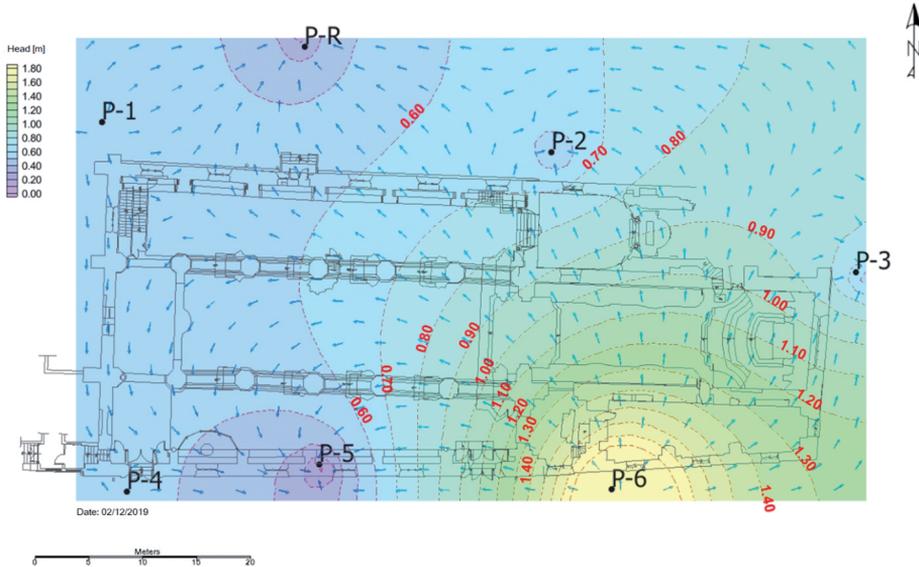
Fig. 6. Groundwater table level map with seepage directions for 2/12/2019, against the background of the Basilica basement level plan

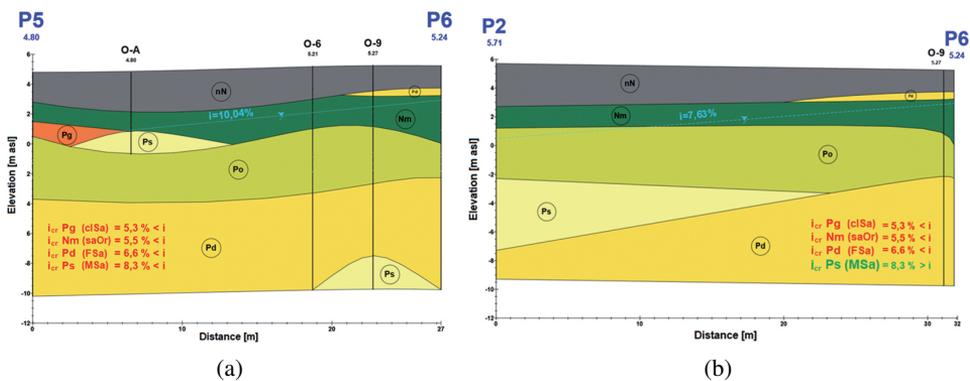
Fig. 7a shows the P5-P6 longitudinal profile and the position of the groundwater table curve position on 2/12/2019, and Fig. 7b shows the P2-P6 longitudinal profile and the position of the groundwater table curve position on 2/12/2019. Fig. 8 shows the P5-P2 longitudinal profile and the position of the groundwater table mean curve position and the local mean curve on 12/7/2019, as well as a diagram of pillar foundation level. Fig. 7–8 also show determined mean gradients between piezometers, relative to the critical gradients for

Fig. 7. Averaged groundwater table position within the Basilica area for 2/12/2019:
 a) P5-P6 longitudinal profile, b) P2-P6 longitudinal profile

given soil types. Red colour marks the soils with exceeded critical gradient values (Bligh criterion) [37].

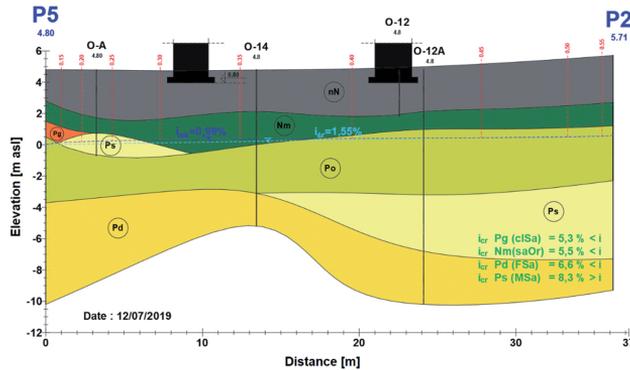
Fig. 8. Averaged groundwater table position and local table change within the Basilica foundation area for 12/7/2019 – P5-P2 longitudinal profile

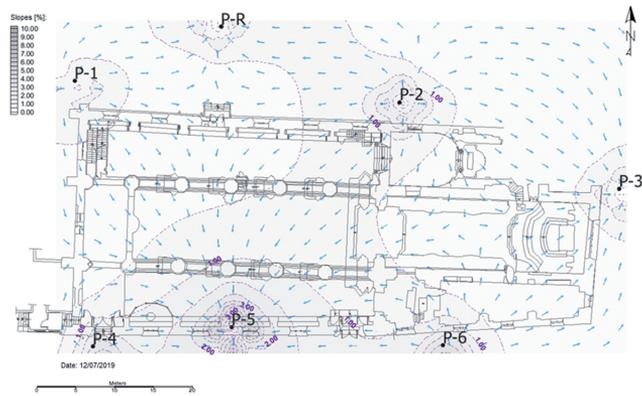
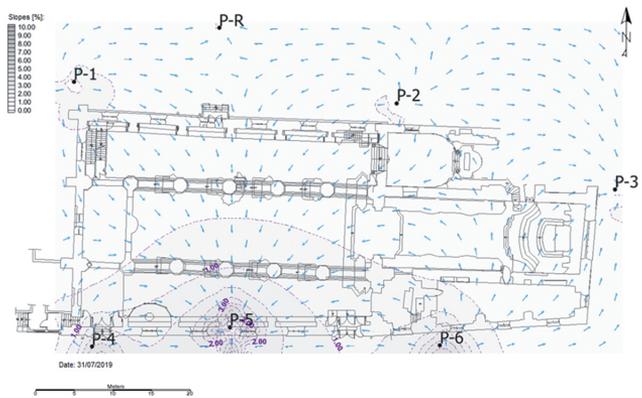
Fig. 11. Map of local groundwater table declines with seepage directions for a) 12/7/2019 and b) 31/7/2020, against the background of the Basilica basement level plan

The presented results show how local declines in the Basilica area subsoil change. It can be clearly seen that the phenomenon varies over time, but qualitatively similar situations occur, such as on 2/12/2019 and 3/2/2020. The cyclical changes in the Basilica subsoil hydraulic gradients can initiate the formation of seepage-induced deformations. These changes can have various location, and the detachment of the subsoil from the Basilica floor was also found in several places.

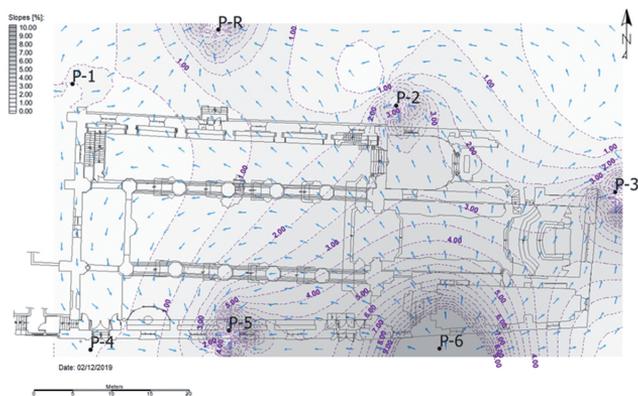
Fig. 12. Map of local groundwater table declines with seepage directions for 2/12/2019, against the background of the Basilica basement level plan
