**OPERATION-ORIENTED STUDIES ON WEAR PROPERTIES OF SURFACE-HARDENED ALLOY CAST STEELS USED
IN MINING IN THE CONDITIONS OF THE COMBINED ACTION OF DYNAMIC FORCES
AND AN ABRASIVE MATERIAL**

This paper presents the results of wear tests of shot-peened and not shot-peened cast steels used in the mining machinery industry, in particular in the construction of chain drums for armoured face conveyors. Wear tests were carried out in the conditions corresponding to the real operating conditions of armoured face conveyors during drifting work in rocks such as sandstone. The operating factors subjected to the analyses included the presence of quartz abrasive and the impact of external dynamic forces. On the basis of the wear tests as well as the microhardness and microstructure examinations performed, it has been found that the action of an additional dynamic force has a synergistic impact on the process of abrasive wear in loose quartz abrasive. It has been further found that the value of abrasive wear of chain wheels operated in the conditions of a combined action of abrasive and a dynamic force depends on whether the area of mating of wheels with the chain was shot-peened or not before the

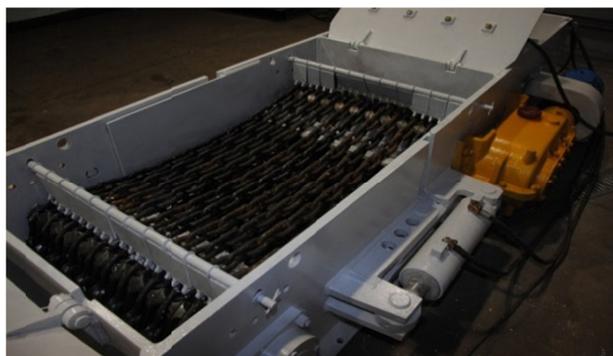
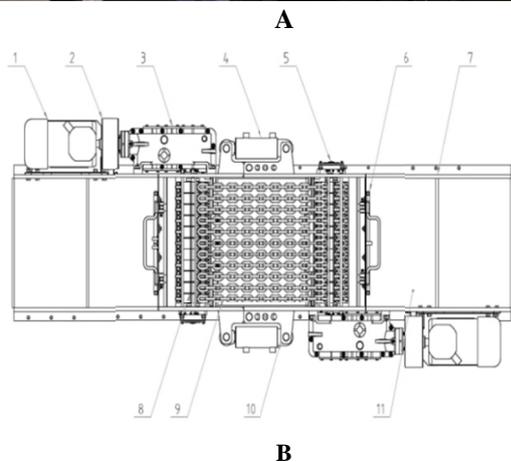
Fig. 1. Test rig, A. View B. Diagram; designations: 1 – Induction motor 22 kW, 2 – Flexible coupling, 3 – Conical-cylindrical reduction gear, 4 – Hydraulic cylinder, 5 – Axle shaft, 6 – Sprinkler system for the test chamber, 7 – Body of the test rig, 8 – Test samples, 9 – Chain, 10 – Mounting bracket of the hydraulic cylinder, 11 – Additional chamber for aggregate

A view and a diagram of the test rig used in the wear tests are shown in Fig. 1. A diagram of the load of the chain wheels for the abrasive wear test is shown in Fig. 2A, while for the abrasive-dynamic test – in Fig. 2B.

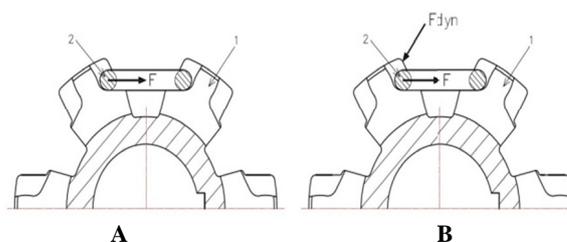
Fig. 2. Diagram of the load of a drum chain; A – for variant 1 of the wear test, B – diagram of the load of the chain drum for variant 1 of the wear test; designations: 1 – chain wheel, 2 – chain, F – driving force, F_{dyn} – external dynamic force obtained by the use of beaters

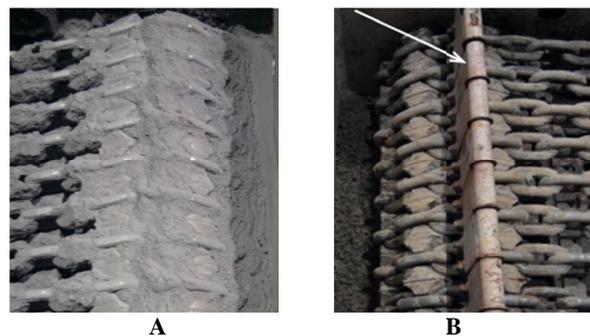
Fig. 3. Test rig, A – a view of the test chamber of the test rig during the wear tests with dry quartz abrasive (variant 1), B – a view of the test chamber of the test rig during the wear tests with dry quartz abrasive and a dynamic load (variant 2); the arrow indicates the installed beaters

The design of the test rig enabled filling of the test box with any abrasive mixture as well as inducing an external force. Beaters with the mass of 1 kg were installed in the test rig in such a way that each tooth of the chain wheel was hit during the rotation of the drive shaft.

Fig. 3A presents a view of the test chamber of the test rig during the wear tests in the presence of quartz abrasive, while Fig. 3B shows a view of the chamber with installed beaters for the wear test with a dynamic load (abrasive-dynamic test).

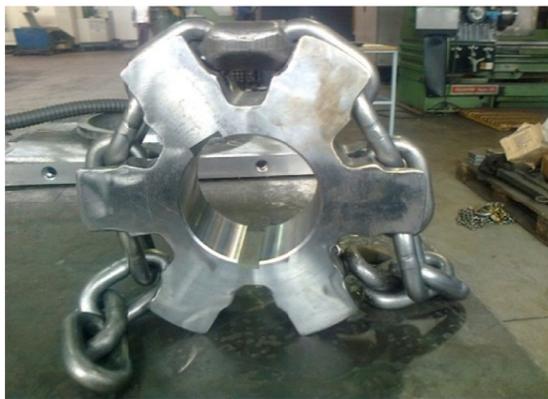
Fig. 4. Test chain wheels

The test chain wheels were cast in sand moulds and subjected to normalization as well as quenching and tempering. After the final machining, the chain wheels were subjected to surface hardening. The surface hardening was performed using the flame method; the surfaces subjected to machining were heated to a temperature of approx. 800°C, and then cooled in 6% solution of water-polymer coolant.

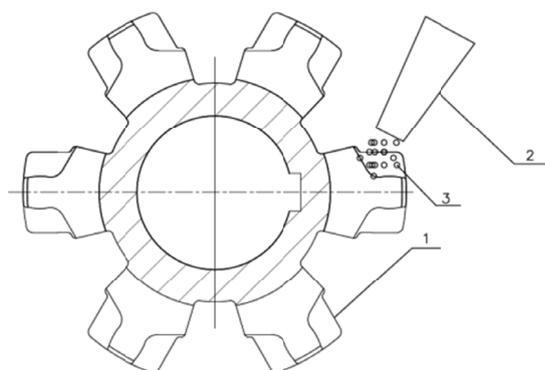
Fig. 5. Diagram of the process of shot peening of chain wheels; 1 – area of mating of the chain drum, 2 – nozzle of the shot-peening machine, 3 – shot

Two identical sets of chain wheels were used for the wear tests. One of them was subjected to shot peening. The shot-peened chain wheels in the area of the contact between the wheel and the chain (Fig. 4) were subjected to a dynamic treatment with the Almen intensity of 0.32% mmA and the coverage of 2×100%. Shot peening was conducted with the use of cut and rounded shot with the diameter of 0.6 mm and the hardness of approx. 54 HRC. Sample views of the surface subjected to shot peening, obtained on the basis of observations with the use of HITACHI S-3500N scanning electron microscope, are shown in Fig. 5. As a result of the action of shot on the tooth surface, there were formed flat deformations with distinct borders of the areas deformed (Fig. 6A) and cracks appeared in the surface layer (Fig. 6B).

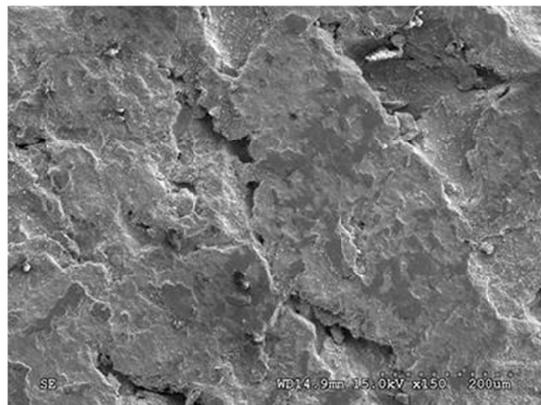
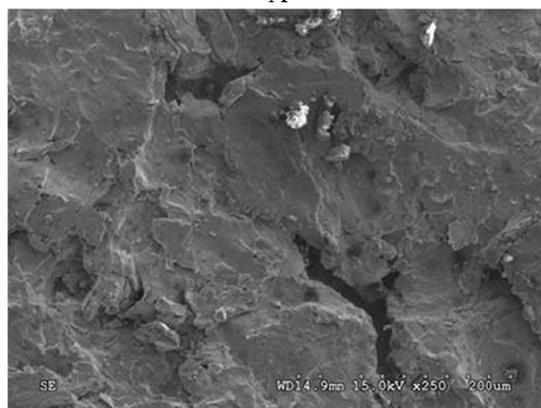
Fig. 6. Deformations of the surface of the chain wheels made of GS42Cr-Mo4 cast steel caused by the action of shot; A – flat deformations with distinct borders of the areas deformed, B – cracks in the surface layer

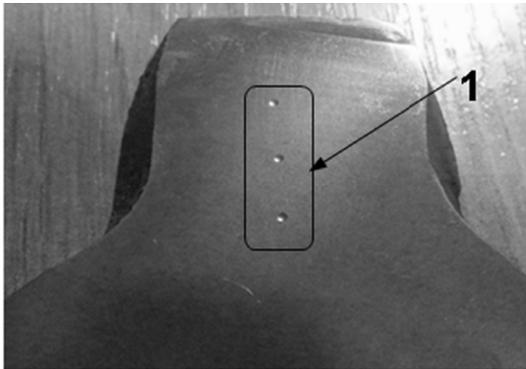
Fig. 7. A view of the area (1) of the tooth subjected to Brinell hardness test

Metallographic tests and measurements of hardness were carried out after the wear tests. Hardness was determined with the use of the Brinell HB method on hardened surfaces of the side teeth (Fig. 7). The structure was determined by cutting out

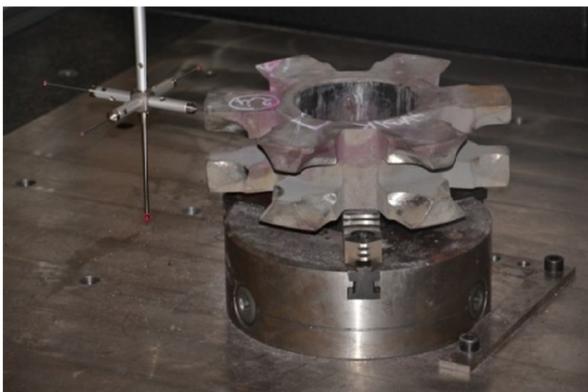
Fig. 8. A view of a chain wheel during the measurements on the coordinate measuring machine

In order to determine the abrasive wear of the chain wheels, the areas of mating between the chain wheel and the chain were measured before and after the wear test using a coordinate measuring machine (Fig. 8). The area of mating between the wheel and the chain was represented by at least 300 points making up the route of the measuring head of the machine (Fig. 9).

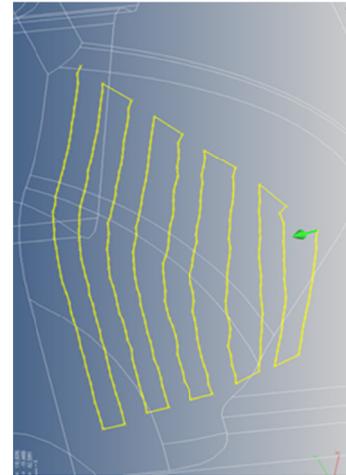
Fig. 9. A view of the route of the measuring head superimposed on the model of the chain wheel (the arrow indicates the end point of the route of the measuring head)

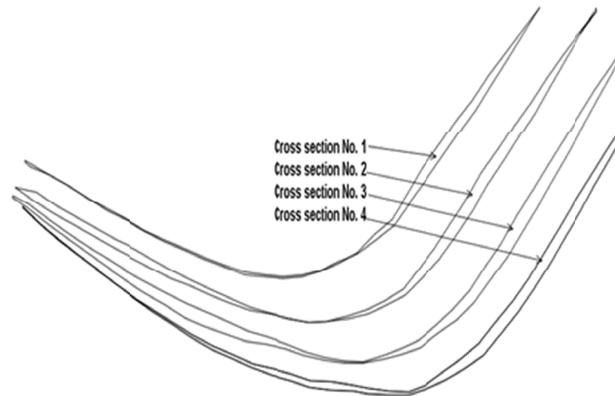
Fig. 10. A view of the surfaces obtained using the data from the measurement of the surface of a tooth made of GS42CrNiMo4 cast steel, before and after the wear test

teeth of the chain drum. Fig. 10 shows the effect of merging the first 4 lines of the route of the measuring head determined before and after the wear tests. It can be easily seen that these paths merge, giving as a result a surface with a variable height, on the basis of which the measures characterising the abrasive wear of the chain wheels can be determined.

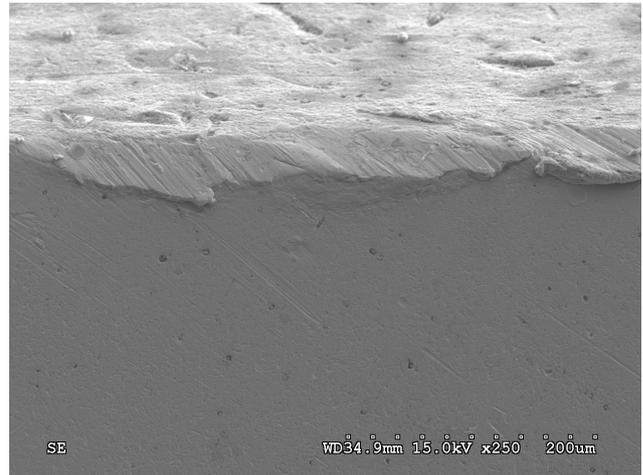
Fig. 11. Traces of microcutting by grains of quartz abrasive on the surface of a wheel made of L35GSM steel

The basic mechanism of destruction of the wheel surfaces mating with the link chain in the presence of quartz abrasive was the process of microcutting. The effects of the cutting action of quartz grains are illustrated in Fig. 11. Large cuts caused by the action of the abrasive can be easily seen in the material of the chain wheel.

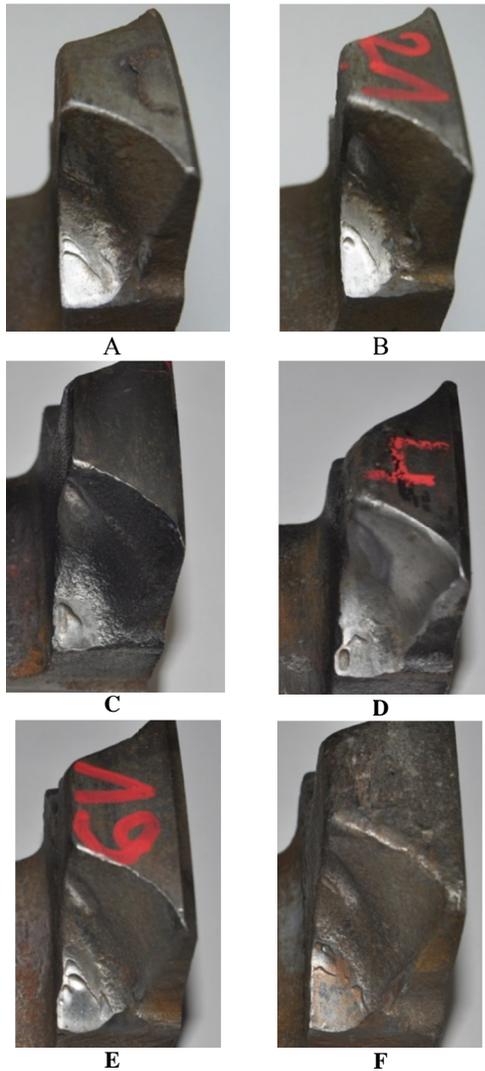
Fig. 12. A view of the area of mating between the cast steel wheels and the chain; A – L35GSM, B – L20HGSNM, C – GS42CrMo4, D – L30GS, E – GS42CrMo4_SP, F – A6

- flat abrasions in the area of mating with distinct border between the zone subjected to the wear and the zone not subjected to the wear (Fig. 12A); small single cavities may occur in the area of abrasion (Fig. 12B),
- deep abrasions in the area of mating having a lenticular shape (Fig. 12C and 12D),
- abrasions in the area of mating with noticeable fairly deep cracks (Fig. 12E and 12F).

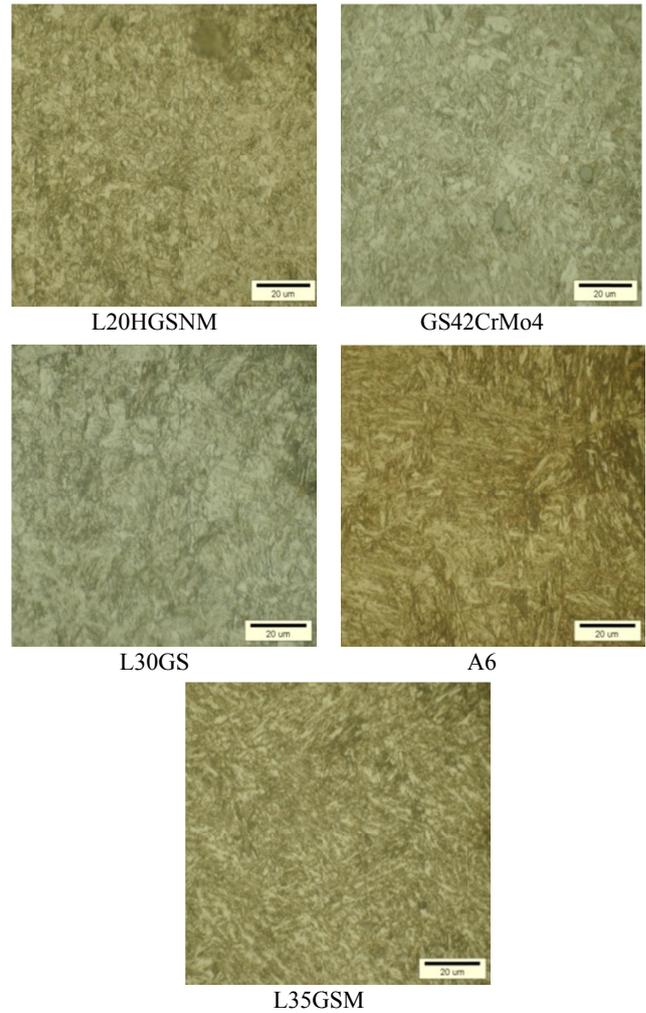
Fig. 13. The microstructure 2 mm under the surface of the tested cast steels

After the metallographic examinations had been carried out, it has been found for the analysed L20HGSNM, GS42CrMo4, A6, L30GS and L35GSM cast steels that in their surface layer there occurred tempered martensite formed as a result of the surface hardening process. In the core of the chain wheels, there was found fine-grained sorbite formed as a result of normalization as well as quenching and tempering of the casts. Non-metallic inclusions were observed in the structure of the casts (sample views of the inclusions are shown in Fig. 14). They were located mainly in the areas of contact between the sand mould and the molten metal.

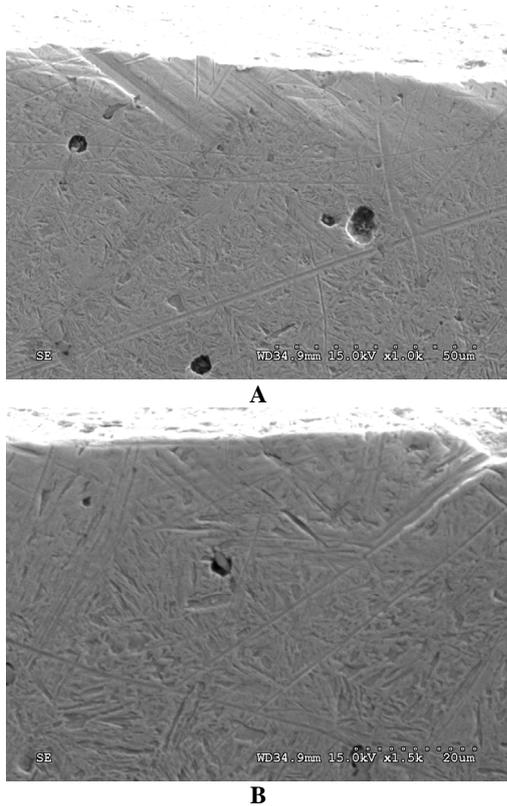
Fig. 14. Examples of non-metallic inclusions in the microstructure of the L35GSM cast steel

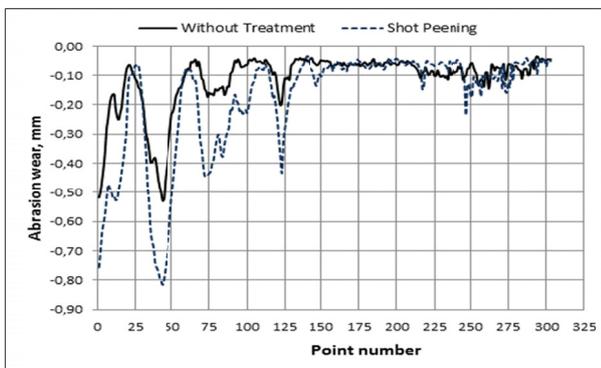
Fig. 15. Graphs of the value of averaged wear of the i -th point of the measuring route $\delta_{i,AVG}$ determined for the shot-peened and not shot-peened variants of the chain wheel made of the L35GSM cast steel

Fig. 15 shows examples of graphs of the value of averaged wear of the i -th point of the measuring route δ_{i_AVG} for the shot-peened and not shot-peened variants of the chain wheel made of the 35GSM cast steel, while Fig. 15 presents histograms of this parameter. Based on Table 4, Fig. 14 and Fig. 15, an increase in the wear of the chain wheels subjected earlier to shot peening can easily be noticed. The increased wear may result from deformations and cracks of the surface caused by the dynamic action of the shot (Fig. 5), which facilitate cutting of the material by the grains of quartz sand.

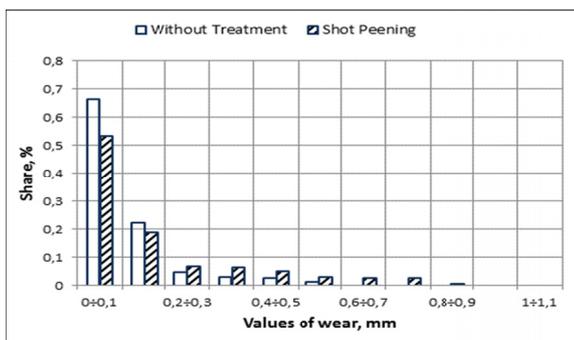
Fig. 16. Histograms of the value of averaged wear of the i -th point of the measuring route $\delta_{i,AVG}$ determined for the shot-peened and not shot-peened variants of the chain wheel made of the 35GSM cast steel

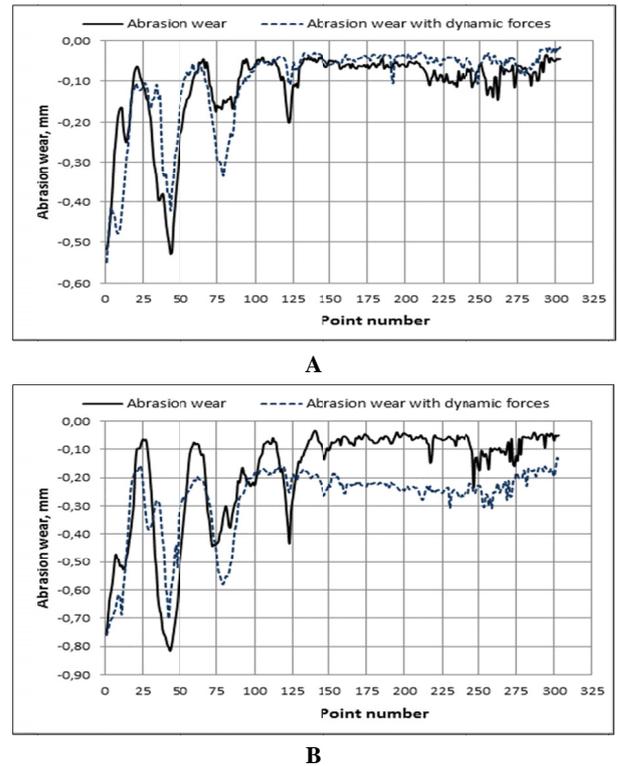
Fig. 17. Graphs of the value of averaged wear of the i -th point of the measuring route $\delta_{i,AVG}$ determined for the chain wheel made of the L35GSM cast steel, A – wheels not subjected to shot peening, B – wheels subjected to shot peening

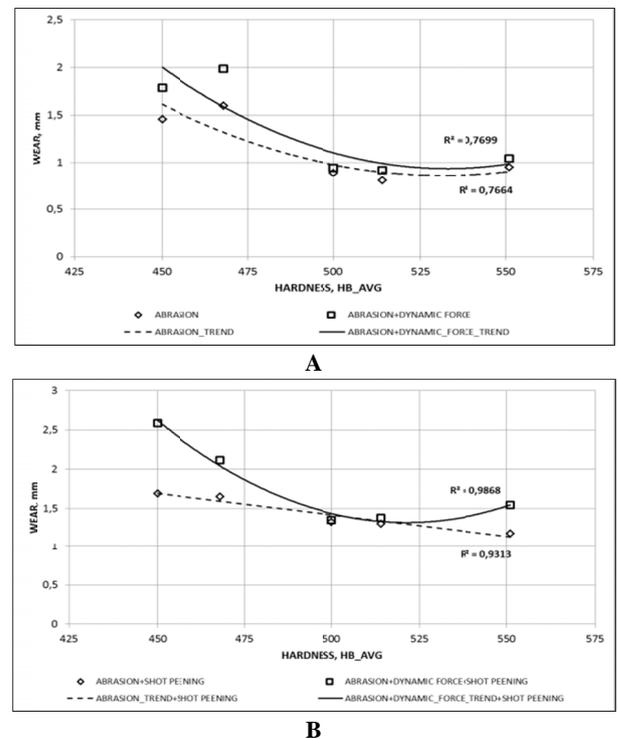
Fig. 18. The impact of an additional dynamic force on the abrasive wear the chain wheels tested as a function of the average surface hardness HB_{AVG} , A – wheels not subjected to shot peening, B – wheels subjected to shot peening

jected to shot peening as a function of the average hardness of the surface, which are presented on Fig. 18A.

An additional dynamic force has a significant impact on the abrasive wear in the case of the A6 and L30GS manganese cast steels. When analysing Fig. 18, there can be noticed a differentiation in the values of the abrasive wear as a function of the average surface hardness depending on the fact whether the wheels were subjected to shot peening or not.

For the non-shot peened variant, the graphs of the wear of the chain wheels, both in the case of their operation with an additional dynamic force and without it (Fig. 18A) have the same non-linear character. The chain wheels operated without the presence of a dynamic force were characterized by greater resistance to wear. Assuming the synergistic component ΔV_{DYN} , determined from the equation (2), as a measure of the impact of the dynamic force on the wear, in percentage terms this component ranged from 10 to 25% (Fig. 19).

The graphs of the wear of shot-peened chain wheels as a function of the average surface hardness of the materials tested differ significantly from each other in the cases of the operation with an additional dynamic force and without it (Fig. 18B). The graph obtained in the conditions of the destructive action in presence of the abrasive only is linear, while the graph for the case of the combined action of the abrasive and a dynamic force has a parabolic shape with a distinct minimum at the hardness of 500 HB. The differentiation in the value of the synergistic component ΔV_{DYN} is significantly higher in comparison with the wheels not subjected to shot peening, as it ranges from 2 to 52% (Fig. 19).

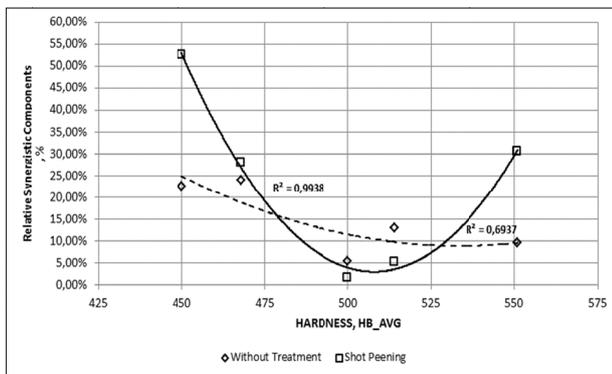
Fig. 19. The values of the synergistic component ΔV_{DYN} as a function of the average surface hardness of the materials tested

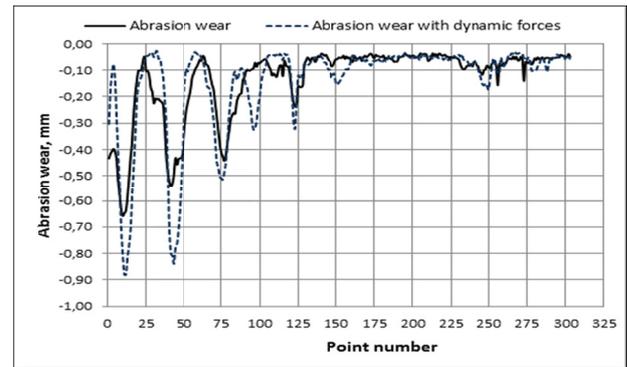
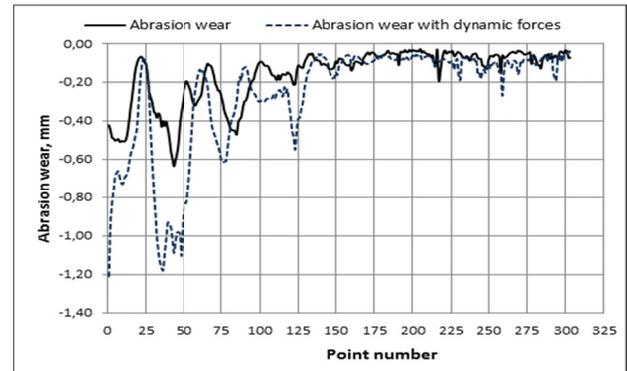
Fig. 20. Graphs of the value of averaged wear of the i -th point of the measuring route δ_{i_AVG} determined for the chain wheel made of the GS42CrMo-4 cast steel, A – wheels not subjected to shot peening, B – wheels subjected to shot peening

In the case of the GS42CrMo4 cast steel subjected to shot peening, the impact of the dynamic force resulted in greater increases in the wear as compared with cast steels of similar hardness, such as L35GSM and L20HGSNMA. Fig. 20 shows a comparison of the values of the averaged wear δ_{i_AVG} obtained at the presence of a dynamic force and without it for both surface preparation variants of the GS42CrMo4 cast steel. The presence of the dynamic force for both variants of chain wheels resulted in an increased wear, but for the shot-peened variant this increase was significantly greater (Fig. 20B).

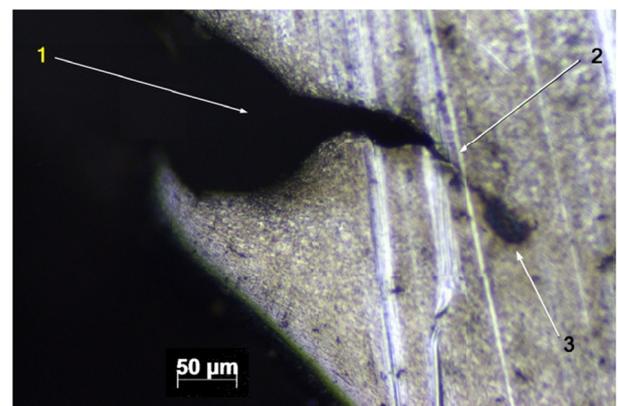
Fig. 21. Microstructure of the GS42CrMo4 cast steel; 1 – microcut, 2 – crack, 3 – non-metallic inclusions

When analysing the microstructure of the surface layer of the GS42CrMo4 cast steel operated in the presence of the abrasive only (Fig. 21), many oblique microcuts were observed.

Cracks were propagated from their vertexes down into the surface layer and in many cases they reached the place where non-metallic inclusions were located. It can be supposed that the resulting cavity with an additional crack is conducive to further cracking of this fragment and enlarging of the damage to the surface. The case shown in Fig. 21 is typical of the materials susceptible to brittle cracking [13].
