# Multi-criteria diagnostics of historic buildings with the use of 3D laser scanning (a case study)

**Key words:** laser scanning; diagnostics; historic buildings; limit state method; beam deflection; mycological tests.

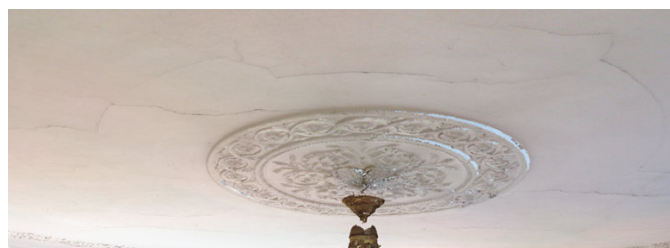
may be at risk of a large error and the location of ceiling beams alone cannot be concluded from it. Nowak et al. conducted similar studies of a historic building planned for reconstruction and adaptation [11], and, based on laser scanning, they estimated the ceiling deflection as 1.39 cm and the deviation of the front wall from the vertical plane by approx. 2 cm.

Fig. 6. Stucco on the ceiling (visible cracks in the plaster)

may be subject to large bending and, consequently, susceptible to scratches and cracks in every direction,

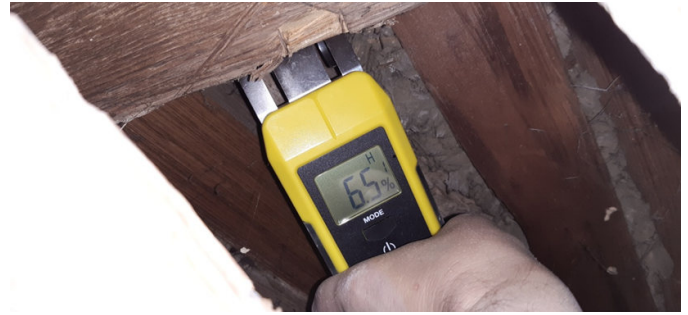
Figure 11 shows exemplary moisture content measurement at measurement point no. 2.

**Fig. 11.** Moisture content measurement of ceiling beams – test hole no. 2

According to the given criteria, the tested ceiling elements in the area near the external wall and in test holes, i.e. the most moisture-prone places, proved to be dry. In situ tests were carried out inside the Palace at maximum temperature  $T = 16.9 - 17.7^\circ\text{C}$  and maximum moisture content 48–52%.

The moisture tests of wood did not confirm any damage to the element, the level of moisture content was 5.8–10.3%, i.e. it did not exceed the value for structures protected against moisture, assuming class 1 use of the structure.

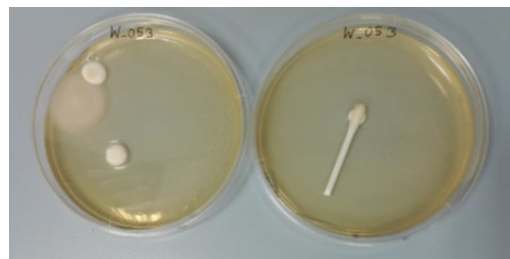
During the examination of the occurrence of condensation on the surface of the ceiling inside the rooms, no "dew point" was found. Also, no symptoms of wood decomposition were observed on the samples submitted for testing as well as no living structures, i.e. domestic fungi belonging to basidiomycetes (*Basidiomycota*) with strong wood decomposition capacity were found (Fig. 12).

**Fig. 12.** Petri dish after incubation (inoculation and the truncated tip from swabs for sample no. 1)

The number of units forming the colonies of mould fungi in the collected samples was low. In the tested samples, no fungi were found that could pose a threat to structural elements in terms of biological corrosion,
