# Research of damage to the rear wheel rim in a tipper-truck

**Abstract.** Serious damage to the inner rim of the rear twin wheel in one dump truck was noted during the operation of the fleet performing transport tasks. It was a drive wheel, and its damage occurred while driving with a load exceeding the permissible value. The examination of selected fragments of the damaged rim surface was conducted visually as well as using a digital microscope with a portable head. The measurements of the Vickers hardness and microscopic observations of the material structure of the sample cut along the thickness of the rim disk were carried out. The drive torque loading of the twin wheels of the tipper-truck rear axle, under their mating with different kinds of road roughness and under various vertical loads of the wheels was calculated. An analysis of stress distributions in the rim modelled using the Finite Element Method was also conducted for several possible scenarios of wheel loading. The damage to the rim was caused by simultaneous action of several factors, such as overloading the car, poor condition of the tires, loading the drive wheel by a part of the vehicle weight and the driving

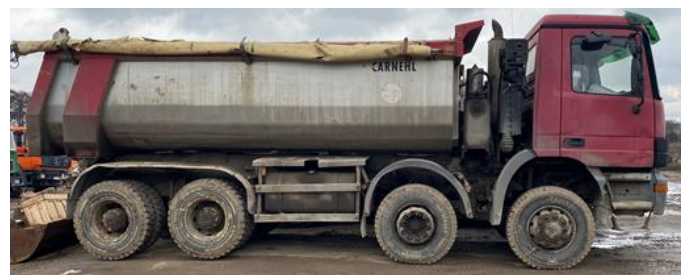
**Fig. 1.** The analyzed Mercedes-Benz Actros 4143 K 2002 tipper-truck with the damaged wheel replaced

The root cause of the problem was analyzed as follows: one of the transport companies, which deals with the transport of construction goods, encountered the necessity of fast, but short-term transport of cargo in the form of pallets with paving stones. The only means of transport available at that moment, capable of accommodating the required number of pallets with a paving slab, turned out to be a long-mileage tipper-truck (Fig. 1), the tires of which were heavily worn, and therefore the car was rarely used.

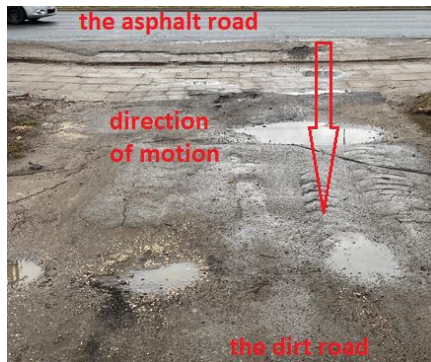
**Fig. 2.** The place of the analyzed traffic issue on the dirt road after leaving the asphalt road

the asphalt road and going onto a dirt road (Fig. 2), which was the driveway to the unloading site, there was a failure on one of the twin wheels of the rear axle of the vehicle (Fig. 3).

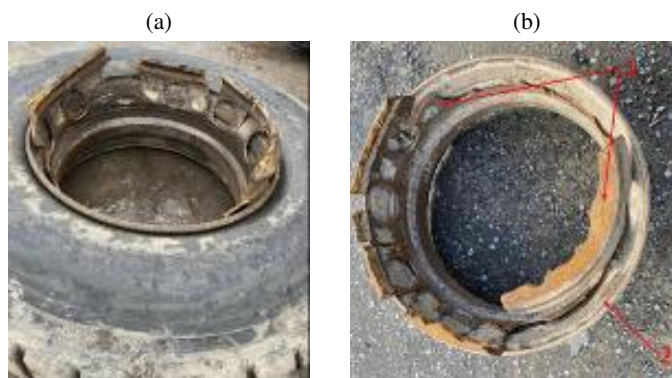
The inner tire simply burst off. Moreover, the rim of this wheel was severely damaged (Fig. 4). Interestingly, the outer tire and rim of this twin wheel were not damaged. There was

**Fig. 4.** The failed wheel with the damaged rim: (a) with a tire; (b) without a tire, 1 – fragment of the damaged rim, 2 – fragment of the rim that is free from damage

also no visible damage to the drive shaft, despite exceeding the permissible axle load. Described observations prompted the authors to look for the cause of such damage to the wheel, especially its rim.
