# PLANT COMMUNITIES IN DRAINAGE DITCHES – CONDITIONS, CHARACTERISTICS AND ENVIRONMENTAL FUNCTIONS

## Abstract:

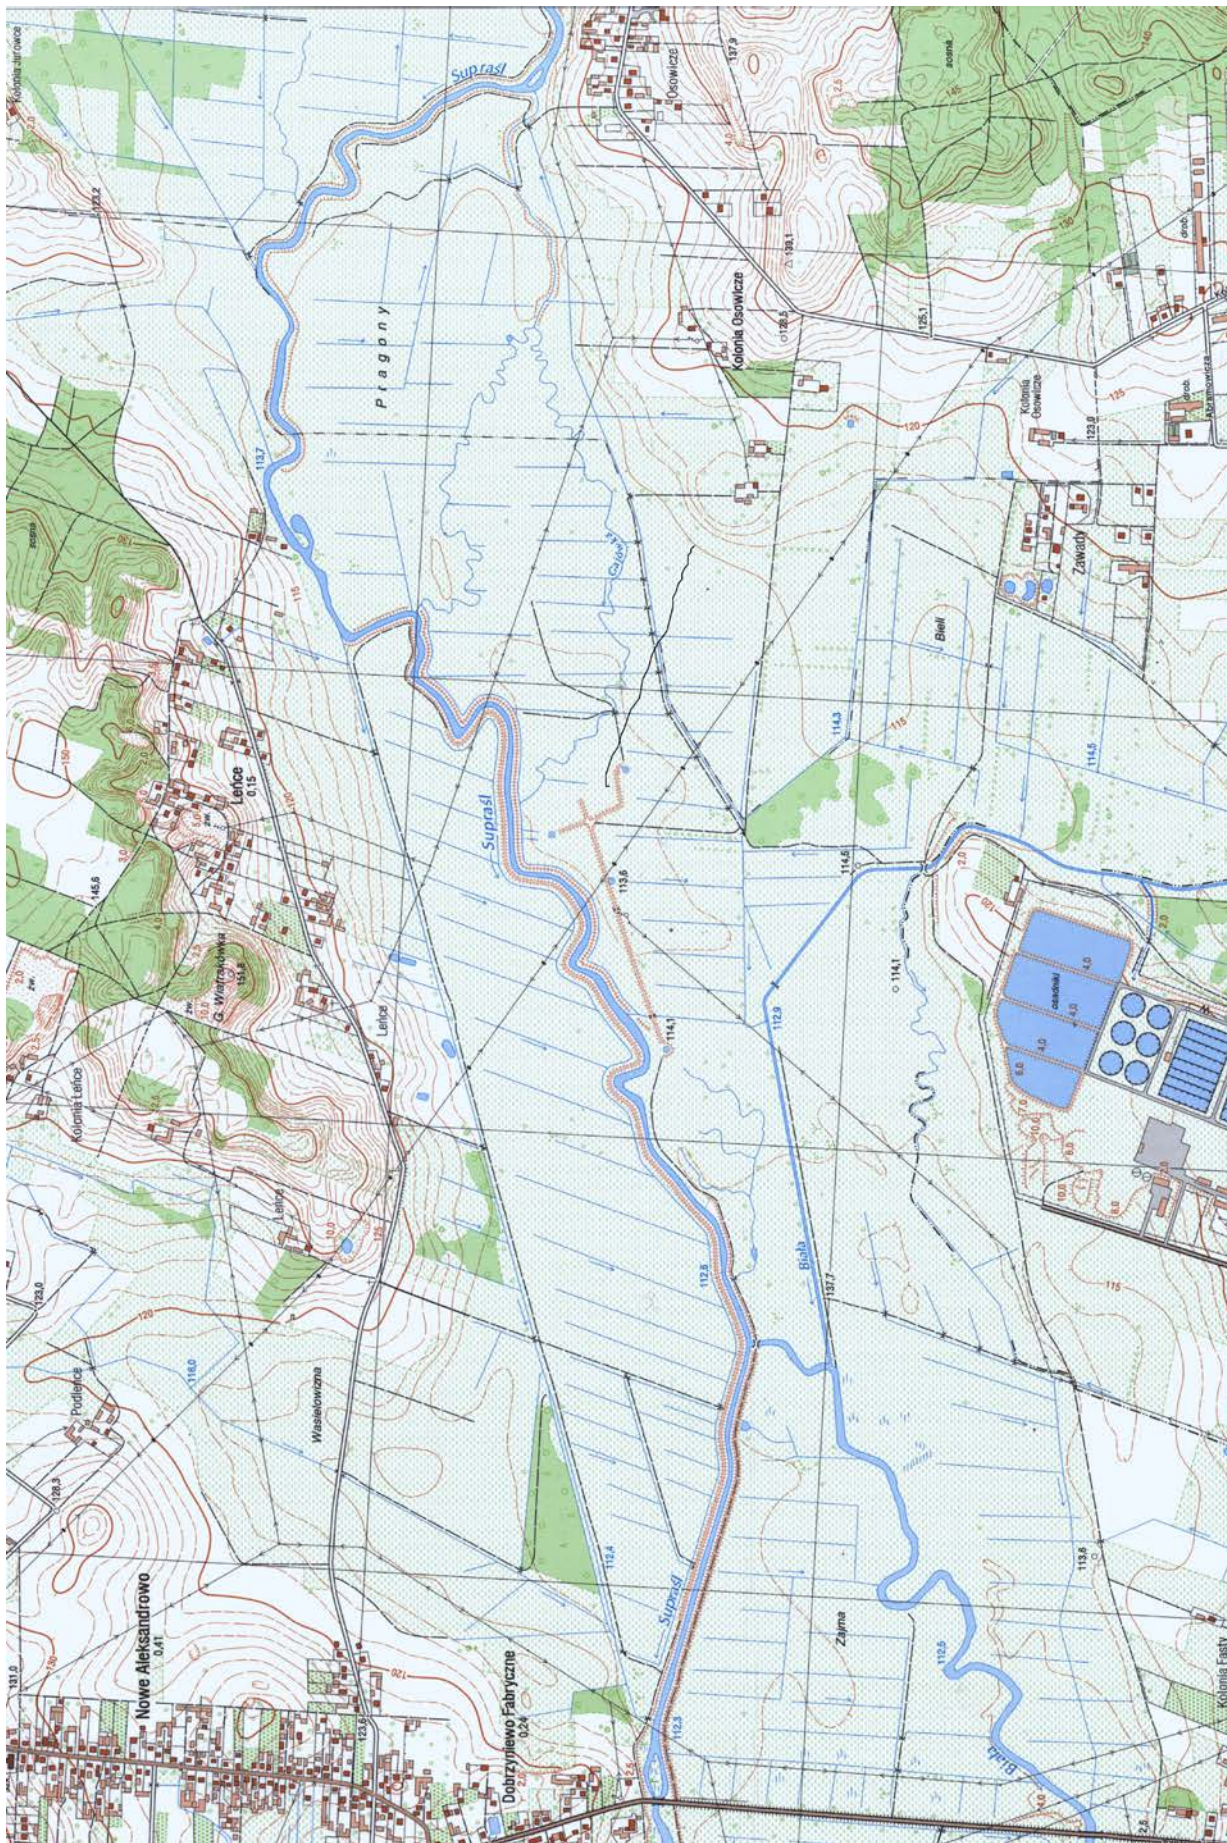
**Fig. 1.** Land reclamation system in the Supraśl Dolna valley (km: 7+500 to 15+300). Source: own elaboration based on GUGiK topographic map Nowe Aleksandrowo N-34-107-A-c-4.

The research was carried out in the lower section of the Supraśl River. The Supraśl river valley and the water system (Fig. 1) fulfill important environmental and economic functions due to their location between the Białystok agglomeration and the Knyszyńska Forest complex). The economic functions comprise providing water for irrigation of post-bog meadows in the area of approximately 5000 ha, drainage of meadows in the early spring and heavy rainfall in summer. Environmental functions include mainly protection of large areas of post-bog against their degradation and protection of valuable natural plant communities. There are also water abstraction points for the Białystok agglomeration by the Supraśl River.

In 2010, 2015 and 2020, floristic lists of plant communities in selected drainage ditches were prepared (Fig. 1). The research was carried out in three main drainage ditches named: Ditch A, Ditch B, Ditch C. Direct measurements of the parameters of water-drainage devices were performed according to the method of Kaca and Interwicz (1991). The results of the obtained floristic tests were calculated using the Microsoft Excel package. Due to the occurring processes of silting, shallowing and overgrowing of ditches, historical parameters (relating to the period before 2000) and current data are provided.

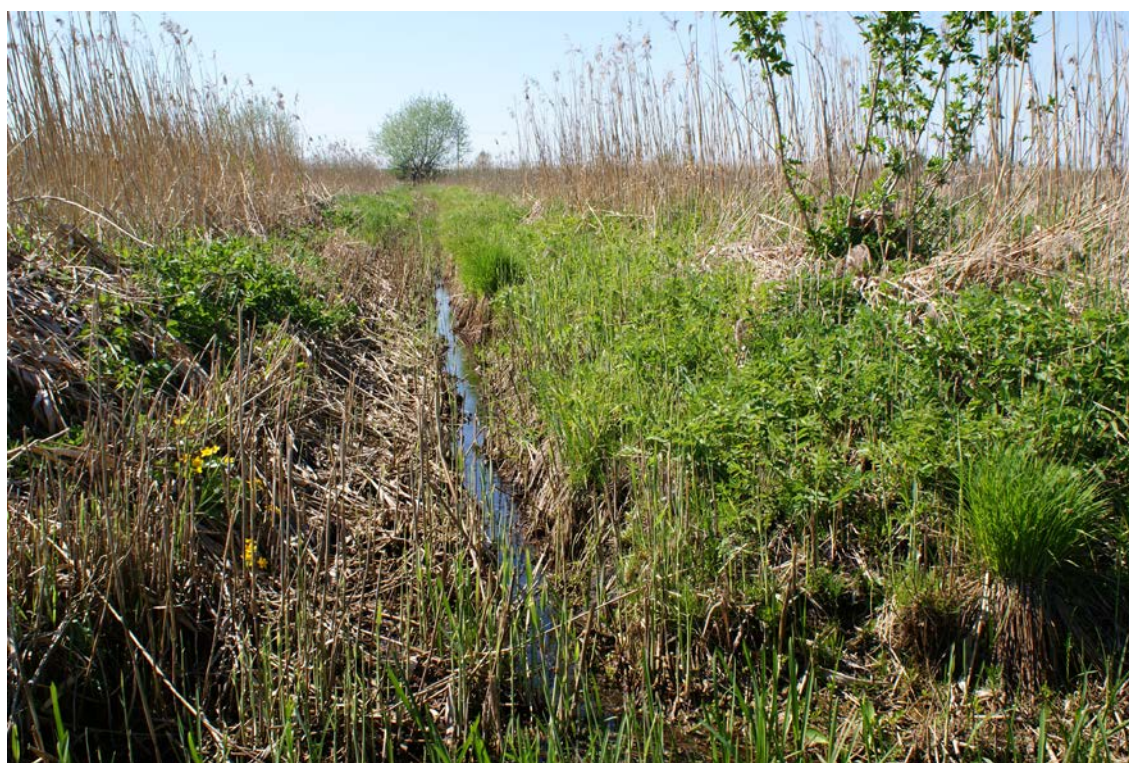
Fig. 2. The slopes of the ditch are overgrown with rushes. *Phragmitetum australis* (Phot. A. Kiryluk).

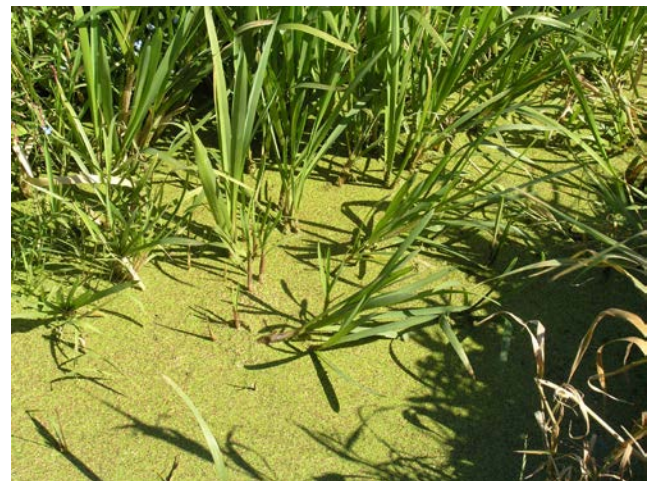
**Fig. 4.** *Lemna minor* on the bottom, indicating a strong eutrophication of the water in the ditch (Phot. A. Kiryluk).

The width and longitudinal slope of the bottoms of the ditches decreased over the period considered. Narrowing of the trench and reduced water flow contributed to increased water eutrophication (Fig. 4). Bottoms of the ditches have been significantly narrowed, mainly due to the lack of the so-called thorough conservation, removing silts (Bondar-Nowakowska *et al.*, 1997). The deterioration of the water conditions in ditches resulted in a reduced quantity of species *Caltha palustris*, *Ranunculus repens*, *Acorus calamus*, *Cardamine pratensis*, *Iris pseudacorus* and the expansion of *Lemna minor* (Table 3; Figs 4–5). The viability of the species remained at a good level (1.24–1.36).

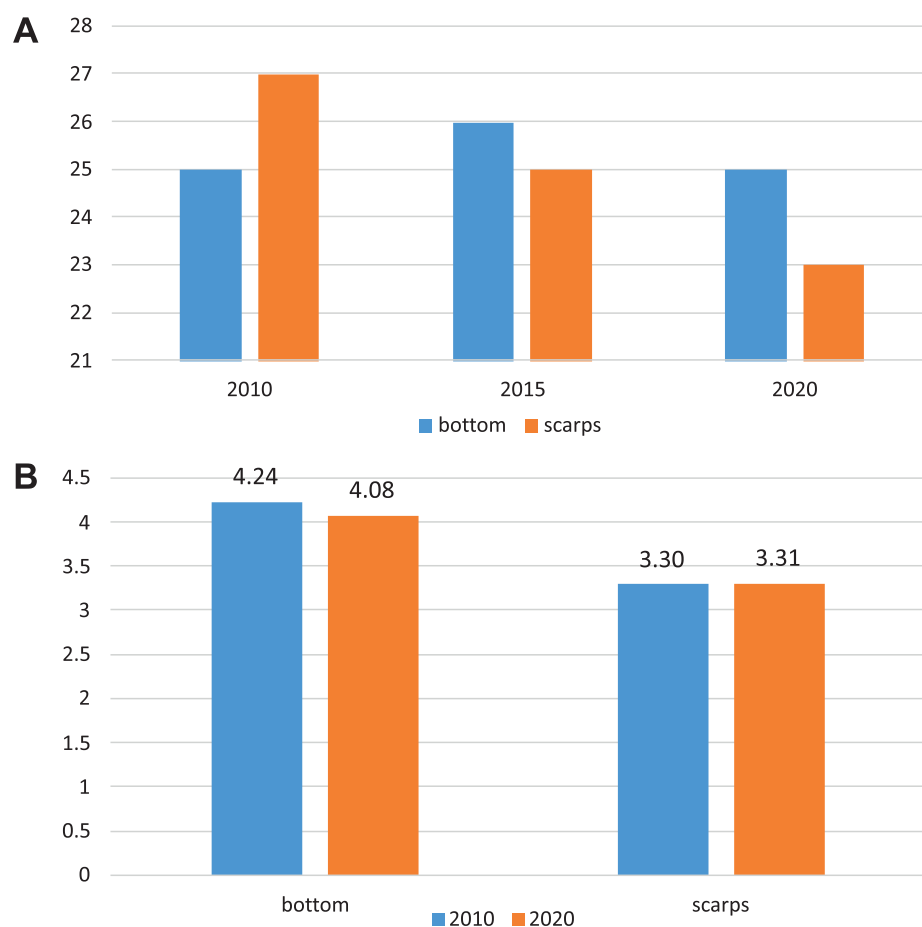
**Fig. 6.** A. Changes in the quantity of species occurring in the bottom and on the slopes of ditches in 2010–2020. B. Changes in the valorization indexes of plant communities in 2010–2020.

Research on the species composition of plant communities showed a decrease in number of species on slopes of the ditches in 2015 and 2016 (Fig. 6B). One of the reasons for the reduction was a reduced rainfall in summer (Kiryluk, 2019). In the studied period, the mowing of vegetation on scraps was also limited, which prevented the growth and development of low-growing species.

A lower valorization index was found on the slopes of ditches (Fig. 6B). The reduction in the index was caused by
