# Laboratory tests and numerical analysis of façade sub-structure made of austenitic steel

**Abstract:** This article presents a study of a wall cladding system composed of stainless steel sub-frame and composite, fibre-reinforced concrete cladding panels, which was been installed on a high-rise public building. The study focused on the assessment of strength, safety and durability of design through laboratory tests and numerical analyses. The laboratory tests were conducted using a three-dimensional tests stand and a full-scale mock-up of the wall cladding system built at the laboratory using the actually used materials and cladding panels. The boundary conditions and the test loads corresponded to the values of actions determined during the engineering phase of the high-rise building under analysis. Noteworthy, wind actions were verified by supplementary wind tunnel testing. In addition, the stainless steel was also tested to determine the strength properties of the material actually used in construction. These test were carried out just before commencement of the curtain wall installation. The 3D model was constructed with the application of the finite element method (FEM) to o

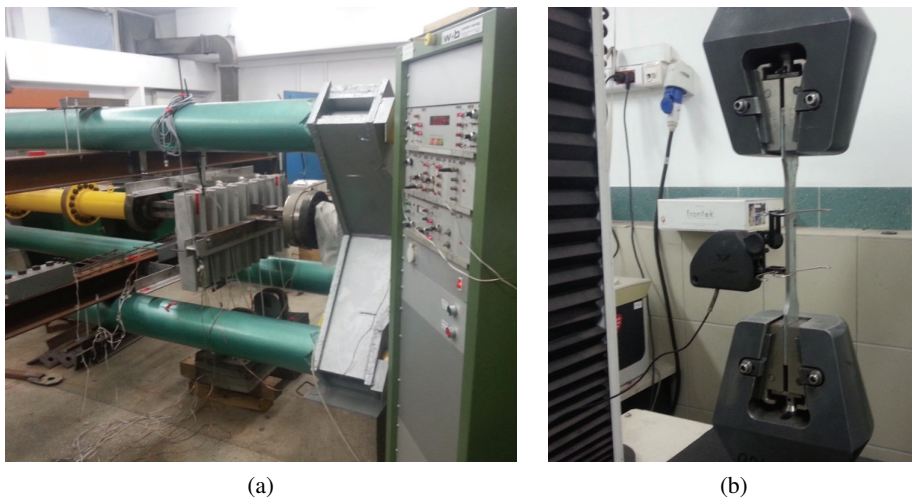
Fig. 1. Overview of the two test stands: No. 1 (a) Basic test stand for façade elements  
No. 2 (b) Steel parameters test stand

The tests described in this article were carried out on two test stands. The first of them (test stand No. 1 – Fig. 1a) was the primary test stand used for testing sections of the wall cladding system brought from the construction site of the building under construction. The second one (test stand No. 2 – Fig. 1b) was used for testing properties of the stainless steel, including yield strength and E-modulus and, last but not least, for assessment of rheological effects.

The main part of the spatial test machine in the test stand No. 1 (Fig. 1a) was a compression tester (press) with a horizontal cylinder that applied a test force at the level of  $\pm 1000$  kN. The working width was about 3.5 m and the support arms were spaced by 1.2 m. The tester was operated by control software which allows setting the values of compression or tensile forces and generate cyclic variable loads simulating the action of wind on the concrete cladding panels. The test frame was used to support the tested sub-frame composed of HEA160 I-beams and  $180 \times 10$  square hollow sections made of S235 steel – Fig. 2. The test frame simulated rigid supports of the building frame and allowed testing of several portions of the wall cladding system in turns with the purpose to obtain repeatability of the test results.

The test stand No. 2 (Fig. 1b) was used for testing the stainless steel of the brackets and the results were subsequently used in the numerical analysis of the curtain wall sub-frame components. INSTRON 5567 strength tester was used in the tests. The displacement rate was set on the strength tester at 10 mm/min. The tested items were obtained from the sub-frame angles and the brackets (flat bars) holding in place the concrete cladding panels. The total number of 15 stainless steel samples were tested in order to determine the yield strength at 0.2% strain (further called offset yield strength) and the E-modulus. The obtained values were used to derive the tensile stress-strain curve, subsequently used for numerical modelling of the steel sub-frame components. The test results are presented in Section 2.2.
