## Research paper

## Behavior of damaged TBM tunnel under MJS and Micro-disturbance grouting treatment: a case study

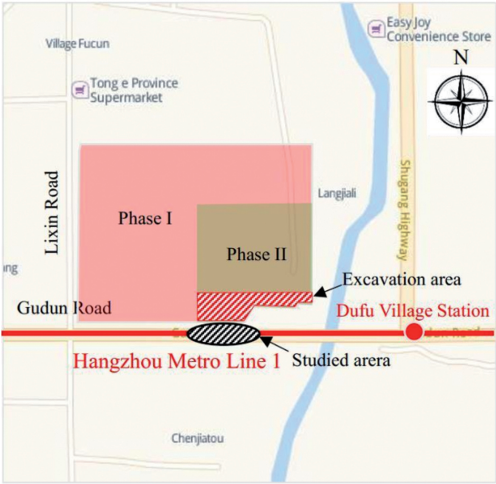
Fig. 1. Plan layout of the site

The over-deformed TBM tunnel is a section of the up-track of Hangzhou Metro Line 2 between Dufu Village Station and Liangzhu Station, which is operated in the year 2017. The studied section is from SDK41+468.55 to SDK41+535.75 along Gudun road, totaling 67.2 m. The foundation pit excavation is located on the north side of the TBM tunnel, which consists of two phases. The excavation depths of the two phases are  $5.85 \div 7.5$  m and 10 m, respectively. The nearest distance between the foundation pit and the TBM tunnel is about 17.8 m. The plan layout of the site is shown in Fig. 1. The depth below the ground surface at the top and bottom of the tunnel is about  $11.12 \div 15.72$  m and  $17.32 \div 21.92$  m. The TBM tunnel is mainly located in the muddy silty clay layer and partially in the clay layer. The underlying soil of the tunnel in the studied section is muddy clay layer ④<sub>3</sub> with a thickness of about  $0.3 \div 3.6$  m. And the clay layers ⑦<sub>1</sub> and ⑥<sub>31</sub> are the underlying soil of ④<sub>3</sub>. The longitudinal geological profile of the studied TBM tunnel is plotted in Fig. 2. The soil physical and mechanical properties from the site, which includes cohesion ( $c$ ), friction angle ( $\varphi$ ), void ratio ( $e$ ), foundation bearing capacity is shown in Table 1.

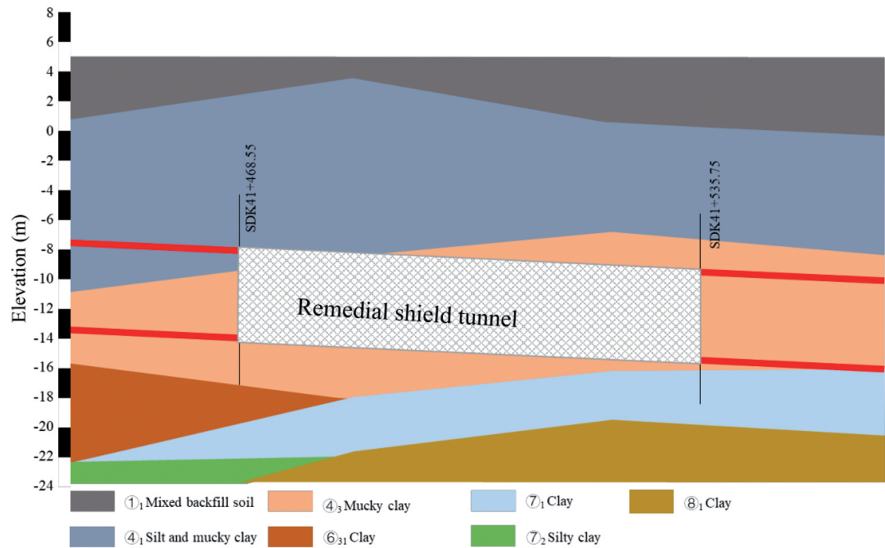
Fig. 2. (Color) Partial longitudinal geological profile of the up-track tunnel

Based on the geological exploration result, the groundwater in the site consists of pore phreatic water of loose rock and pore confined water loose rock. The depth below the ground surface of phreatic stable water level is  $1.3\div 4.1$  m below the ground, which is mainly recharged by atmospheric precipitation and lateral runoff, and changed with seasons. The confined pore confined water is distributed in ⑦<sub>1</sub>, and the depth below the ground surface of water head is  $4.58\div 5.79$  m.

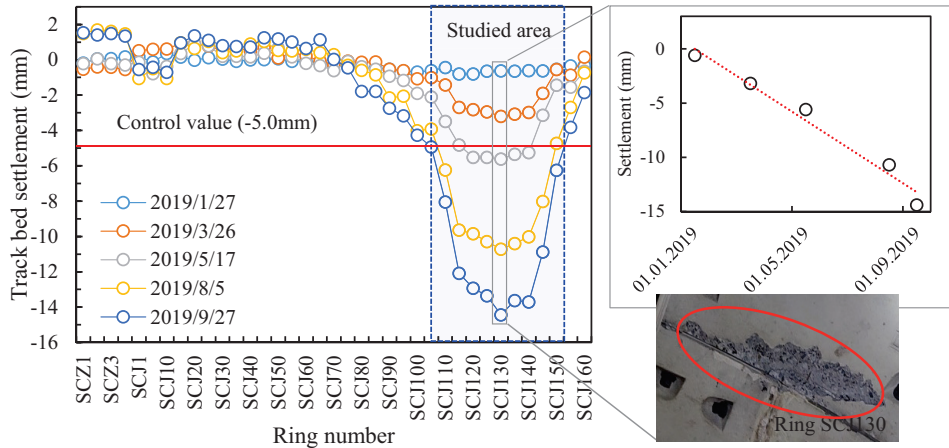
According to the settlement monitoring results, the cumulative track bed settlement of up-track tunnel is presented in Fig. 3. From Fig. 3, the local settlement of the up-track TBM tunnel was obvious, and the settlement area is mainly between ring SCJ105~SCJ155. The maximum settlement was -14.4 mm at ring SCJ130 during excavation construction on September 27, 2019, which was about three times the control value. Based on the variation of track bed settlement at ring SCJ130, the track bed settlement did not tend to be stable,

Fig. 3. Track bed settlement of the affected up-track TBM tunnel

but still increased gradually. After the basement structure completion on August 5, 2019, the settlement continued to develop.

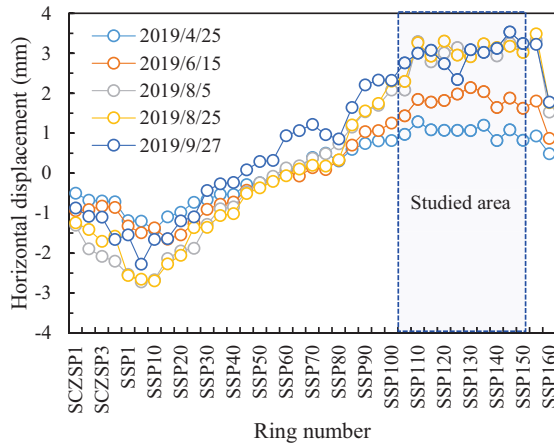
Fig. 4 plots the horizontal displacement of the affected up-track TBM tunnel, from which there was an obvious horizontal movement towards the foundation pit from ring 105 to 150. The maximum horizontal displacement was 3.5 mm. After the basement structure was completed, the horizontal displacement tended to be stable gradually.

Fig. 4. Horizontal displacement of the affected up-track TBM tunnel

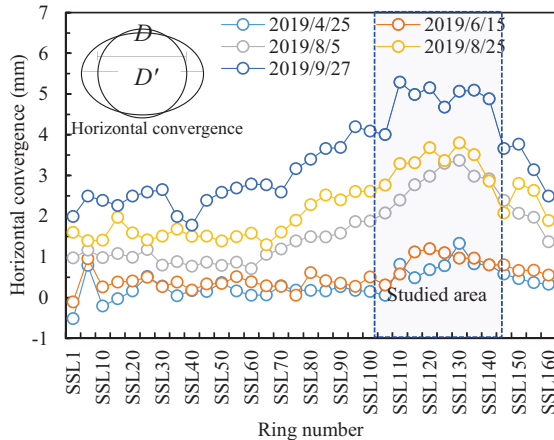
The horizontal convergence ( $\Delta D$ ) of the affected up-track TBM tunnel is presented in Fig. 5. From Fig. 5, the up-track TBM tunnel had evident compression deformation between ring 80 and ring 150 during excavation. The maximum horizontal convergence of the affected up-track TBM tunnel was 5.3 mm at ring 90. The horizontal convergence continued to increase after the basement structure was completed.

Fig. 5. Horizontal convergence ( $\Delta D$ ) of the affected up-track TBM tunnels

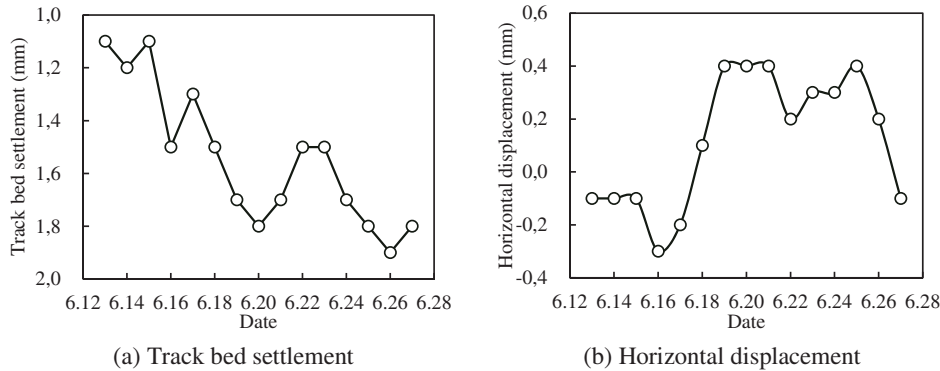
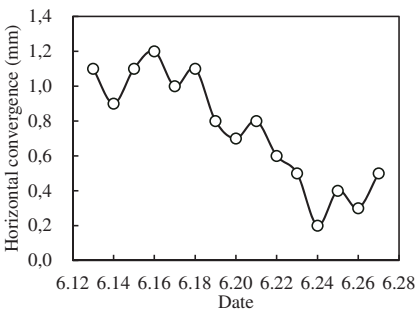
Fig. 7 (a), (b)

From Fig. 7, the MJS test pile construction has little impact on the damaged tunnel. The track bed settlement gradually increases during the whole test pile construction, and the maximum value is 1.9 mm on June 26. The horizontal displacement and convergence are very small and have almost no effect on damaged TBM tunnel.

(c) Horizontal convergence

Fig. 7. Variation of behavior of damaged tunnel adjacent to test piles (ring number 153 to 155)

The positions with small deformation (ring number 153 to 155) are selected as the test section for pile test. Both diameters of the four test piles are 2400 mm, with a length of 8.6 m. The pile centers on both sides are 4.6 m from the center line of the damaged TBM tunnel. In order to ensure the safety of the tunnel, test piles on the south side are carried out first. The construction is planned in the sequence of North M39, South M38, North M38, South M39. The interval time of jet grouting with adjacent pile positions in a row shall not be less than 24 hours. The test pile construction starts from June 13, 2020 to June 27, 2020. During MJS test pile construction, the variation of behavior of damaged tunnel adjacent to test piles (ring number 153 to 155) is shown in Fig. 7.

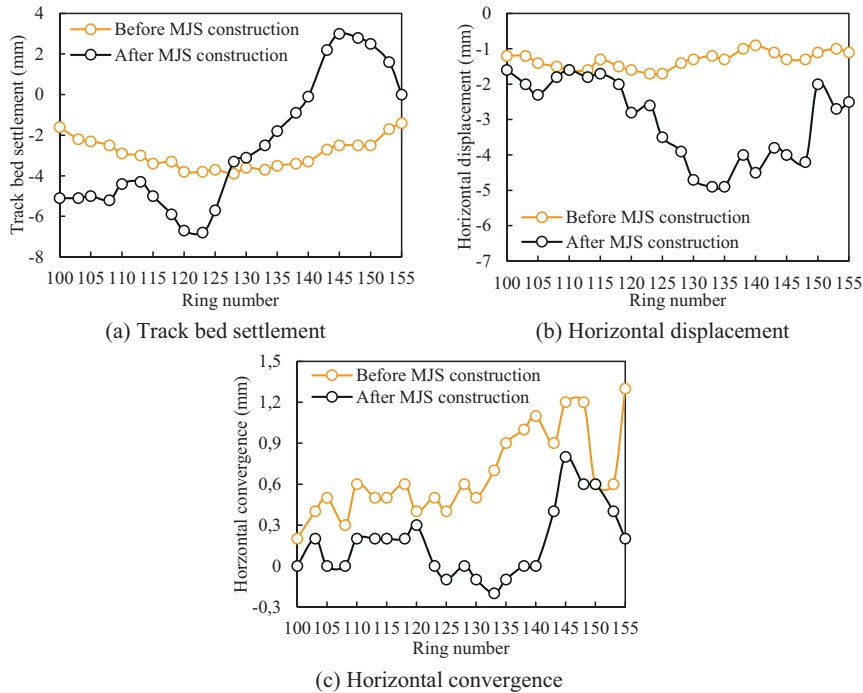
Fig. 8. Comparison results of damaged TBM tunnel deformation

from which MJS construction has the greatest influence on horizontal displacement of the damaged TBM tunnel. The maximum horizontal displacement is  $-4.9$  mm at ring 133 and 135. From Fig. 8a, the track bed uplift was caused by MJS construction between ring 128 and 155, and the maximum uplift was 3 mm at ring 145. The horizontal convergence of all rings was small. To summarize, the effect of MJS construction on damaged TBM tunnel is not significant.

According to the experiences and parameters obtained from test pile construction, the remaining 74 MJS piles are constructed in the test section. The construction method is the same as the test pile construction. During MJS construction of test section, the grouting volume and grouting pressure did not exceed the design value. In addition, the monitoring data of the damaged TBM tunnel were stable and within the control value. Comparison results of damaged TBM tunnel deformation (ring number 100 to 155) are shown in Fig. 8,

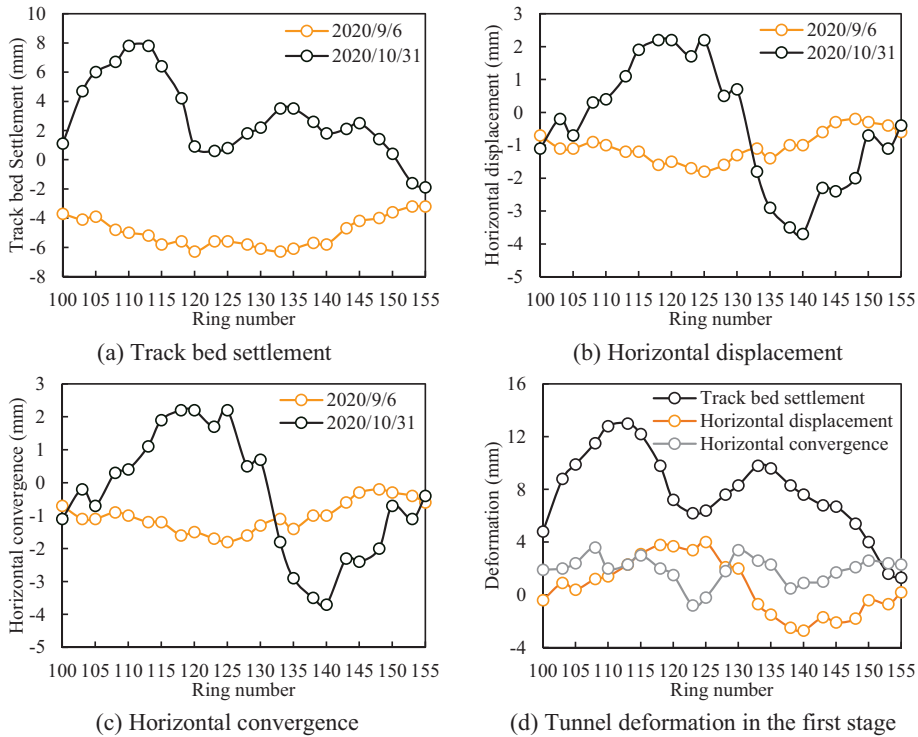
The first stage starts from September 6, 2020 to October 31, 2020, and a total of 110 grouting holes in 55 rings have been completed. The construction parameters were adopted based on the design scheme, and each grouting lift is close to the control value of 2 mm. Comparison results of damaged TBM tunnel deformation caused by micro-disturbance grouting in the first stage are shown in Fig. 9a–9c, and the tunnel deformation in the first stage (Fig. 9c) are determined by the difference at the beginning and end of the first stage construction. The micro-disturbance grouting construction in the first stage has obvious effect on the damaged TBM tunnel treatment from Fig. 9. The maximum track bed uplift is 13 mm at ring 113 in the first micro-disturbance stage, and the minimum uplift is 1.3 mm at ring 155. The average of the track bed uplift is 7.8 mm. The changes of horizontal

displacement and convergence are relatively small, and no more than 4 mm in the first stage.

Fig. 9. Comparison results of damaged TBM tunnel deformation

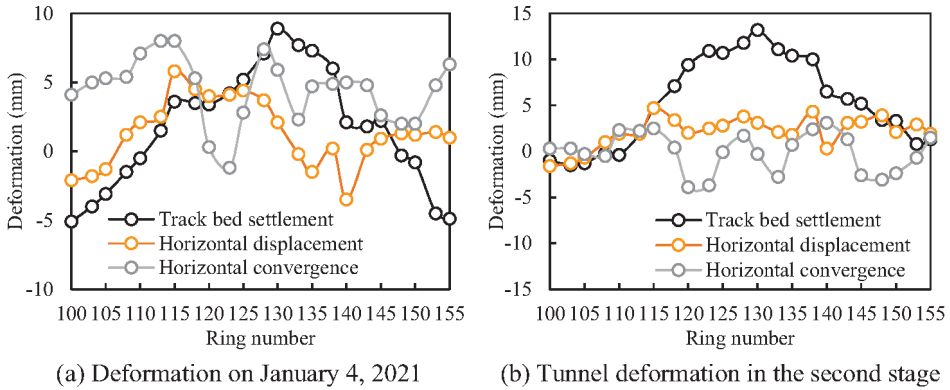
Based on long-term monitoring data of Hangzhou metro line 2, the maximum settlement area is located at ring 125 to ring 135. As of September 6, 2020, the maximum settlement of the line 2 is located at ring 130, and the value is  $-74.7$  mm. After the grouting in the first stage, the maximum settlement of the TBM tunnel is  $-66.1$  mm by October 29, 2020. The micro-disturbance grouting scheme of the second stage is the same as the first stage. The grouting construction of the second stage started from November 27, 2020 and ended on January 2, 2021. A total of 44 micro-disturbance grouting was carried out with the same grouting scheme in the first stage. The tunnel deformation at the end of the second stage grouting is shown in Fig. 10a, from which the track bed settlement shows obvious uplift deformation. On January 4, 2021, the maximum uplift is  $8.9$  mm at ring 130. The changes of horizontal displacement and convergence is small, which is similar to the first stage. Fig. 10b presents the deformation caused by the second stage grouting, which is the difference at the beginning and end of the second stage construction. The average of the

track bed uplift caused by the second stage grouting is 5.35 mm, and the maximum uplift is 13.2 mm at ring 130. Both the horizontal displacement and convergence are less than 5 mm, which are relatively small.

Fig. 10. Variation of the tunnel deformation caused by the second stage grouting

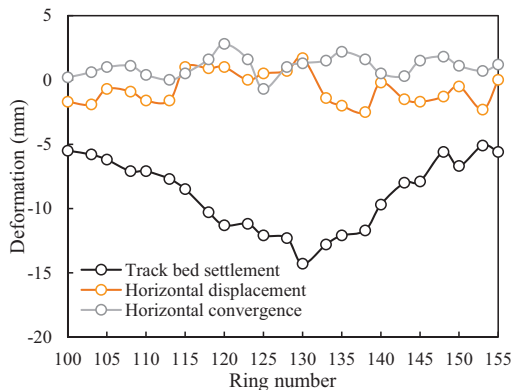
Variation of the tunnel deformation after micro-disturbance grouting is presented in Fig. 11, which is the measure difference between January 4, 2021 and March 16, 2021. After the second stage of grouting, the large settlement of the TBM tunnel was still observed based on the monitoring data. Once again, the average of track bed settlement is  $-8.9$  mm from Fig. 11. The maximum track bed settlement is  $-14.3$  mm located at ring 130. The variation of horizontal displacement and convergence is relatively small. Therefore, the third stage grouting was proposed to meet the requirement that the settlement rate is less than  $\pm 0.02$  mm/d for 3 months.

Fig. 11. Variation of the tunnel deformation after the second micro-disturbance grouting

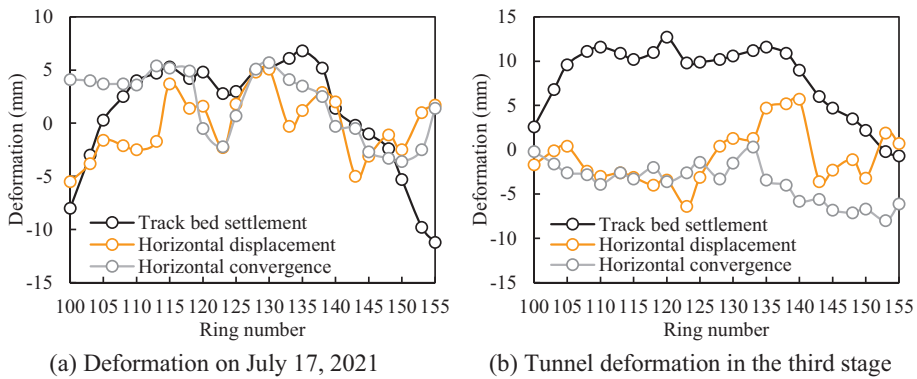
The third stage micro-disturbance grouting starts from March 16, 2021 to July 17, 2021, and the grouting holes and scheme is the same as the first stage. The difference is that grouting depth is 24 m due to the thick muddy soil layer under the tunnel, which is deeper than the first stage. The tunnel deformation at the end of the third stage grouting is shown in Fig. 12a, from which the track bed settlement shows obvious uplift deformation. On July 17, 2021, the maximum uplift is 6.8 mm at ring 135. The deformation caused by the third stage grouting is shown Fig. 12b, which is the difference at the beginning and end of the third stage construction. The average of the track bed uplift caused by the third stage grouting is 8.05 mm, and the maximum uplift is 12.7 mm at ring 120. The maximum horizontal convergence is  $-6.1$  mm at ring 155, and the horizontal displacement is relatively small.

Fig. 12. Variation of the tunnel deformation caused by the third stage grouting

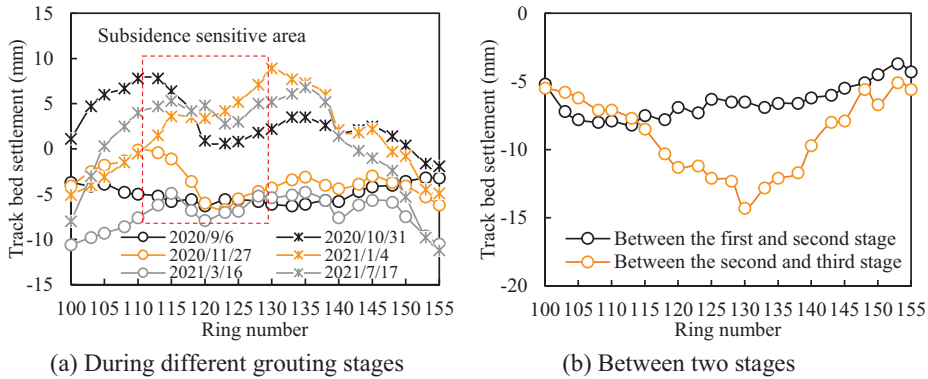
Figure 13 presents the track bed settlement under different grouting stages. From Fig. 13a, the maximum liftings of three grouting stages were 13 mm (ring 113), 13.2 mm (ring 130) and 12.7 mm (ring 120) respectively, from which the micro-disturbance grouting has significant effect on tunnel uplifting. However, the average track bed settlements at the start of the three stages were  $-5.0$  mm,  $-3.6$  mm and  $-7.2$  mm, respectively. It means that once the grouting was completed, the remedial TBM tunnel quickly sink again. According to the previous monitoring results, the up-track tunnel at ring 115–130 showed large convergence deformation before tunnel operation, and the mechanical performance of tunnel structure was weakened, which was easy to sink again (subsidence sensitive area). From Fig. 13c, the average of track bed settlement between the first and second stage (26 days) was  $-6.5$  mm, and the maximum settlement was  $-8.2$  mm at ring 113. The average settlement between the second and third stage (71 days)  $-8.9$  mm, and the maximum settlement was up to  $-14.3$  mm at ring 130. Therefore, it is difficult to completely stabilize the thick mucky clay under the TBM tunnel by micro-disturbance grouting method. Combining

with geological and site conditions, the phenomenon can be speculated for the reasons: (1) thick mucky clay layer under the TBM tunnel; (2) poor mechanical performance of tunnel structure; (3) heavy vehicle loads and surcharge above the tunnel.

Fig. 13. Track bed settlement under different grouting stages
