# LOSING THE GROUND BENEATH YOUR FEET

Any insufficiently understood dynamic geological  
process can be potentially dangerous.

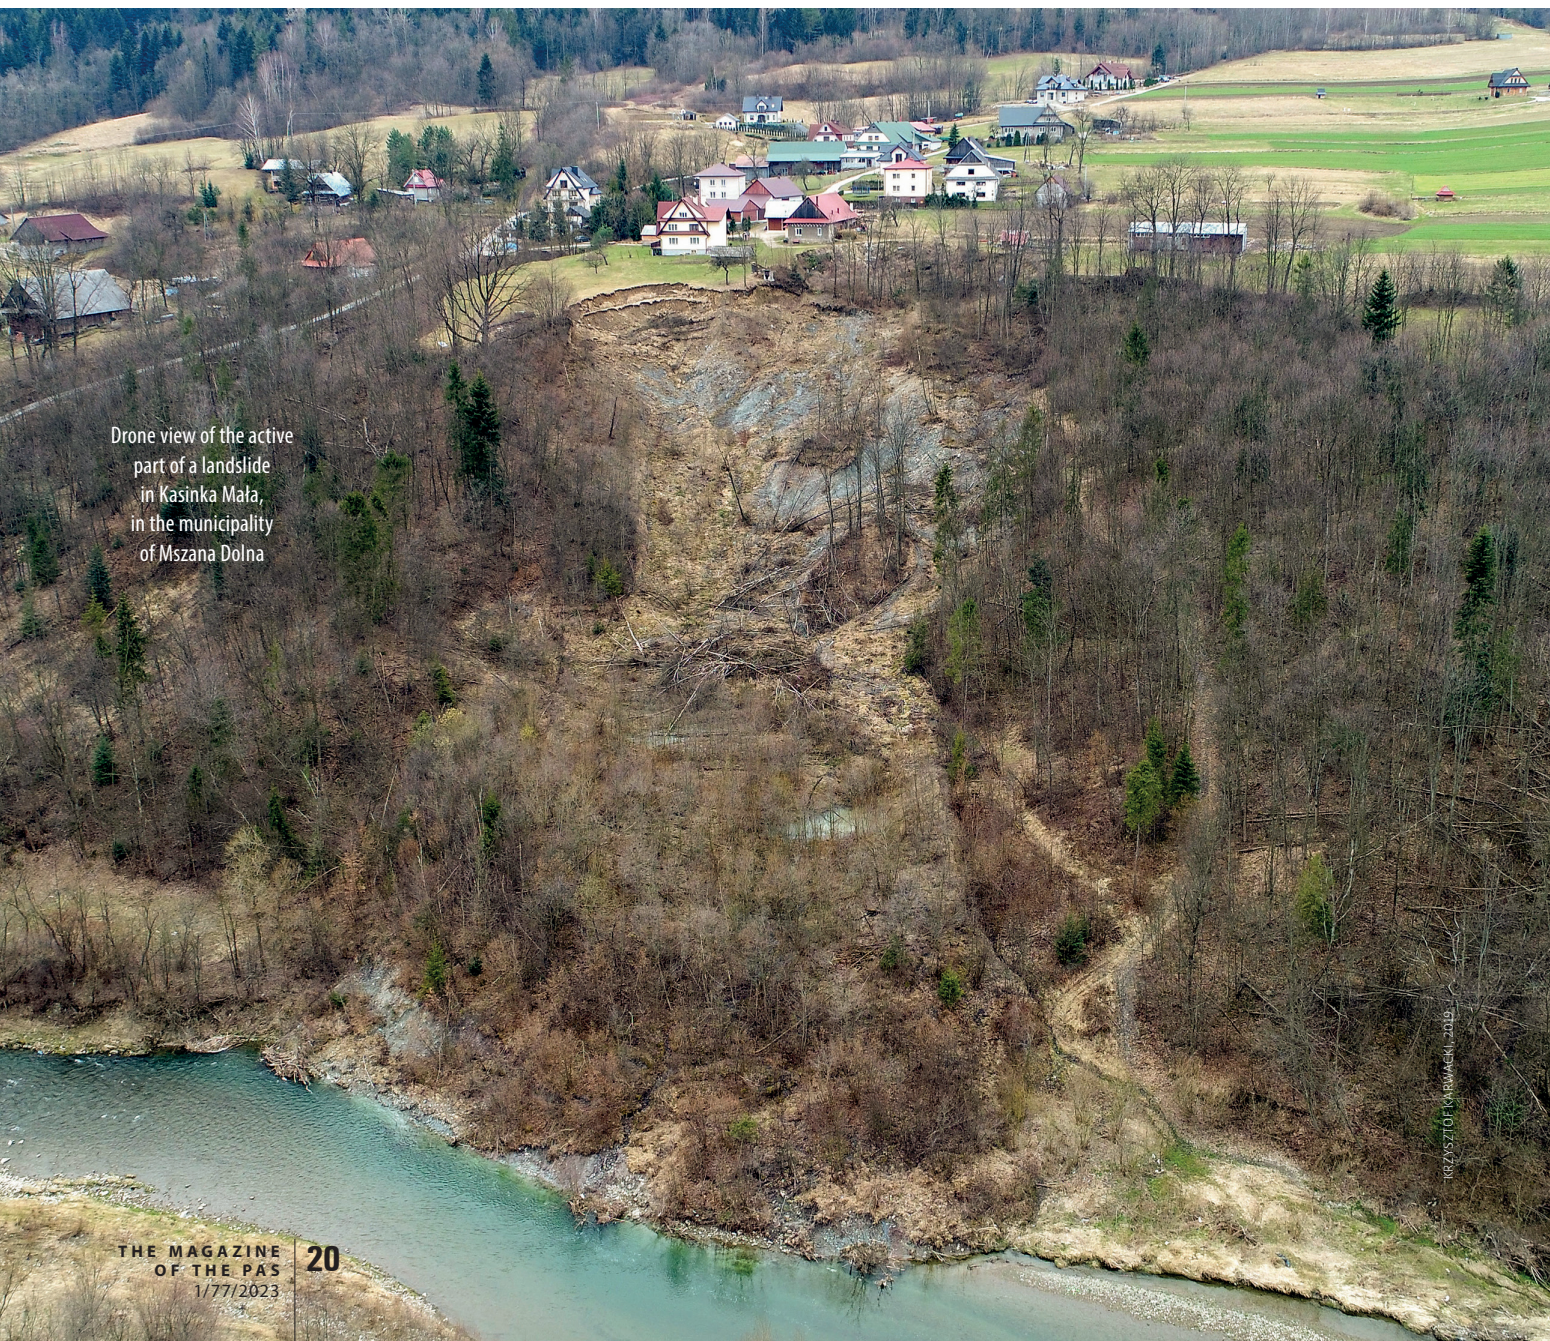
Drone view of the active  
part of a landslide  
in Kasinka Mała,  
in the municipality  
of Mszana Dolna

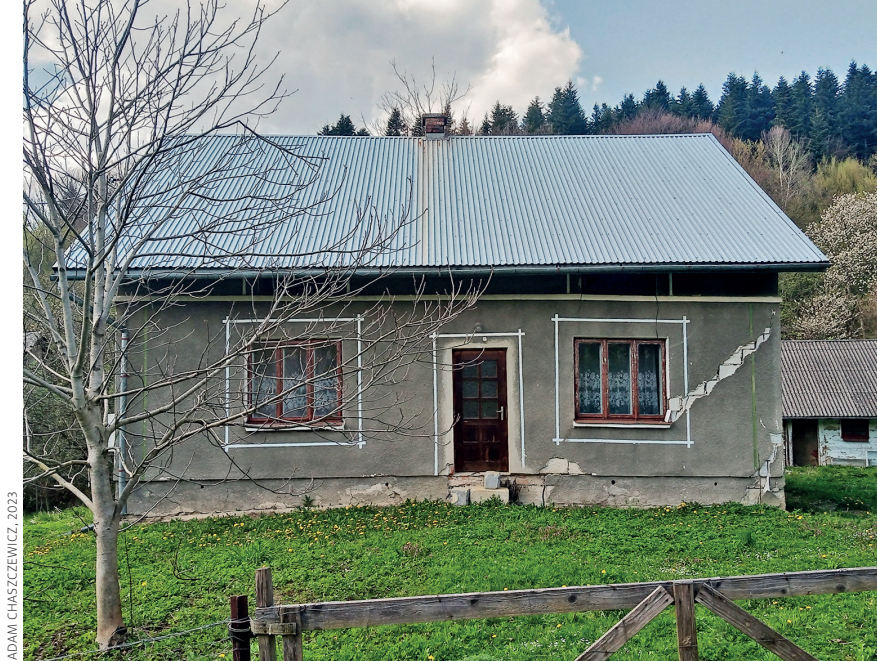
Cracks forming in the walls of a residential building built on landslide colluvium – Dąbrowka Starzeńska, Dynów municipality

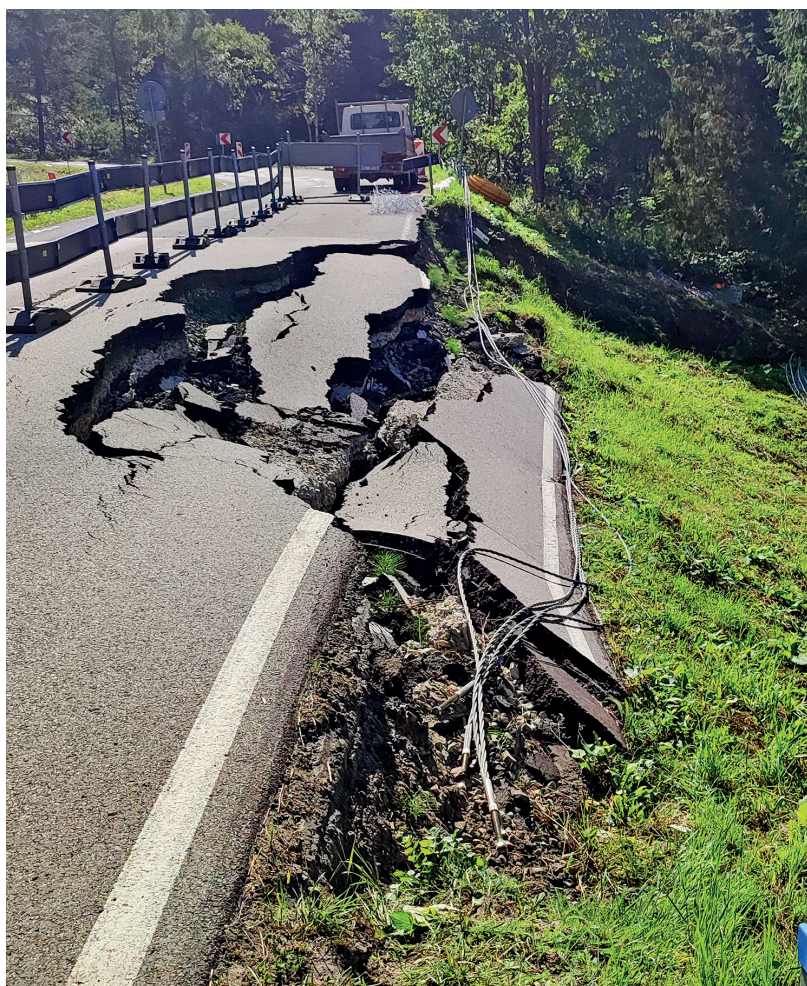
Landslide-damaged  
fragment of road between  
Wetlina and Brzegi Górne

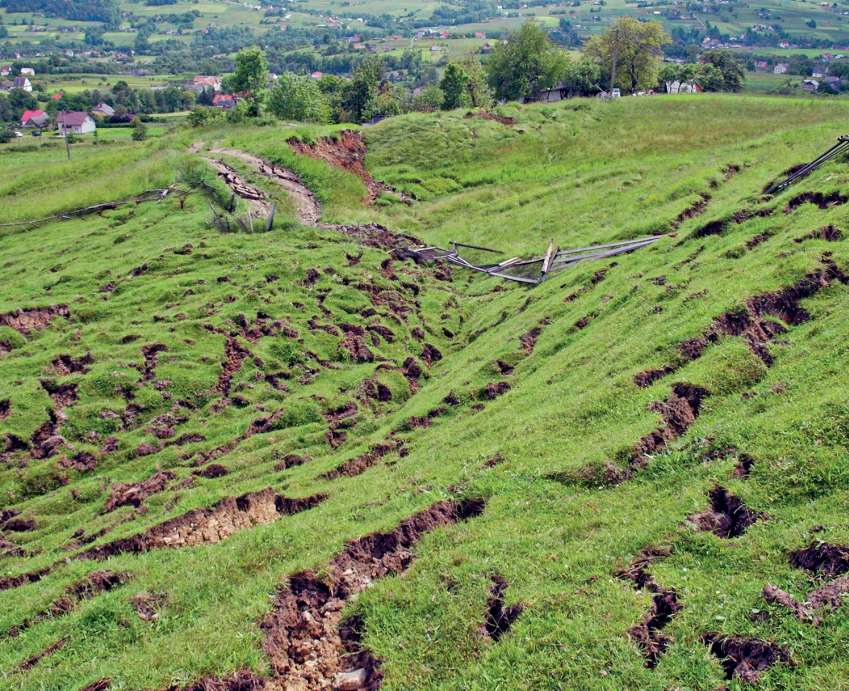
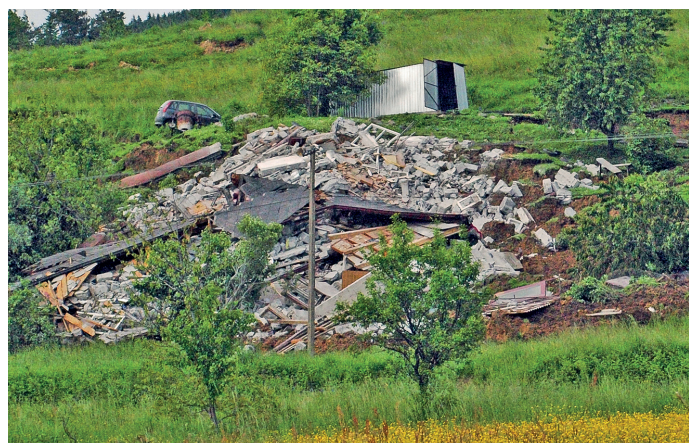
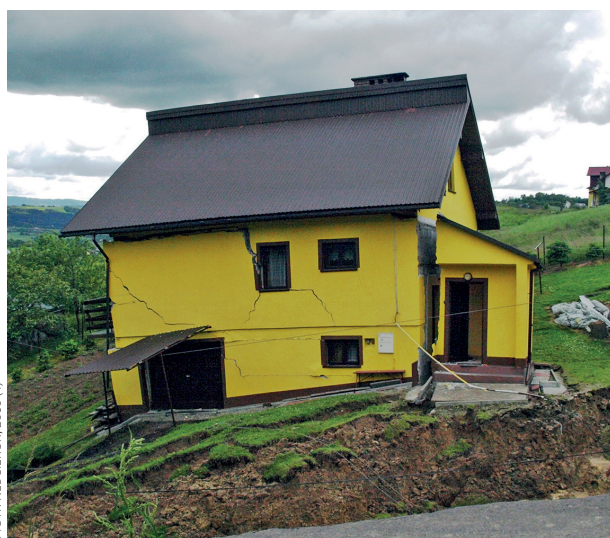
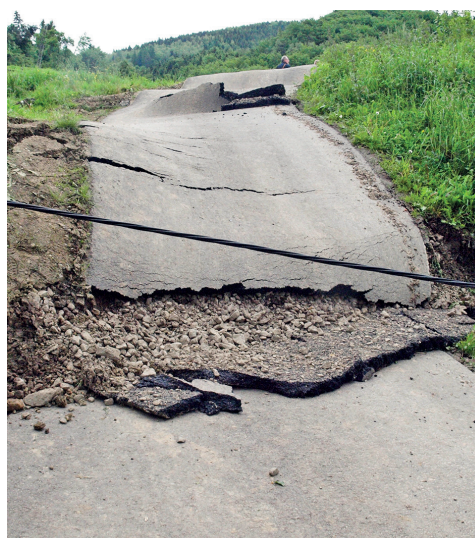
Devastation caused by a landslide in Kłodne, Limanowa municipality
