# The Nova Kakhovka dam collapse flooding as seen from Sentinel-1 SAR satellite images

**Abstract:** The destruction of the Nova Kakhovka dam in Ukraine on June 6th, 2023, produced an enormous flooding in the entire Kherson region. Thousands of people and agricultural fields were affected, bringing down an economy already devastated by the ongoing war. In addition to that, in the months prior to the collapse, the water level in the reservoir has been firstly decreased to a minimum, before rising it to an all-time maximum. Both these two situations are studied by means of Sentinel-1 SAR images, using the so-called change detection technique, with the aim of identifying those areas that got covered by water due to the Lake Kakhovka level rise and due to the flooding in the downstream region of the dam. The obtained results are then validated through comparison with optical images from Sentinel-2 and Landsat 9 satellites. The initial validation involves a visual assessment of both data types, followed by a more in-depth analysis that includes pixel classification of the optical images. This final step enables a precise quantification and comparison of the extent of the damage. It is

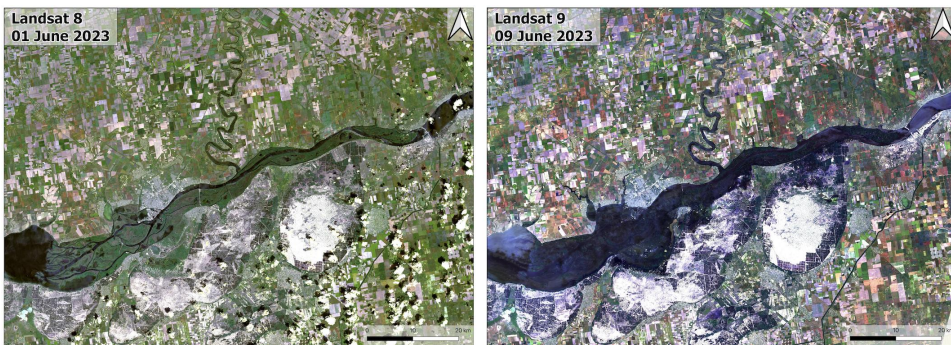
Fig. 11. Landsat 8 and 9 optical images for the pre-flooding (left) and post-flooding (right) condition

quantification of the flood extent while also providing insights into affected human settlements, potentially highlighting areas where people's lives may have been jeopardized. The two figures below show the multiband optical images (Fig. 11) and the classified ones (Fig. 12) for the flooding scenario.
