NON-DESTRUCTIVE METHODS FOR EVALUATION OF THE STATE OF PRESERVATION IN HISTORICAL STONE MONUMENTS: THE CASE STUDY OF THE STEP PYRAMID IN SAQQARA

Agnese Kukela, Valdis Seglins

University of Latvia, 10 Alberta street, Riga, LV-1010, Latvia, e-mail: agnese.kukela@lu.lv, valdis.seglins@lu.lv

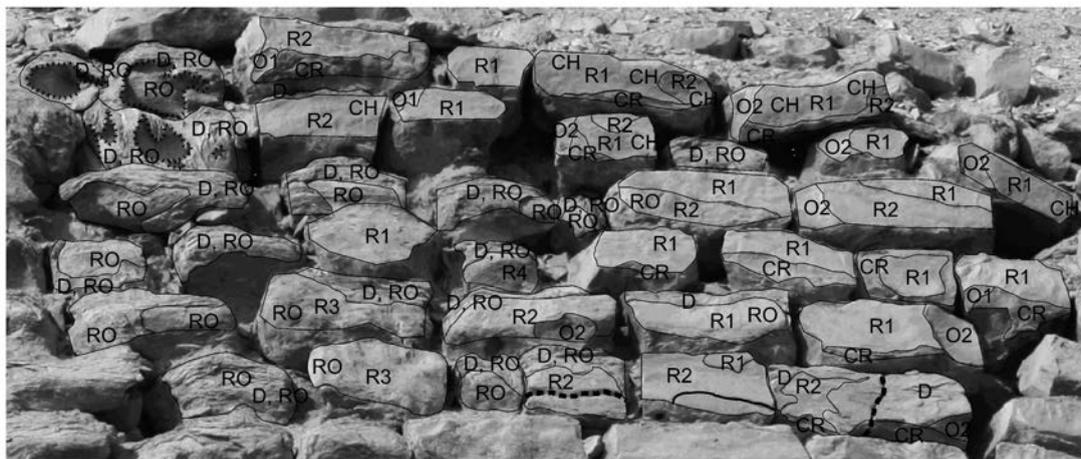
Weathering forms	Abbreviation/Intensity
Chemical changes	CH
Changes in relief	R / R1, R2, R3
Detachment of layers	D
Fragment break off	O / O1, O2
Crumbly loss of material	CR
Rounding	RO

Weathering forms	Designation
Cavern	
Split	
Fissure

Fig. 2. Weathering intensity map. The fragment of the Step Pyramid's southern facade.

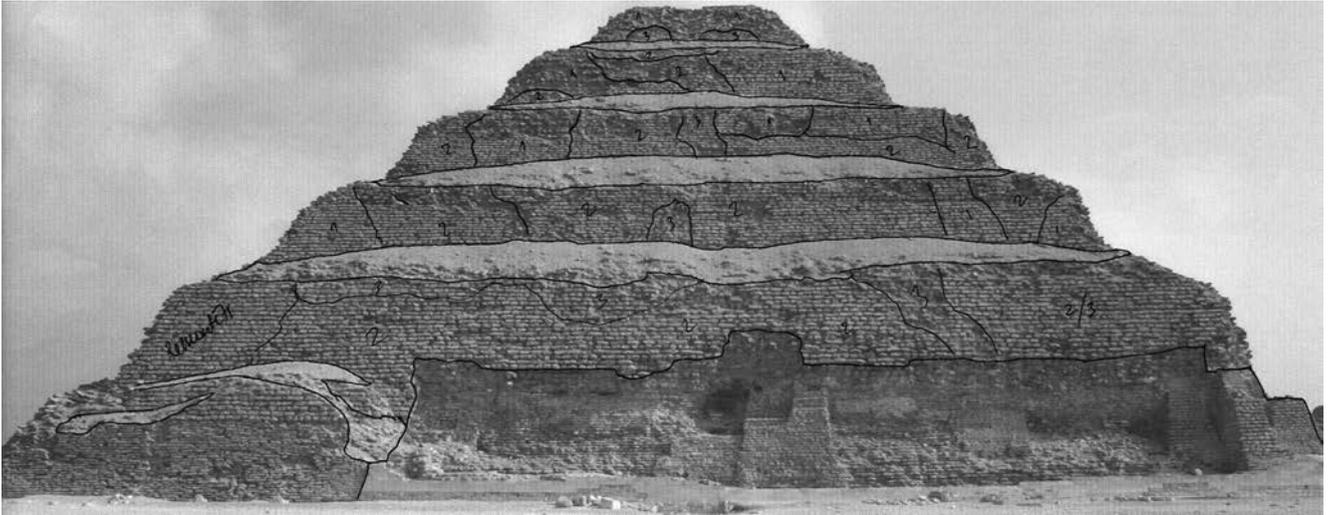
Fig. 4. Schematic depiction of possible construction stages of the Step Pyramid, characterising various quality of the stone material used (different quality material is marked as “1”, “2”, and 3”).

of simplified assessment of the quality of construction blocks and their resistance to weathering in general are schematically demonstrated and denote to several supplies of the material of different quality (Fig. 4). Scree layers and recently reconstructed areas of the pyramid were excluded from this assessment.

This data demonstrate that during the pyramid's construction process only a part of the building material was accumulated on the construction site; the other part was delivered upon necessity from different limestone quarries, situated in the vicinity of the Step Pyramid complex (Welc, 2011) and escarpment quarries of the Saqqara plateau. The speed of stone material provision was not sufficient in comparison to the speed of construction. This could explain why along with high quality construction blocks, lower quality material was used. Should this be confirmed, it could indicate that the main core of the pyramid would consist of low quality material and due to economical reasons some parts would be filled up with debris or even left empty.

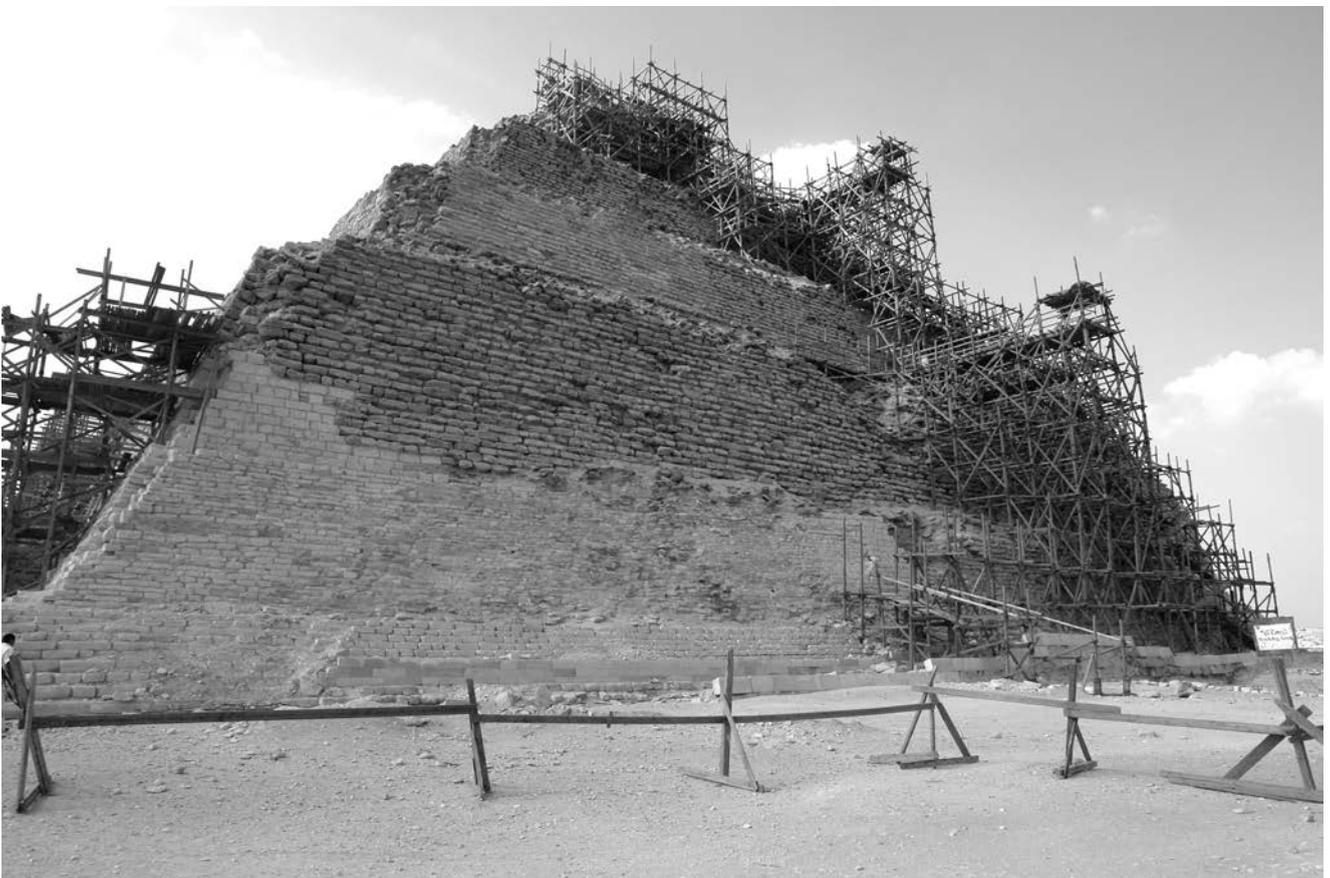
Fig. 5. Step Pyramid’s reconstruction process. Eastern facade in the year 2012.

To establish possible construction sequence of the pyramid, to identify the areas of ancient reconstructions work and to perform detailed stone material and mortar analysis, additional investigation would be necessary. However, such studies are currently impossible and, apparently, will not be possible in the nearest future due to vast reconstruction currently in progress (Fig.5), which has defaced all these important indications.
