PIOTR STRZAŁKOWSKI^{1*}, GRZEGORZ DYDUCH¹**IMPACT OF STRENGTH PROPERTIES OF TIMBER LININGS IN FORMER WORKINGS
ON THE SINKHOLE FORMATION HAZARD. THE CASE STUDY
IS ON THE UPPER SILESIA COAL BASIN, POLAND**

Keywords: old workings timber lining; timber bending strength; sinkhole hazard; wood laboratory tests

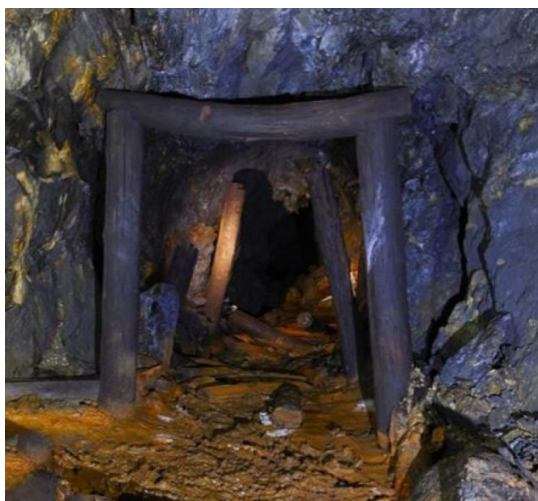
The condition of old wooden support from the 19th century is well illustrated by a photograph taken in adit Marcinków in Sudetes Mountains (Poland). In the photograph, one may note the musty fragments of the lining laying on the floor and the German-type support sets in which the roof bar is bent and broken due to the load exerted by the rock mass. The fracturing of the props may also be noted (Figs. 1 and 2).

Fig. 1. General view of the adit from the 19th century in Marcinków (Sudetes Mountains – Poland – photograph by A. Pastuszak)

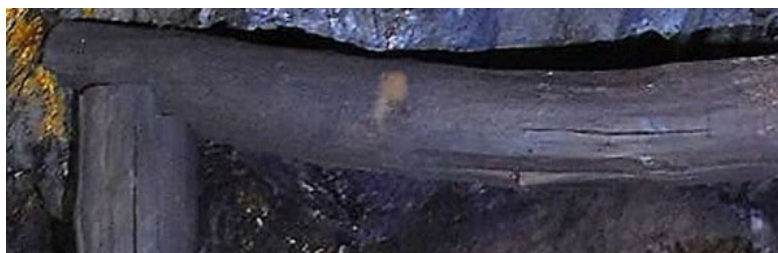
Fig. 2. Damaged prop and roof-bar (enlarged photograph from Fig. 1)

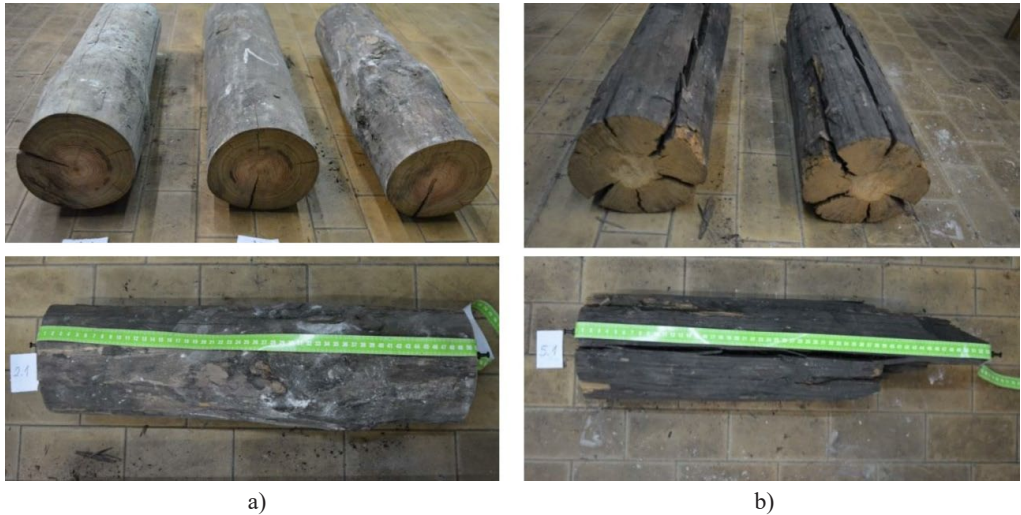
(4 & 5) were obtained from props installed in the raise adjacent to the gallery. The gallery was driven in 1950, and the raise was driven in 1937. The diameters of the props and roof-bars were approx 15 cm. The wood was preserved in various conditions, as shown in Fig. 3, exhibiting examples of fragments cut out from the props and roof-bars from groups 2 and 5.

Fig. 3. A view of examples of fragments cut out from the props and roof-bars from groups: a) 2, b) 5

Even by visual inspection, it may be concluded that the condition of the wood from the raise was much worse than that of the timber from the gallery. This mostly results from the time of exposure of the lining elements to the corrosive factors, which in the case of the raise was much longer.
