LESZEK SZOJDA

NUMERICAL ANALYSIS OF BUILDINGS LOCATED ON THE EDGE OF THE POST-MINING BASIN

Keywords: mining subsidence; masonry structures; numerical analysis; post-mining areas

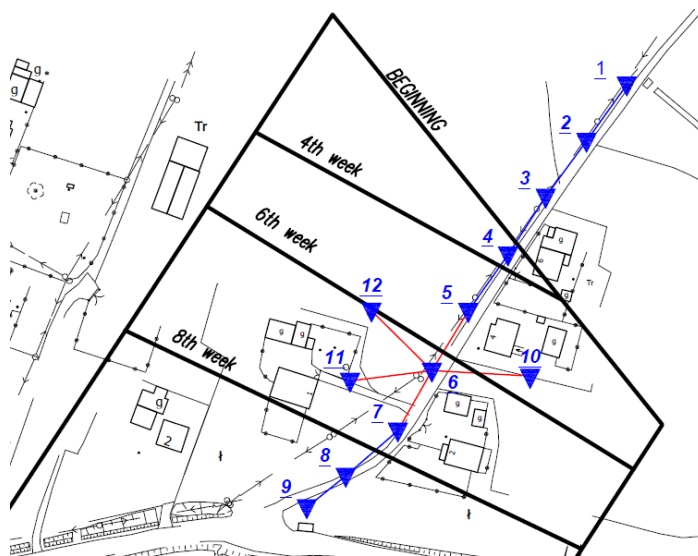
Fig. 3. Location of the points of the field rosette and the progress of the operational front in time (*Source: own study based on materials from the Marcel Coal Mine*)

Marklowice is a small town in the Silesian Voivodeship in Wodzisław County, Poland. Nearly 80% of the area is farmland. The dominant buildings are small, single-family houses with outbuildings. It is a mining area, and the exploitation in the Marklowice region is continuing. Due to the cave-in of exploited deposits lying at a depth of approximately 300 m, very large deformations are forecast here (categories IV and V of mining area deformation in the Polish mining industry). The exploitation analysed in this study is characterised by the following parameters: depth of exploitation – 320 m, the height of the exploited wall – 3 m, and mining technology – caving in. The width of the exploited wall is about 190 m. Due to the high variability and the hard-to-predict pace of change of the deformation rate, the place of the commencement of exploitation is very special, presented in [8]. This interesting area was adopted in the study as a testing ground (Fig. 3).

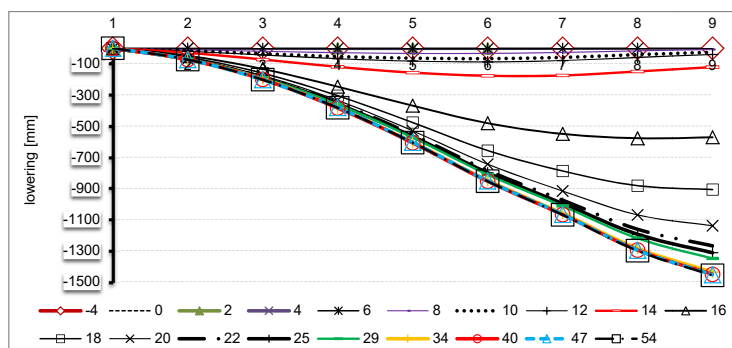
Fig. 4. Lowering the field line during the exploitation (Source: own study)

To monitor the extent of the deformation of the terrain surface, two auxiliary systems were stabilised in the field: a line consisting of eight sections (points 1-9) and a five-pointed rosette with a central point (no. 6), see Fig. 3. This location of points was dictated by the desire to determine the difference in surface deformation between the points, and not the total settlement, which does not affect changes in internal forces in the structure. Each of the installed geodetic field marks is a steel bar, stabilised at a depth of about 1.3 m below the ground surface on a concrete foundation, according to [21]. Periodic geodetic measurements were performed at the field points of lines 1-9. A Sokkia SDL 50 code leveller was used for levelling. The accuracy of the instrument is defined as a standard deviation, e.g. for 1 km of double-levelling it is ± 1.5 mm. The first, so-called 'zero measurement', took place four weeks before the start of the exploitation. Changes in the geometry of the subsoil were then monitored at two-weekly intervals. After just over a year, the measurements were finally completed, once no further changes in the geometry of the line had been observed for three months. Additionally, along with the levelling measurements, a change in the length of individual sections of the rosette was also observed. The diagram in Fig. 4 presents changes in the shape of the field line. The measurements were only performed to find the size of the terrain deformation indicators, hence the monitored area points were not linked to fixed benchmarks outside the impact zone. Only the impact of the deforming subsoil on the development was investigated in the study; analysis of land subsidence was not the subject of the study. Fig. 4 only shows the changes in the shape of the field line.

The diagram shows that, in the initial stage of the measurements, slight changes in the ground geometry were observed. The dynamics of the changes intensified in the 16th week after the commencement of the exploitation. Each subsequent measurement was carried out at

approximately two weekly intervals, showing significant changes in the shape. 22 weeks after the start of the measurements, a slowdown in the dynamics of the changes in the shape of the terrain surface was observed. Starting from the 40th week until the end of the observations, no significant changes in the geometry were observed, therefore, it was decided that the measurements on the 54th week should be terminated.

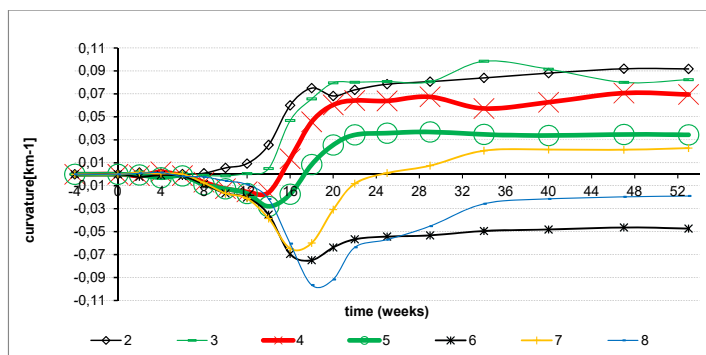
Fig. 5. Variable curvature of the terrain at the points of the field line over time (Source: own study)

Based on the known slopes of individual sections of the field line, changes in the terrain curvature were also determined, as observed at the points of the line: 2-8 (Fig. 5).

The diagram in Fig. 5 shows that the accumulation of changes in curvature took place between the 8th and 22nd week after the commencement of the exploitation. The following weeks represented the period of curvature index stabilisation. The maximum convex curvatures were recorded at points 2, 3, and 4, which is consistent with the initial predictions. The closer to the interior of the subsidence basin, the greater the spread of curvature sizes. At points 6 and 8, the end of the curvature is concave. Point 7 shows a slightly convex curvature. The results show that the interior of the basin after exploitation remained ‘wavy’ and variable in terms of curvature.

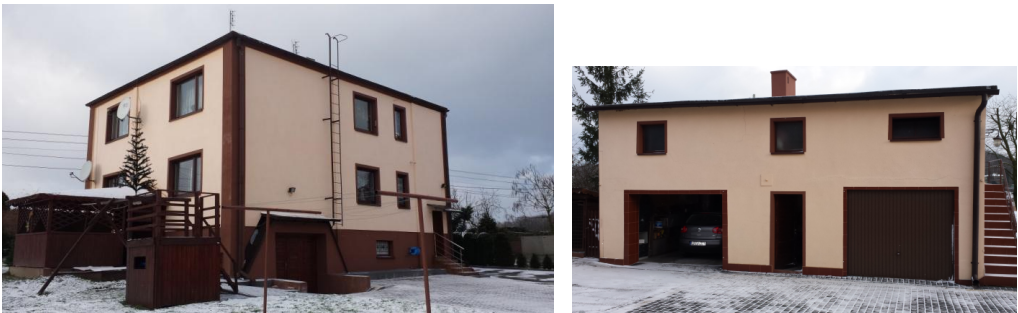
Fig. 10. Buildings # 1 and # 2 located in the zone of the convex curvature of the terrain (*Source: own study*)

In an attempt to take into account the influence of the convex curvature of the terrain on the existing buildings in the area covered by the field research, two buildings, numbered # 1 and # 2, were selected (Fig. 7). Building # 1 is a residential building. It is a two-storey building with a basement made of brick with traditional technology. The dimensions of the building, in projection, are 12.1×10.2 m. Building # 2 is a single-storey outbuilding with an attic serving as a loft (Fig. 10). It was made of bricks using traditional techniques and with dimensions in the projection of 10.1×6.6 m.

Based on the technical documentation of the buildings, and supplemented with an on-site inspection, both objects were modelled as spatial shell models with panel thicknesses corresponding to the actual wall thicknesses, respectively: 38 cm external walls, 25 cm internal walls and

12 cm partition walls for building # 1 and 25 cm for all walls in building # 2. The buildings were made with reinforced concrete ceilings.

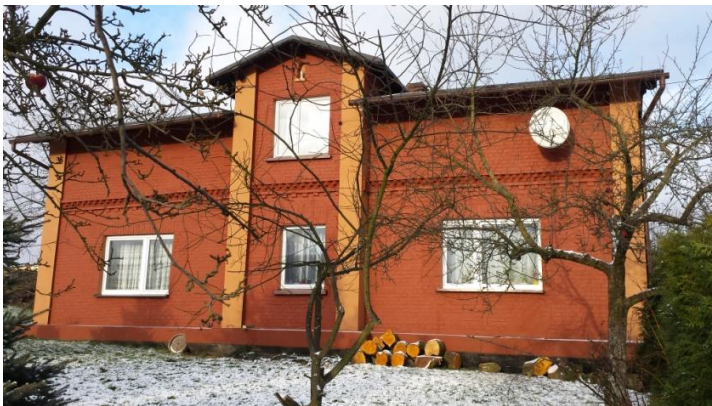
Fig. 15. Southern wall of the building # 3 (Source: own study)

the zone of strong compressions (Fig. 7). Residential building #3 has the dimensions 14.2×9.4 m and has two storeys and a basement. It was built in the 1930s using traditional brick technology, with brick foundations, wooden ceilings and a roof. Fig. 15 shows the southern elevation of the building.

It is worth mentioning that the building is reinforced at the level of the basement walls, with a reinforced concrete band at ground level; this is visible in the photograph (Fig. 15). Such prophylaxis, in the event of sinking occurring, can neutralise ground pressure on the basement walls. For tangential stresses under the footing, it may turn out to be ineffective. Fig. 18 shows the result map of stresses caused by horizontal deformations for building #3.

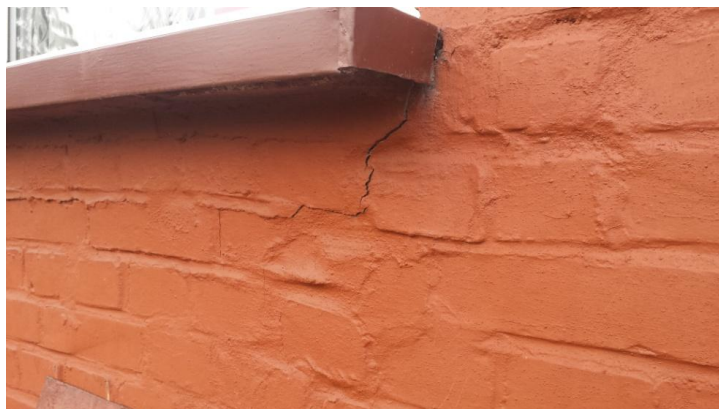
Fig. 19. Crack in the corner of the window opening of building #3 (Source: own study)

The impact of horizontal deformations caused much greater stresses than the previously analysed curvatures. Compressive stresses dominate on the presented map. They do not pose any major threat, especially for the lower, more massive walls of basements. However, it should be noted that, as in the case of the curvature of the terrain, horizontal deformations may cause some concentration of tensile stresses in the corners of the window openings. This poses a real threat to the structure. This is because scratches may form in these places. Fig. 19 shows cracks in the structure of building #3, formed after the exploitation front had passed and corresponding to the stress concentration shown in Fig. 18.
