A study on microbial self-healing concrete using expanded perlite

Abstract. The increasing concern for the safety and sustainability of structures is calling for the development of smart self-healing materials and preventive repair methods. This research is carried out to investigate the extent of self-healing in normal-strength concrete by using *Sporosarcina aquimarina* – NCCP-2716 immobilized in expanded perlite (EP) as the carrier. The efficacy of crack-healing was also tested using two alternative self-healing techniques, i.e. expanded perlite (EP) concrete and direct introduction of bacteria in concrete. A bacterial solution was embedded in EP and calcium lactate pentahydrate was added as the nutrient. Experiments revealed that specimens containing EP-immobilized bacteria had the most effective crack-healing. After 28 days of healing, the values of completely healed crack widths were up to 0.78 mm, which is higher than the 0.5 mm value for specimens with the direct addition of bacteria. The specimen showed a significant self-healing phenomenon caused by substantial calcite precipitation by bacteria. The induced cracks were observed to be repaired autonomously by the calcite

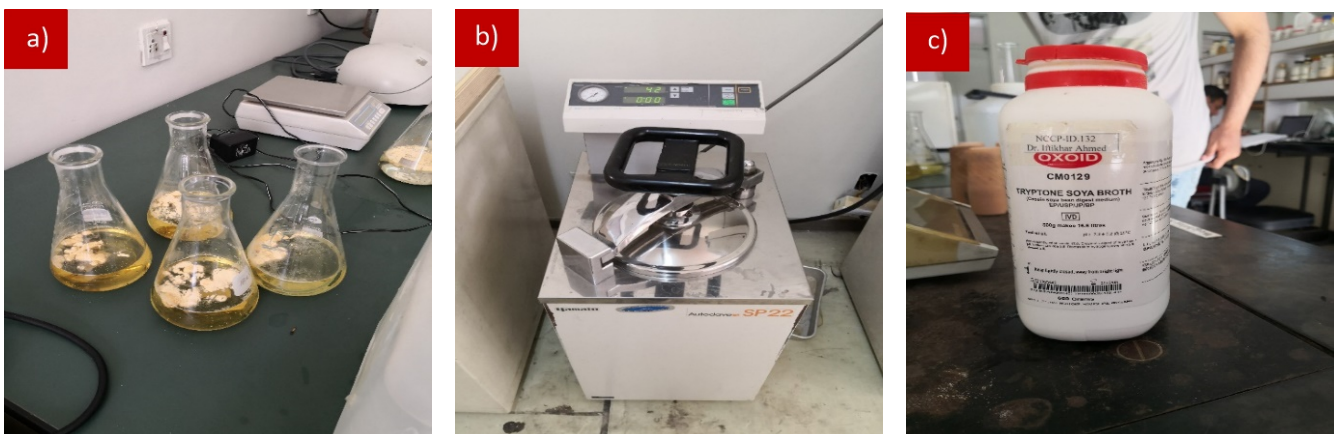
Fig. 2. Preparation of growth medium (a) TSB solution, (b) autoclave, and (c) Tryptone Soya Broth

Growth of bacteria (NCCP-2716 514 714) [*Sporosarcina aquimarina*] culture was achieved in National Agriculture Research Centre (NARC) Islamabad. In the first step, TSB (Tryptone Soya Broth) was mixed with distilled water in 5 flasks and placed in Autoclave (15 psi pressure, 20 minutes, 121°C temperature) for sterilization. Then 5 different salts were mixed in each flask and inoculation was done with a sterilized inoculation needle in a laminar flow clean bench. Figure 2 depicts the preparation of the growth medium. Then the 5 flasks were sealed with corks as shown in Fig. 3 and placed in a shaking incubator. Spores were finally formed. The transparent solution turned turbid which is a clear indication of spore formation. The turbid solution was poured into centrifuge tubes and the tubes were placed in a centrifuge machine that has a capacity of 6 tubes (at max).

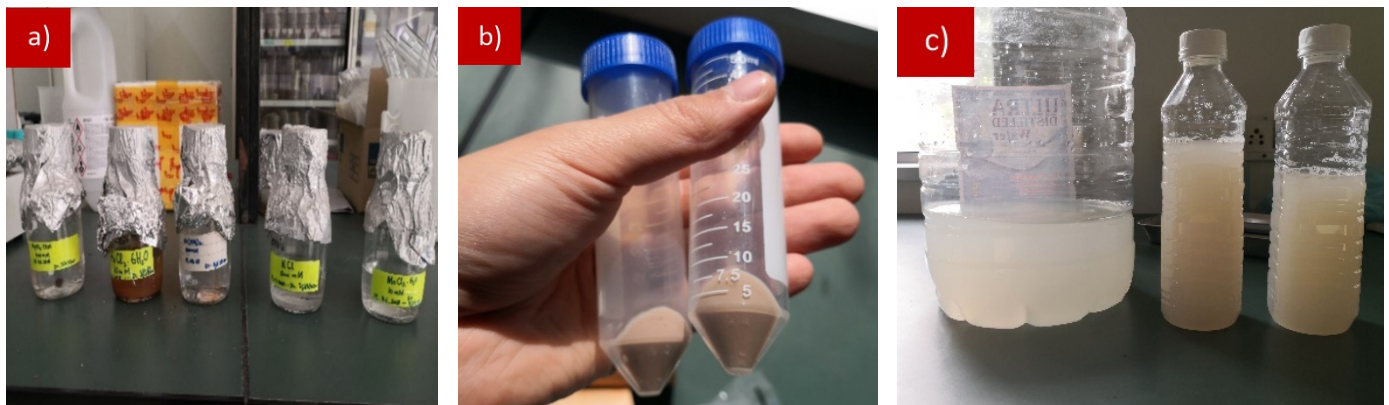
Fig. 3. (a) Different salts were mixed in each flask, (b) spores, and (c) prepared bacteria

After the centrifugation process, the spores got separated from the broth solution and the broth solution again became turbid. The vortex machine vigorously shakes the spores to make a homogenous solution. Now we use a spectrophotometer to dilute the solution to a 0.5 value. Finally, at 0.5 value of absorption, the solution ready to be added to concrete was made.

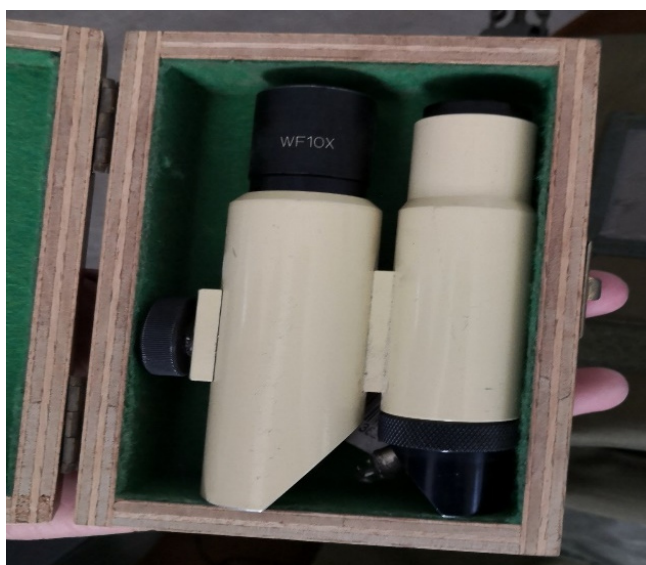
Cracks were visually inspected using a crack detection microscope as shown in Fig. 4 which has a scale with a 0.02 mm precision. The samples were pre-cracked until they developed cracks of varying diameters. Samples were classified as 7 days pre-cracked or 28 days pre-cracked to identify the age at which cracks formed. The initial widths of several cracks were measured and documented. During the curing procedure, both types of samples were completely submerged. The samples were removed after 14 and 28 days of curing and the crack widths were

Fig. 4. Crack detection microscope

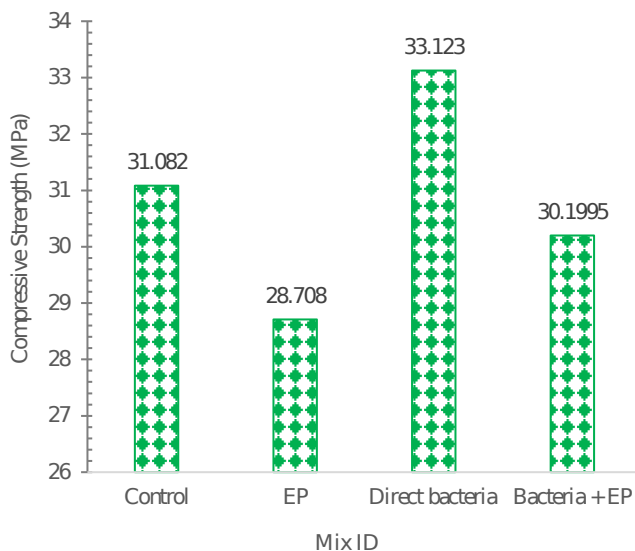
The compressive strength with and without Expanded Perlite (EP) reinforced microbial concrete at 28 days is shown in Fig. 5. Type of bacteria, bacterial percentage, strategy, and incubation period are the primary factors of compressive strength [24, 25]. It can be observed that the compressive strength of concrete slightly decreased with the addition of EP i.e. 7.6% less than from the reference mix (concrete without EP). Similarly, a study also claimed that the compressive strength values decline with the addition of EP [26]. The decrease in compressive strength can be retributed due to EP weaker strength and porosity which ultimately decreased compression strength. The findings of an additional study indicated that when the EP aggregate content was raised, the overall porosity of the concrete also increased [27] due to the porous nature of EP. The increase in porosity results in decreases in strength properties [28–30]. However, in the case of direct bacteria addition, a slightly increased compressive strength was observed which was 6.5% more than from reference blends. A study [31] observed that the bacteria can repair early cracks in the mortar. According to research, concrete compressive strength is improved when bacteria of the *Sporosarcina pasteurii* species are present at quantities of 10^5 cells per milliliter [32]. More bacteria added to concrete has a detrimental impact on its quality [33]. This is due to the fact that there is intense nutritional competition between cells when cell density rises. In comparison to normal concrete, the compressive strength is reduced by around 10% when the concentration of bacteria cells exceeds the optimal threshold [34]. However, in the case of combined addition (EP and bacteria), the compressive strength is approximately equal to the reference concrete. It is because EP decreased compressive strength and bacteria improved compressive strength. Therefore, a combination of EP and bacteria can be used without any adverse effect on compressive strength.

Fig. 5. Compressive strength

- The compressive strength of concrete slightly decreased with the addition of EP, i.e. 7.6% less than from the reference mix (concrete without EP). However, in the case of combined addition (EP and bacteria), the compressive strength is approximately equal to the reference concrete.
- Bacterial spores are immobilized in expanded perlite successfully conserved calcium lactate pentahydrate and bacterial metabolic activity, resulting in enough CaCO_3 generation.
- Under controlled settings, 0.8 mm crack healing was achieved after the 28-day healing period in the samples that were pre-cracked after 7 days. The ability of bacteria immobilized in expanded perlite to perform crack repair in concrete was proven by visual observation using a crack-detecting microscope.

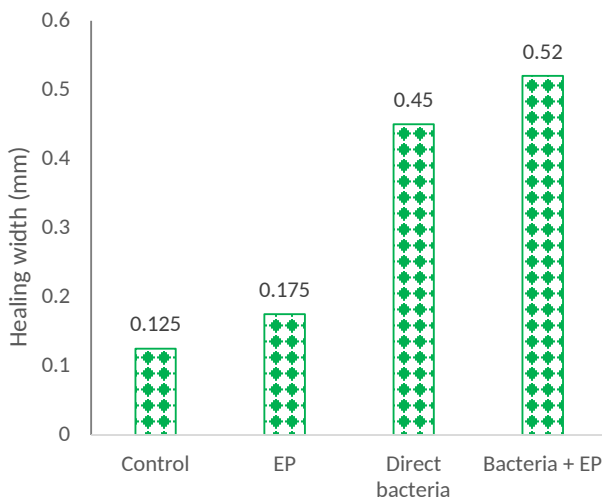
Cracks produced in the control specimens did not show noticeable healing, despite the fact that calcium lactate pentahydrate and the process of autogenous healing resulted in very small-scale healing of tiny cracks, whereas some cracks were repaired as a result of abundant mineral precipitation on the cracked region in all EP induced microbial formulations, confirming that bacteria immobilized in EP are capable of producing large amounts of healing product as shown in Fig. 7.

Fig. 7. Healing width

In all EP-reinforced microbial specimens, substantial healing was observed under a crack-width measuring microscope, especially after 28 days of exposure to healing conditions. Organic nutrition is abundant in the concrete mix during the initial days of healing, which is devoured by bacteria to generate CaCO_3 . Healing was measured in terms of the difference in crack width before healing and its width after healing. Previous studies that used EP as a bacterium carrier found healing of up to 0.78 mm [18].

This project resulted in the total healing of fissures up to 0.78 mm in diameter. Because hydration is not complete at this age, additional hydration of cement was used to seal some fissures [35]. As a result, the healing accomplished in concrete samples that were cracked at the 28-day intervals was lower than in the samples pre-cracked at 7 days. The healing parameters in the other groups of specimens did not change appreciably over time. Only 0.2 mm of crack closure was achieved in the control specimen. Worth-considering fact is that the results of visual observation are not viable enough to be referenced to internal fracture healing because only a few cracks were identified, and they were difficult to discern over time.

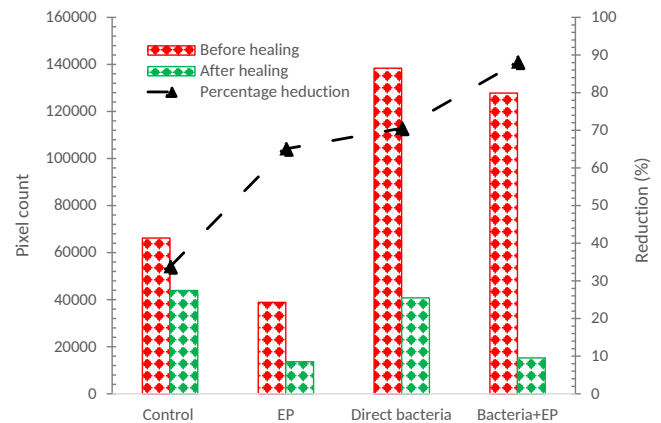
The authors used digital image processing to measure the crack diameters of concrete. The crack area to pixel count is measured before and after the healing by using digital image processing in MATLAB software according to a past study [36]. The original image is imported into the workspace by setting variables. The original image is also referred to as an RGB image. Then the RGB image is converted into a grey-scale image. Threshold valuing is the simplest method of converting a grey-scale image to a binary image as shown in Fig. 8. MATLAB software was used to calculate the extent of healing in terms of the proportion of crack pixels replaced by CaCO_3 produced by bacteria. The pixel count of concrete different blends is shown in Fig. 9. It can be observed that pixel count after healing decreases with EP and direct bacteria. However, a maximum decrease was observed with a combination of EP with bacteria. Therefore, the

Fig. 9. Pixels in the crack before and after healing

study recommends using EP in combination with bacteria instead of direct bacteria.
