FOUNDRY ENGINEERING

Defects Appearing in the Surfacing Layers of Abrasion Resistant

R. Bęczkowski *, M. Gucwa

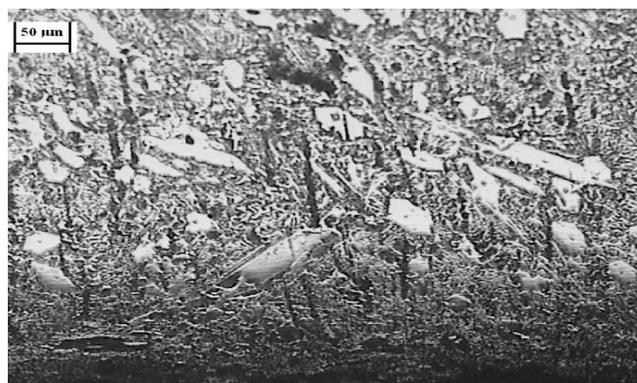
Fig. 3. Structure of material over the fusion line

Figure 1-3 shows chromium carbides Cr_7C_3 in the structure of surfacing layer. In the figure 1 chromium carbides are visible on the top of surface layer, and in figure 2, in the middle, and in the figure 3 they can be seen over the fusion line.

Analysing figures from 1 to 3 the nature of change in chromium carbides dispersion can be found. The big particles of carbides go down over the fusion line, when changing the distance from fusion line to the face of welding the particle of chromium carbides are smaller.

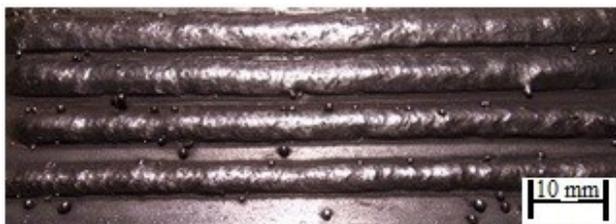
To identify the imperfection in macro scale the scheme norm PN EN ISO 6520-1 was used. If the set of parameters isn't correct many spatters can be found.

This kind of welding imperfection in some situations is accepted. (Fig.6).

Fig. 6. Spatter on the surface

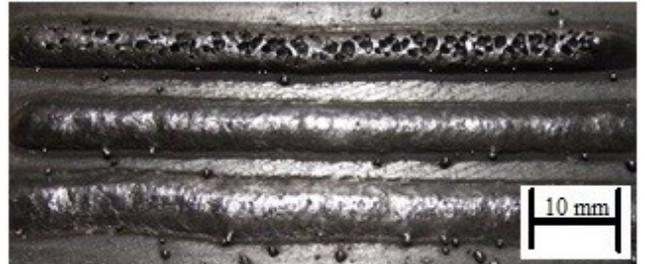
If the distance between contact tip and end of the wire is wrong, there isn't enough gas protection of welded metal. (fig. 7) In such a case the surface porosity can be found in micro scale in the single layer (fig. 8) or in wide layer (fig. 9)

Fig. 7. Surface porosity

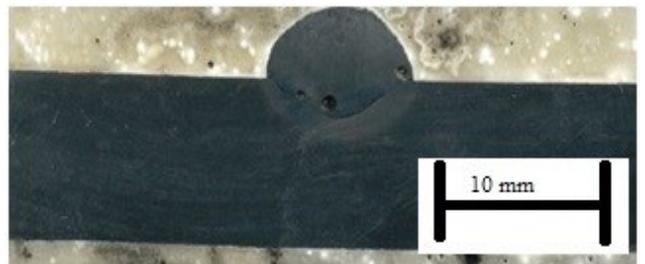
Fig. 8. Gas pore in the single layer of the weld

Analysing the localization of porosity it is visible that in the single layer the imperfection are near fusion line (fig. 8), whereas in wide layer it can be seen on the top of layer (fig. 9).

Special attention should be paid to localization of the pores in the weld. In the case of single layer pores are located in the lower layers of the deposit due to the high rate of heat dissipation.

For samples made with oscillating gas pores are localized in the upper layer of the weld, and in the case of beads made without oscillation -in the lower region of the weld just above the fusion line. This proves that the conditions of the heat and the type of heat source affect the location of this type of imperfection.

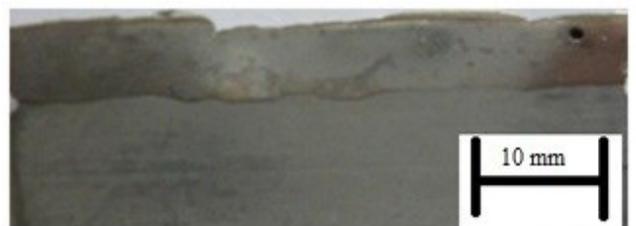
In the case of using wide layer of the width of 40 mm, pores are located on the top of the layer due to the larger volume of liquid weld pool.

Fig. 9. Gas pore in the wide layer the weld

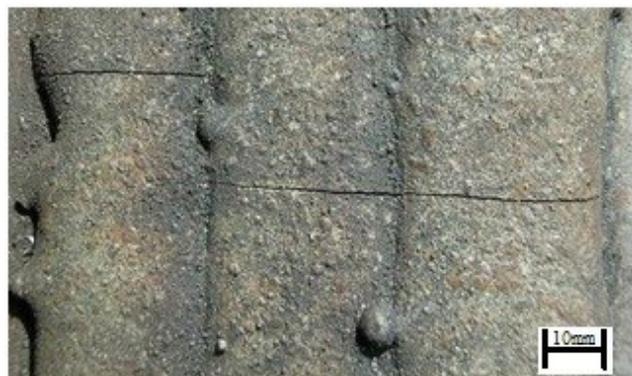
Next imperfection indicated by protection process of surface are cracks. Stress cracks in welds made by straight stitch shown in figure 10. Cracks wide bead made by oscillating (with oscillation width 40 mm) are shown in figure 11.

Fig. 11. Craks in the wide bead

Layer of high hardness above 60 HRC can be regular cracks. These imperfections are cracks relaxing.

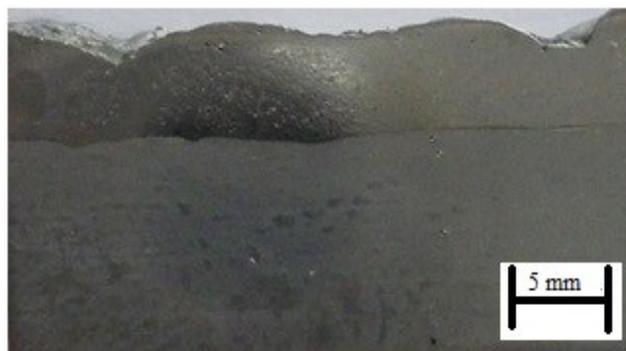
Analysing geometric discrepancies the easiest way to specify them is by performing metallographic section surface characteristic to welds made by semiautomatic methods. Figure 13 shows the inequalities face. Norm PN EN ISO 5817 allows this kind of imperfection but in limited range depending on the specific quality level in function of the thickness or value corresponding to 0.5; 1 or 2 mm.

Fig. 13. Inequalities face

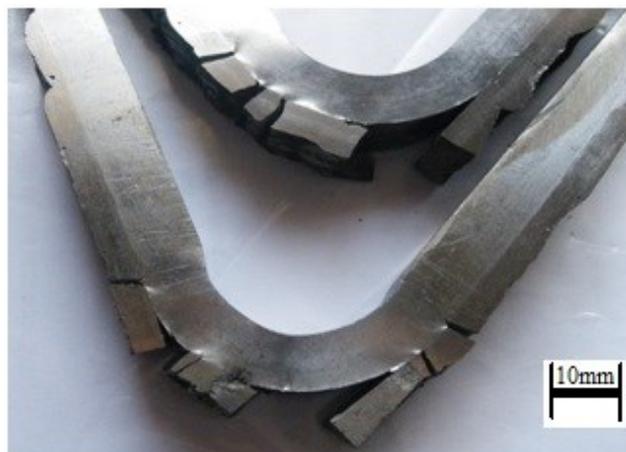
Character derived layers often necessitate bending elements. In this case these elements must be bent so that the deposited layer was stretched during the process and this leads to loosening of the deposit from the base material. Figure 14 shows the sample after the bending process on a mandrel with a diameter of 40 mm.

Fig. 14. Sample after the bending process

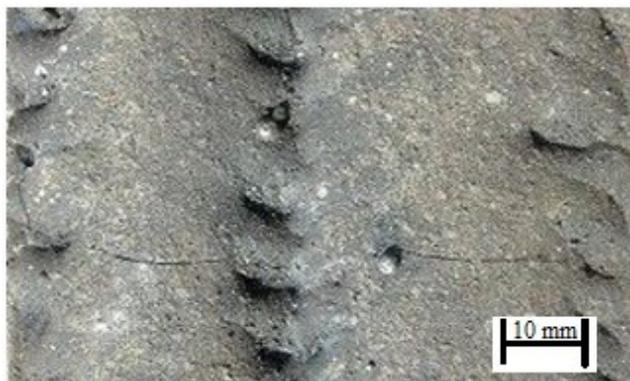
Surfaces protected has full and uniform coverage. Figure 16 shows the effect of incorrectly selected parameters of the process, whereby the inequalities of the face are obtained.

Fig. 16. Face inequalities by automatic welding.
