THE INFLUENCE OF NATURAL CLIMATIC FACTORS ON THE GEOMECHANICAL PROPERTIES OF SILICEOUS LIMESTONES FROM KAZIMIERZ DOLNY (POLAND)

Joanna Pinińska, Alicja Bobrowska, Dominik Łukasiak

*Department of Geology, University of Warsaw, ul. Żwirki and Wigury 93, 02-089 Warsaw, Poland,
e-mails: joanna.pininska@uw.edu.pl; a.bobrowska@uw.edu.pl; dominik.lukasiak@uw.edu.pl*

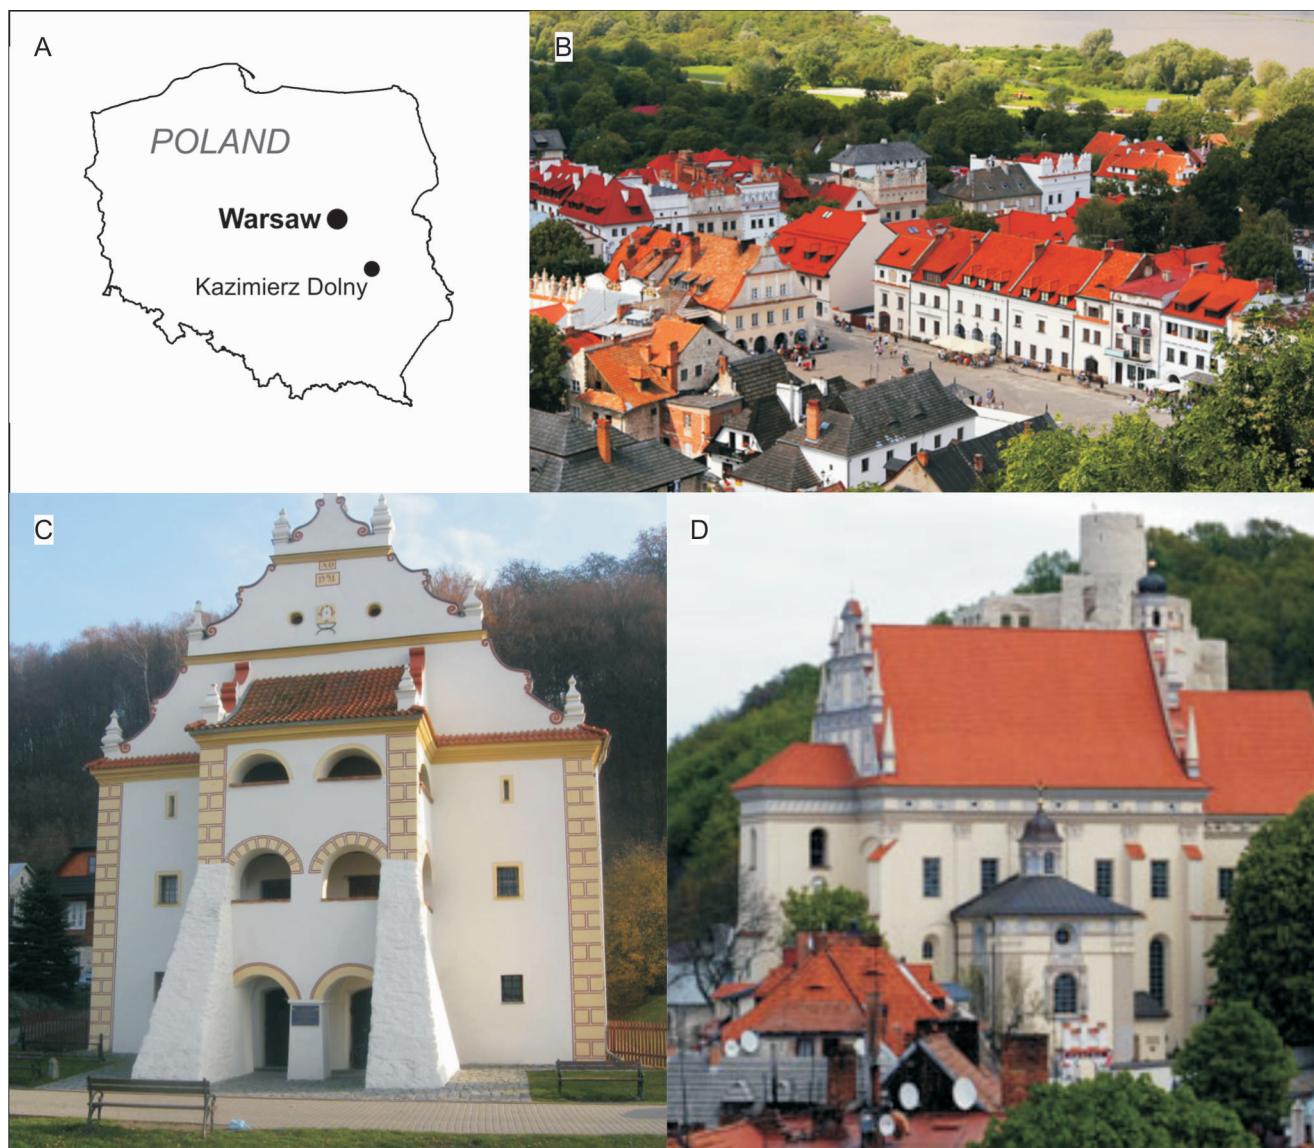
Fig. 1. Kazimierz Dolny. **A** – location; **B** – a preserved medieval urban layout of the old town; **C, D** – examples of medieval brick buildings with masonry (in order: a granary, a parish church).

The valley of central Vistula is a special area of Poland, where a well-known water trade route from southern Europe to the Baltic Sea made a significant impact on economic development of the region and farther on a unique style of the Middle Ages stone architecture. Common Upper Cretaceous and Neogene carbonate rocks from easily accessible, exposed slopes of the river, has had positive impact on the building industry prosperity. Following the development of the mining of siliceous limestone rocks opoka: a porous, flinty, and calcareous sedimentary rock, consisting of fine-grained opaline silica (up to 90%), and hardened by the presence of silica of organic origin (silicified residues of radiolarian, sponge spicules, and diatoms), commonly known as a “white stone”, urban complexes were formed with a characteristic architecture, exerting considerable impact on the cultural landscape of the region. The evidence of this influence is to this day preserved in medieval character of the urban layout of Kazimierz Dolny and its stone architecture, changed in 16th century from the wooden and inflammable to brick one (Fig. 1).
