## THE USE OF SURFACE ASPERITIES ANALYSIS TO INVESTIGATE WEAR OF BODIES IN CONTACT ON EXAMPLE OF BRAKE ELEMENTS

### Abstract

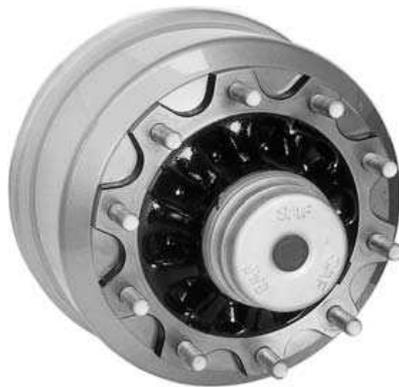
The construction of a typical SAF drum brake is shown in Fig. 1. Brake shoes are backward struted in the brake drum direction by means of a pivot shaft with cam, pressure is caused by a pneumatic brake actuator located on inner side of the axle. In most modern vehicles automatic controllers of the braking force are used, adjusting the distance between the drum and lining as it wears down. The appearance of an axle after covering 250 000 kilometres is presented in Fig. 2.

Fig. 1. Typical SAF drum brake with 9-tons capacity [1].

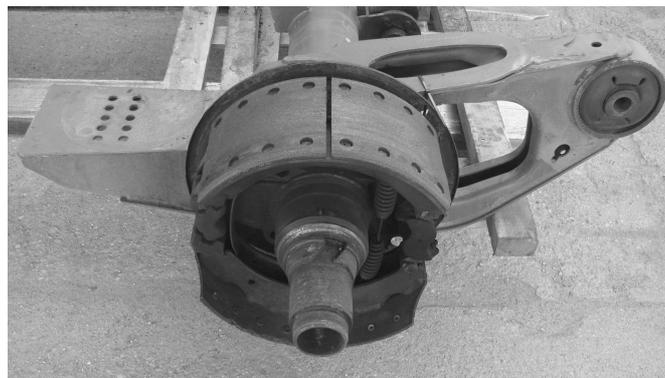
Fig. 2. Vehicle axle after 250 000 kilometres.
