# TENSION-STRUT SYSTEMS IN CONSERVATION OF HISTORICAL BUILDINGS: EXAMPLES OF APPLICATIONS

S. JURCZAKIEWICZ<sup>1</sup>, S. KARZMARCZYK<sup>2</sup>

*Keywords:* tension-strut systems, vaults, rafter framings, conservation of buildings

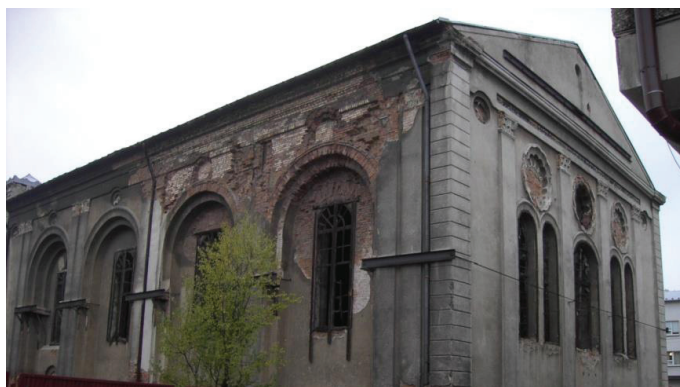
Fig. 4. Synagogue in Dąbrowa Tarnowska. Southern elevation. Damage to the wall caused by rain water.

The Germans changed the synagogue into a warehouse during the World War II and it was used in this way until the seventies of 20<sup>th</sup> century. Then a design of adaptation for the community centre was made but very few of design works were completed. The condition of the building was constantly deteriorating, the biggest segment of the vault over the entrance collapsed and one of bowstrings broke off. For a long time the vault was moistened by rain water because of leakage in the roofing so corrosion damage of bowstrings inside the walls was very likely, too (Fig. 4).

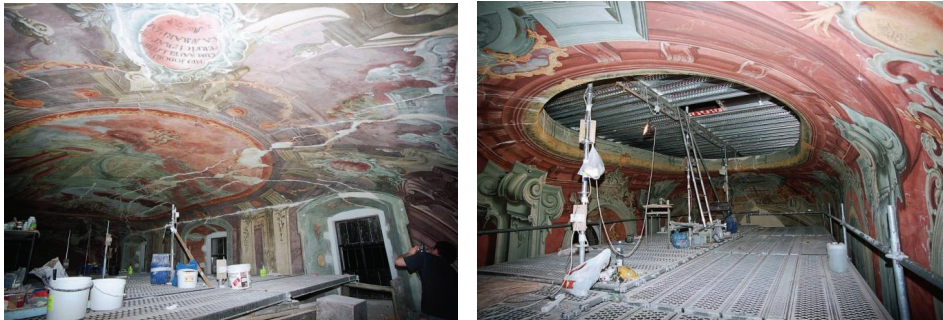
Fig. 7. Treasury of archcathedral in Lublin. Upper and lower vault during conservation.

The vault in the treasury of the archcathedral in Lublin, Poland was seriously damaged, threatened by a disaster. The treasury built as an annexe to semicircular presbytery was equipped with a double layer vault decorated by the court painter of king August III Sas. The outside wall leant out because of weak foundation and thrust forces from the vault. Large cracks appeared on the lower and upper vaults (Fig. 7). The foundation was reinforced during recent renovation but it was also necessary to remove dangerous horizontal forces from vaults pushing the outer wall and reinforce uncommon structure of the roof. A system of four inclined steel beams fixed with bolts to the roof rafters was designed in the attic (Fig. 9). The upper ends of beams were anchored in the presbytery wall and the lower ones on the top of the outer treasury wall. In this way the middle sector of deflected rafter framing was supported and both longitudinal walls fastened together. The cable systems transmitted thrust forces down to the level of the vault abutment and reduced the bending of the steel beams fixed to the rafters. The designed structure was assembled in the attic of the treasury and now fulfils its role as expected by the authors (Fig. 8).

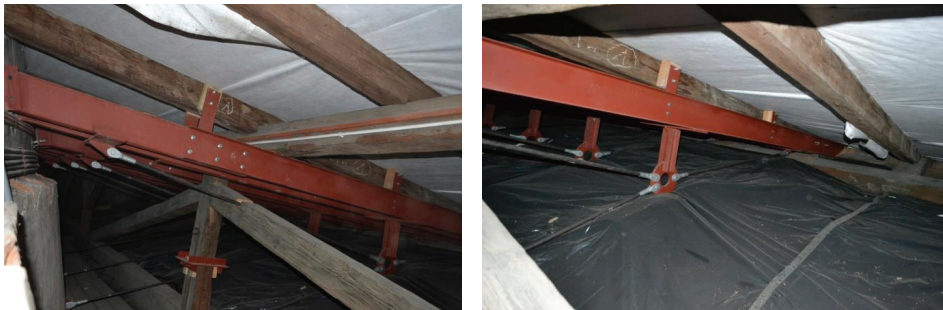
Fig. 8. Tension-strut system assembled in the attic of Lublin archcathedral treasury.

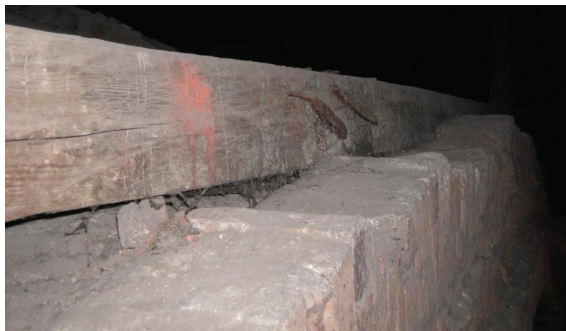
Fig. 11. Synagogue in Dąbrowa Tarnowska. Wooden truss bowstring loading the vault rib.

A similar threat to the vaults from the roof structure occurred in a synagogue in Dąbrowa Tarnowska. Suspended timber roof trusses equipped with three hangers have the span of 15.0 m. After a long time they deflected significantly and loaded the brick ribs of the vault (Fig. 11). Our cable system was supposed to pull up the lateral hangers. In this way the bottom wooden bowstrings of trusses were to be lifted until they got straightened and a safe distance between the roof structure and the key course of the vault could be achieved. We designed pairs of steel bars joined with bolts only in the top nodes of the truss hangers. Their lower ends were welded to steel plates leaning on a footing beam near the truss supports. The steel plates were connected with a horizontal steel bowstring which could be shortened by a tightening screw. This action was supposed to force the plates to slide on the surface of a wooden beam and steel bars and lift the truss hangers (Fig. 12). Afterwards, the plates were to be fixed with screws to the footing beam and additional wooden bracings were to be assembled in the middle of the truss in order to stiffen the structure. Despite the simplicity and structural logic, the designed tension-strut system was rejected by the contractor of renovation works. The roof lifting was executed without our participation, probably using hydraulic jacks put on the old brick ribs which caused additional threat to the vault structure.

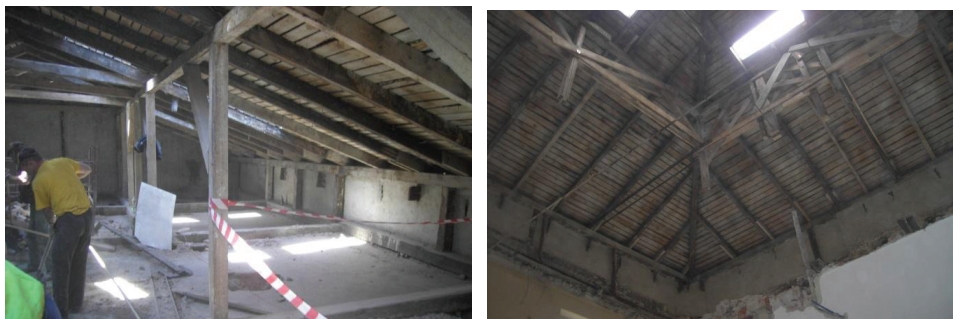
Fig. 13. Building of Cracow University of Economics. Roof structure before and after rebuilding.

A similar situation happened in the case of reconstruction of a building of Cracow University of Economics. It was decided that the original thick brick walls and ceilings would be removed. The interior was designed in a completely different way with an additional floor and a new roof. The contractor asked for the solution of temporary protection of the interior (Fig. 13). Purlins of the existing roof structure were supported by posts standing on the floor of the attic. We proposed to change the static system of the roof trusses by adding steel cables connecting ends of rafters and supporting the posts. Thus after demolition of the upper floor the span of roof trusses was over 14 m and the posts of the old rafter framing became compressed members of new trusses (Fig. 14).
