RELOCATION OF A HISTORIC BUILDING AT THE OLD NORBLIN FACTORY IN WARSAW

P. G. KOSSAKOWSKI¹

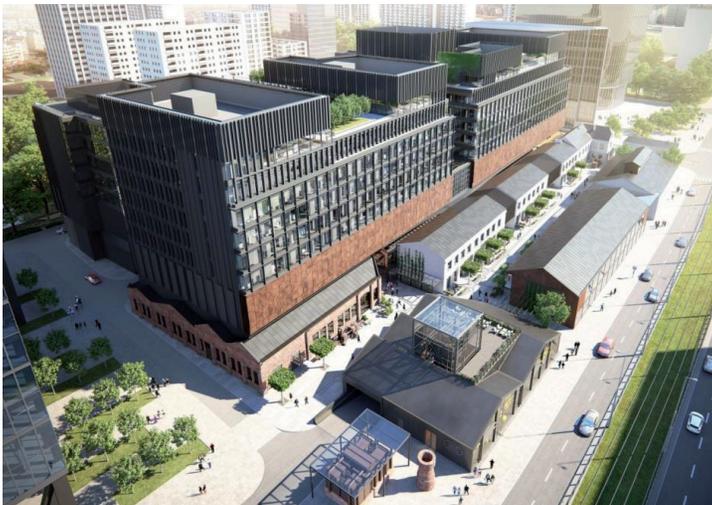
Fig. 3. Visual presentation of the development of the old Norblin Factory in Warsaw [17]

The history of this building dates back to 1847 [16], when the plot delimited by the Prosta, Żelaza and Łucka Streets was purchased by a German industrialist Edward Luckfield. Together with his business partner, Gustaw Henninger, he began the production of metal products at the site. In the following years the factory changed ownership. 1893 sees the creation of a company under the name of Towarzystwo Akcyjne Fabryk Metalowych Norblin, Bracia Buch i T. Werner, which in a short period of time becomes a major manufacturer of metal, mainly non-ferrous, products within the Kingdom of Poland. During the II Polish Republic the Norblin Factory, as it is known in short, was also one of the biggest manufacturers of metallic products in the country. After the end of World War II it was hastily rebuilt and operated until 1982 under the name of Walcownia Metali “Warszawa” (Warsaw Metal Rolling Mill). It subsequently served as a museum, being gradually reduced, as in the 1990s manufacturing halls between Sienna and Prosta Streets were demolished. The museum was closed in 2008 because of the facility being previously taken over by a private investor. It was decided to develop the old Norblin Factory into office and commercial buildings, simultaneously preserving some of the post-industrial buildings. In accordance with the developed architectural concept design, it was also decided to set out a generally accessible pedestrian passageway and three streets covered with a glass shelter roof. The visual presentation of this project is shown in Figure 3.

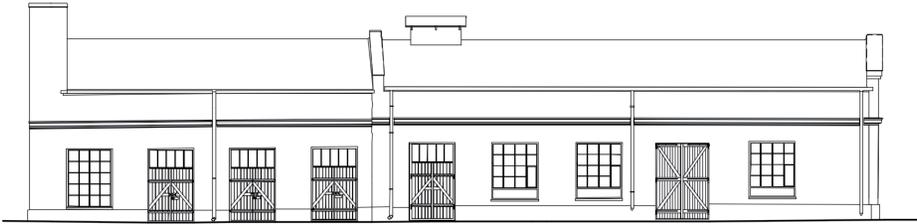
Fig. 4. South elevation of building No. 15 at the old Norblin Factory

Building No. 15 was built on a rectangular plan view of the dimensions of 31.5 m × 12.0 m. It is a single-floor building with a pitched roof and a traditional, brickwork structure (Figs. 4 and 5).

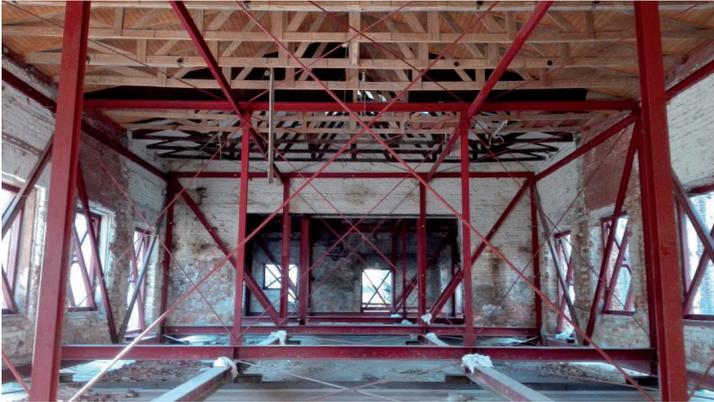
Fig. 7. View of internal strengthening structure of building No. 15

In order to ensure the safe relocation of building B15, a frame made of HEA 240 steel profiles was designed, which were stiffened using C 160 posts and cross braces and type X vertical bracing made of two 20 mm diameter rods (Figs. 6 and 7). Near masonry walls, the frames were to be bolted together using M16 bolts spaced apart 170 cm maximum. In order to ensure adequate stability, the spatial structure was braced in the bottom and top plane of the frame using type X bracing made of two 20 mm diameter rods. All bracings were provided with the possibility of tension adjustment. In places of the occurrence of high crosswise forces, I-beams were additionally strengthened using longitudinal ribs. A steel profile C 200 girder was designed in the place of the removed wall in order to support the existing steel beams.

- stiffening of the remaining middle wall in the form of doubled crosswise structural arrangement shown in Fig. 7,
- construction of continuous foundations for the tracks inside and outside of the building,

- construction of the bottom steel grate (Figs. 7 and 8),
- securing of wall openings: upper openings in gable walls were bricked up to the entire wall thickness, whereas openings at the floor level were secured by introducing steel stiffening profiles,

- construction of spacial frame in accordance with the above-mentioned description (Figs. 6 and 7).
- creation of openings for the passage of tracks made of C 240 profiles and track beams,

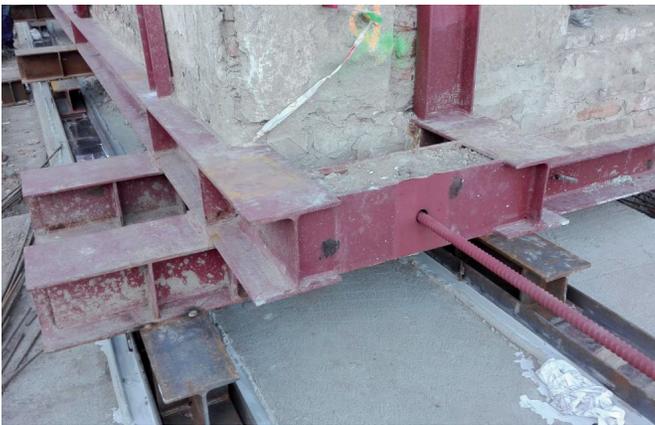
According to the design, the movement of braced frame together with the building was to take place on HEB 200 I-beams, supported on C 240 profiles (Figs. 8 a and b). Teflon was installed between the profiles in order to reduce friction to a minimum. Steel spacers were provided at the interface between HEB 200 and HEA 240 profiles in order to allow any necessary adjustment. C 240 profiles were installed under land survey supervision, with a maximum tolerance of up to 2 mm. In order to reduce the effects of thermal expansion, the possibility of movement by at least 5 mm in the direction perpendicular to the profiles was ensured at the interface between HEB 200 and C 240 profiles.

Fig. 8. Outer node of the bottom frame of the stiffening structure of building No. 15; a) design detail; b) erected structure

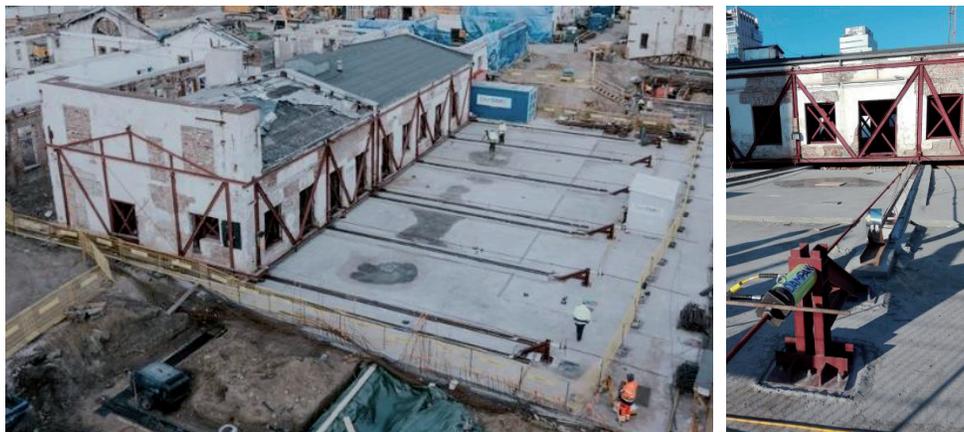
The operation of relocation of building No. 15 began at about 10:30 on Friday, 30th November 2018, and finished on the following day, on Saturday, 1st December, at about 7:00 in the morning. A view

of the building during relocation and one of the tensioning tracks can be observed in one of the figures below.

Fig. 9. View of building No. 15 during the operation of relocation

The correct progress of this procedure was supervised by over a dozen of persons: engineers, land surveyors, structural supervision engineers and construction workers. The relocation was carried out on site by the DAMPAK company, where the entire process was managed by an engineering team consisting of Damian Pakuła, Mariusz Rogowski, Piotr Pacak, Tomasz Pacak, as well as Paweł Kossakowski, the author of this article. The weather conditions were good, without any precipitation, temperature was quite low, between -12°C at night and -2°C during the day, which was quite uncomfortable for the engineering team who supervised the whole operation for virtually 24 hours. The 900-tonne building moved at a speed of approx. 3 cm per minute, in 25-centimetre cycles, with intervals in between. The building was moved by a total of 15 metres to its temporary location. The subsequent relocation of the building to its original location took place on 25-26 April 2019. The procedure was conducted similarly to the first operation of relocation. Notable is the fact that the building did not suffer any damage during these operations, which was especially important due to its historic character.
