ARCHIVES  
of  
FOUNDRY ENGINEERING

# Effect of Cathodic Protection on Corrosion of Water-pipe Network in Kraków - Case Study

The paper is a summary of a project aimed at identifying and eliminating or minimizing the causes of frequent failures of the Krakow water supply network related to corrosion damage. The paper presents the method of searching for factors responsible for frequent corrosion damage. There were taken into account several factors that may destroy the pipes associated with corrosion processes, such as the composition of the water, aggressiveness of ground, or stray currents. The monitoring method of the corrosion processes applied to observe the condition of the water supply network was discussed. The study showed that the main problem appeared to be stray currents related to the electrical infrastructure widely present in a large city, such as a tram or railway network. To eliminate this threat, a cathodic protection system has been implemented to prevent further failures. There were also demonstrated results of research proving that the applied solutions are effective.

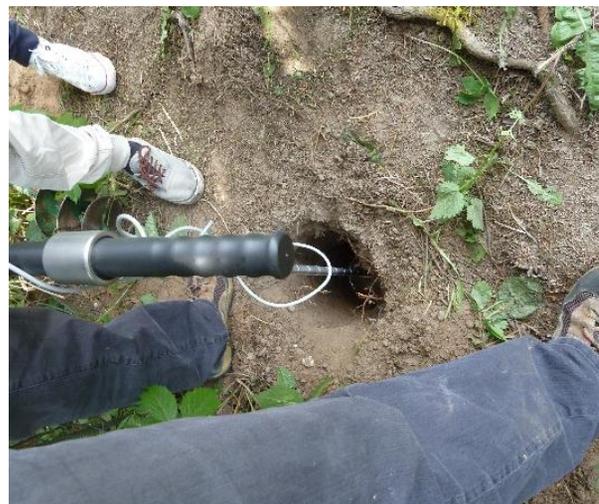
Fig. 2. Collecting the soil samples

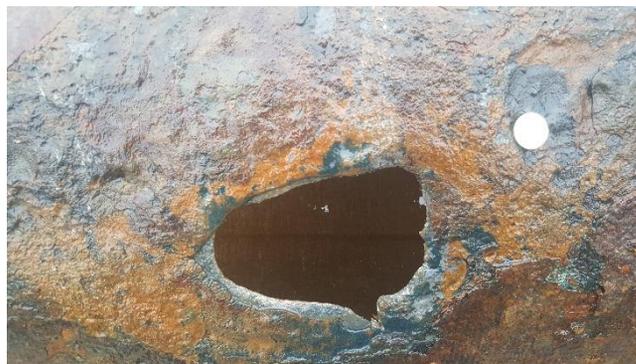
Most failures occurred at a site distant from the sources of stray currents sources namely the tramway and railway traction systems. For the Kościuszko Reservoir, despite the distance of about 1 km from the tram line, the impact of stray currents on the water supply system was visible. For the measurement point in Nowa Huta district, it was found that the water supply system was not endangered by the harmful effects of stray currents associated with the presence of tram traction or high voltage lines. For water supply bus at Wodna St. both the railway and tram lines occurred to be the source of the cathodic polarization of the pipe network in this area. Despite the significant distance from the tram and railway lines, the influence of stray currents was observed in the area of Hallera St. Figure 4 presents the effects of stray currents on water pipe corrosion.

Fig. 4. Corrosion damage of water pipe as a result of stray currents

To eliminate the influence of stray currents on the pipes transporting drinking water in the area of Krakow and to prevent metal corrosion as a result of electrochemical reactions with aggressive components of water and soil, the cathodic protection system was modernized and significantly expanded. In many places, interactions with other parts of the city infrastructure, such as gas lines, etc., which caused a short circuit with water pipes and initiated corrosion processes, were eliminated. The cathodic electrolytic protection system with an external DC electrical power source was used. By the end of 2020 in Krakow was installed 18 cathodic protection stations and 86 measuring points allowing control of potential in the pipeline.

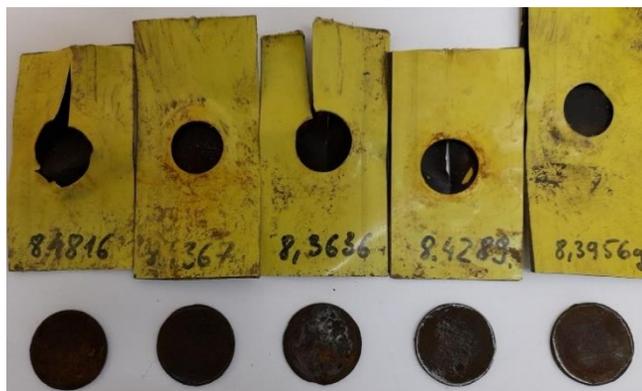
Samples of carbon steel with working area of 3.46 cm<sup>2</sup> were placed in soil for 4 years (June 2015 - May 2019) in the vicinity of the water reservoirs:

- Kosciuszko Mound - 1 sample connected to the water pipe, no CP station in the area,
- Nowa Huta district - 1 sample connected to the water pipe, no CP station in the area,
- Wodna St. water bus supply - 1 sample connected with the water pipe, CP station at the distance of 10 meters,
- Hallera St. - 2 samples: 1st not connected to the pipe, no CP, 2nd connected to the pipe, CP station at the distance of 800 meters.

Figure 5 presents samples taken out of the foil protecting non-corroding surface.

Fig. 5. Carbon steel samples after 4 years of exposure in the soil nearby to the main water tanks of Krakow water supply network

The lowest corrosion rate was recorded for the sample located in the immediate vicinity of the cathodic protection station. The highest corrosion rate was observed for the sample exposed in the Nowa Huta district, in highly corrosive soil (see Table 2) in the absence of cathodic protection. A very significant difference in the rate of corrosion was observed for two samples located at Hallera St. The value for the sample without any current protection is three times higher than that of a twin sample connected with a pipeline protected by a cathodic station almost one kilometer distant.
