## Review paper

# Composite materials in conservation of historical buildings: examples of applications

This paper presents a few examples of practical applications of composites the authors have designed for structural reinforcement of columns, vaults, masonry walls, balconies, stone facades and timber rafter framings.

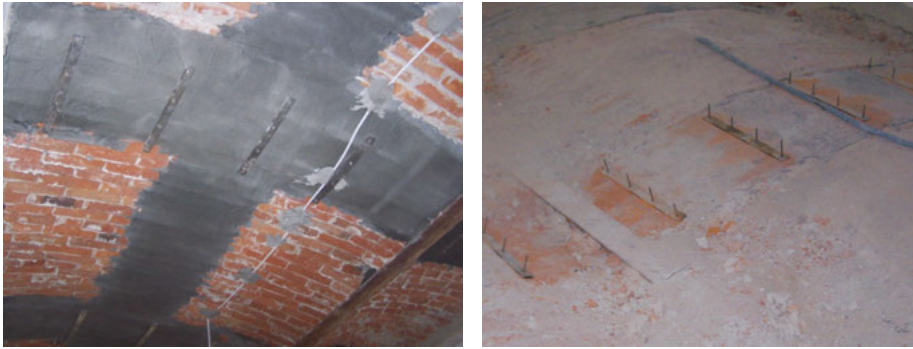
Hinge and formation of cracks can be prevented and vault can be strengthened by increasing the load capacity of the vault section. Improving the tensile strength of old brick masonry is not possible, but similar effect can be obtained if the composite strong mesh is stuck on the tensioned side of the vault. Taking into consideration all combinations of loads acting on the floor mesh should be stuck on the whole upper and lower surface of vault (Fig. 3). Such way of reinforcing the segmental barrel vault was applied in a school in Gorlice where both sides of the vault were uncovered during restoration works (Fig. 5). Location of thrust line in the arch of vault and values of stresses in critical sections were found on the basis of diagrams of bending moments and axial forces. The calculations showed that reinforcing both sides of the shell with strips of composite mesh 0.5 m wide in 1.0 m spacings is sufficient. Thus the initially designed heavy reinforced concrete slab did not have to be applied. Transversal steel strips seen on Fig. 5 protect the mesh against detachment from the bottom side of the vault. Strips are connected with stainless steel screws through the vault. Currently composite bundles of fibres are available and can be used for this purpose [11].

Fig. 5. School in Gorlice. Reinforcement of segmental barrel vault with FRP composite mesh. Bottom (left) and upper (right) sides of vault

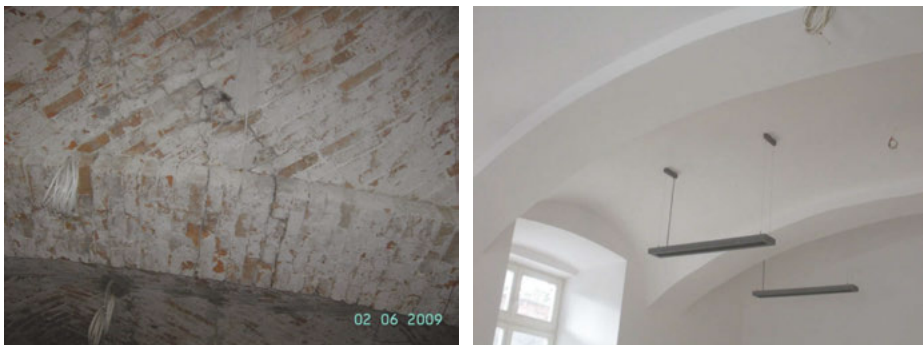
However, there is usually only one side of the vault available for sticking the mesh either because the whole building cannot be renovated at the same time or the bottom surface of the vault is decorated with paintings or stucco. It was the case of the Royal Palace in Łobzów where the Faculty of Architecture of Cracow University of Technology is currently located. The ground floor rooms were restored only when the works on the first floor had been completed. Therefore strips of mesh were stuck crosswise the cracks only on the bottom side of the vaults. In such a way only some of the hinges in critical sections with cracks on visible side of vault were eliminated, but it turned out to be sufficient for the security of the vault. The repair was successful and cracks did not reappear (Fig. 6).

Fig. 6. Royal Palace in Łobzów, Cracow. The vault before (left) and after (right) renovation

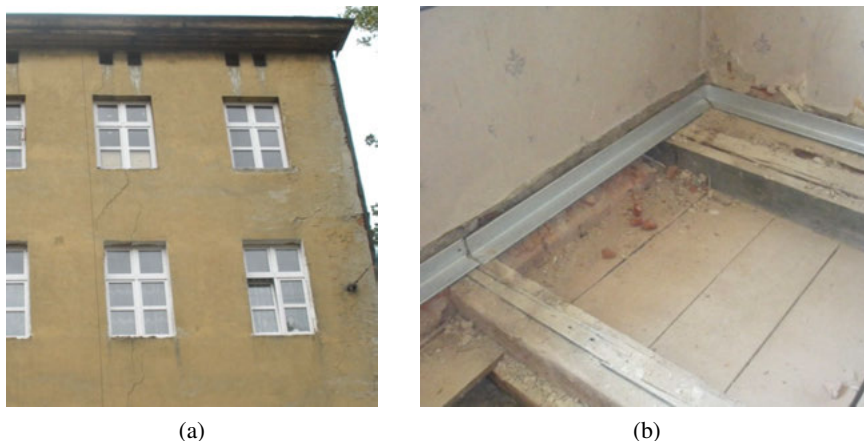
Walls of masonry buildings require bracings in order to withstand horizontal tensile forces from differential settlement of foundations or thrust forces of vaults. Beams surrounding the reinforced concrete floors fulfil this role in modern buildings. Traditional timber beam-framed floors are not sufficiently effective braces for masonry walls. This structural defect becomes apparent in the formation of cracks of inter-window strips (Fig. 8a). In the past during renovation works original timber floors existing in historical buildings were commonly replaced by steel and reinforced concrete floors type WPS, and later by corrugated steel floor decking with concrete topping. Such structures ensured adequate stiffening of the building. Nowadays timber floors are removed only if old beams have been completely destroyed by biological corrosion. Wooden beams can be strengthened to the assumed bearing capacity and required fire resistance provided by lightweight layers of fire-proof materials. When a major renovation of the building interior is performed additional bond beams made of steel angles may be fixed to wooden beams and walls (Fig. 8b).

Fig. 8. Tenement house in Łódź, Żeromskiego street: a) cracks on elevation and b) steel bond beam

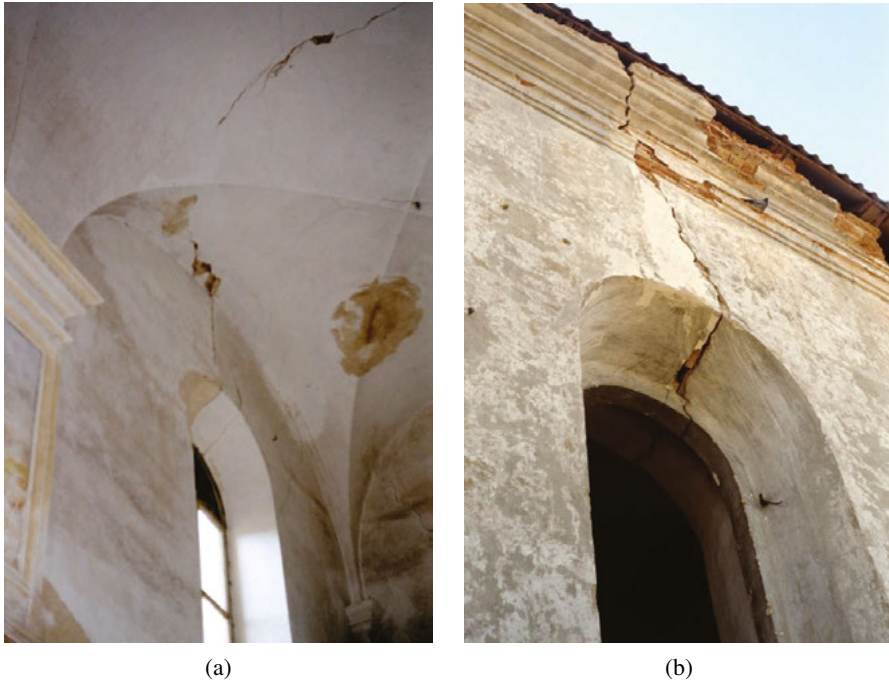
At the beginning of 21<sup>st</sup> century design works were undertaken on conservation of synagogue in Słonim, Belarus built in 1642. The building was covered with a system of barrel and cross vaults supported on perimeter walls and central bima. The haunch of the vault was filled with brick rubble. Cracks of vaults and arches above windows (Fig. 9) showed that the thrust forces from the vault were the source of threat to the stability of the building structure.

Static calculation of the structural system of vaults with upper strip of walls above windows supporting them proved that excessive tensile stresses existed in that zone. The strengthening system which was designed consisted of two pairs of steel cables holding the walls together on the top of the inter-window pillars. Three-span brick masonry beams reinforced with composite FRP carbon fibres plates were created in each wall. Such a new static system replaced the original system of one span beams without reinforcement. Inter-window pillars were strengthened with FRP carbon fibre plates stuck on the outer side. Other FRP plates bond on the whole perimeter of building eliminated the negative impact of horizontal components of reactive forces from the vault flowing into corners (Fig. 10). In such a way, having changed the static system of the structure supporting the vault, tensile stresses causing cracking of walls were significantly reduced. Thanks to the application of small-size composite materials it was achieved with minimal structural interference in the historical wall.

Fig. 9. Synagogue in Słonim, Belarus: a) cracks of the vault and b) the arch above window

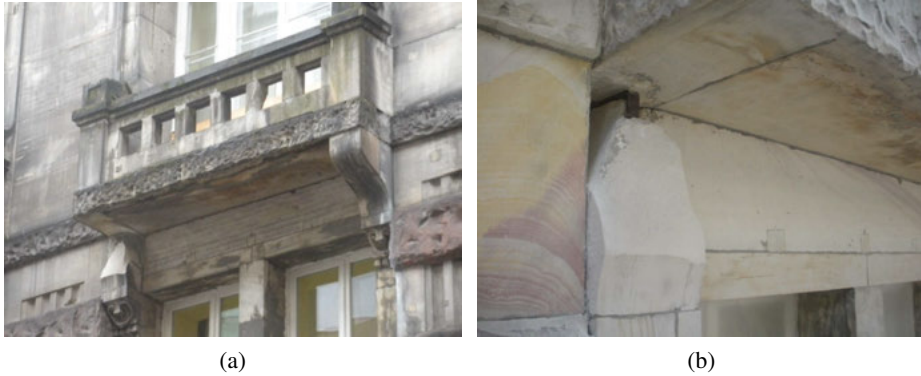
Fig. 11. Warsaw, Kredytowa street 3: a) stone balcony and b) bracket fallen down from the facade

One of stone brackets from the balcony on the second floor fell down a few years ago. Damage of stone panels could be observed, too. A close inspection showed that the cause of the damage was the corrosion of steel anchors fastening stone elements to the wall (Fig. 11b).

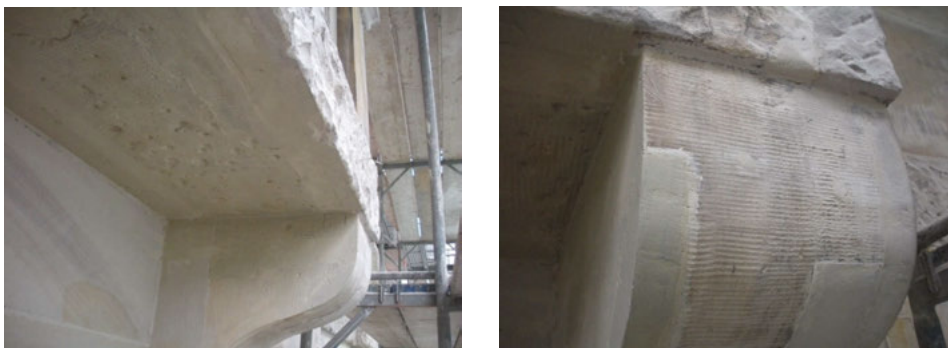
Fig. 13. Warsaw, Kredytowa street, 3. Strengthening elements covered with colour mortar
