## THE USE OF LIMESTONE IN HISTORIC ROAD SURFACES – A CASE STUDY

**Abstract:** The article presents the problem of selecting the correct type of limestone for producing paving stones used to renovate the surface of Mariacki Square in Krakow. Due to using up local limestone deposits, imported limestones began to be used. The first one was a Turkish limestone with the trade name Lotus Beige. Despite substantial physical and mechanical parameters (compressive strength 134 MPa, water absorption 0.26%), after several years of use, the paving stone cracked and, as a result, fell apart into smaller fragments. Hauteville limestone from France has been selected for the following reconstruction of the surface. This limestone in the air-dry state was characterised by even higher parameters, i.e. compressive strength of 157 MPa, flexural strength at 16.9 MPa, Bohme Abrasion test at 15275 mm<sup>3</sup>, and water absorption at 0.23%. The tests also showed absolute frost resistance and high resistance to thermal shock. Unfortunately, after several years of using the surface of Mariacki Square, cracks and flaking of the rock material have been observed in terms of some paving stones. These crac

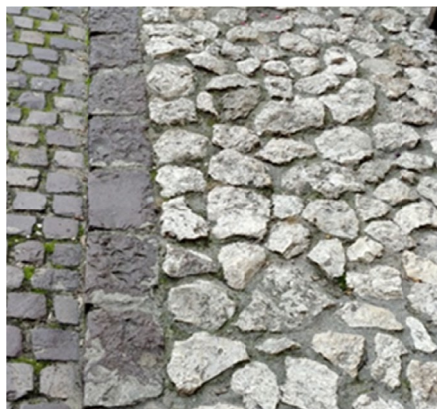
Fig. 2. Section of a reconstructed pavement made of cobblestone

The first stone road surfaces of Krakow were built in the 13th and 14th centuries and were made of selected stones obtained mainly from broken limestone or ceramics. The paving stones were shaped into wedges and driven into the sand bed. As a result of use, especially under the impact of vehicle traffic, the paving stones got deformed, and their edges crumbled. Surfaces made in this way were called „cobblestones“ [2,3]. Over the centuries, most of the street and square surfaces in Krakow were rebuilt using stone materials that were more durable and resistant to the increasing traffic of vehicles, such as granite, basalt, etc. Nevertheless, limestone surfaces have remained in several historic locations in Krakow. Such surfaces are found, for example, at Mariacki Square, around the Church of St. Wojciech on the Main Square, at the end of ul. Gołębia, around the Florian Gate, or in the courtyard of the Wawel Royal Castle. In many places, to present the historical „cobblestones“, fragments of surfaces were reconstructed with the use of irregular cubes recovered during disassembly (Fig. 2).

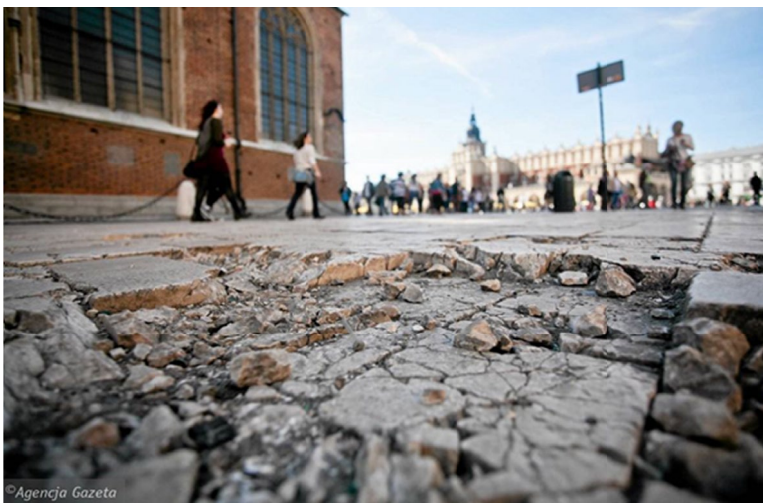
Fig. 4. Numerous cracks and damages of Turkish limestone paving stones [15]

Even though the used elements were much larger than the historical „cobblestones“, they formed significant cracks and broke into smaller fragments after several years of use (Fig. 4). To determine the causes of such a rapid and intensive destruction of the used material, Rembiś and Smoleńska [13] as well as Mazurek [14] carried out tests of samples taken from the paving stones from Mariacki Square used at that time. Mazurek [14] showed primarily a very high variability of mechanical properties. The compressive strength values ranged from 93 to 180 MPa (average 140 MPa), while the flexural strength was from 0.45 to 13.3 MPa (average 7.6 MPa). During a frost resistance test, some samples were completely destroyed, while for the remaining samples, after 56 cycles of freezing and thawing, only a few percent decrease in strength parameters was noted. The cause for the damage, as well as significant discrepancies in the results, consisted

of cracks that developed extremely quickly within the discontinuity zones, i.e. stylolite seams and calcite veins. It was confirmed by observations of these cracks carried out by Rembiś and Smoleńska [13] with the use of an SEM scanning microscope. They showed that the main cause of the damage consisted of the crystallisation of salts from deicing agents.

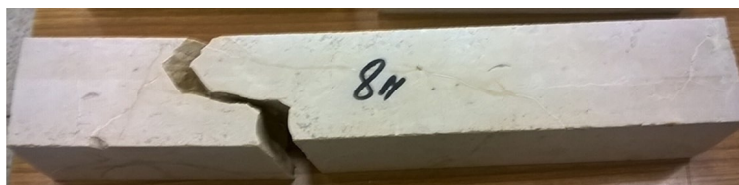
Fig. 7. A sample with dimensions of 50×50×300 mm after the flexural strength test with visible cracks within the so-called stylolite seams

Despite the high mean values of the examined mechanical parameters, the wide dispersion of results concerning mechanical properties, regardless of the state of the test, was disturbing. This was also confirmed by the high value of variation coefficients, which ranged from a dozen to even 30%, and the minimum values accounted for less than 50% of the mean values. In many cases, the dispersion of the results is due to the discontinuity of stylolite seams. Their impact on the manner of destruction was observed on more than ten samples subjected to the flexural resistance test (Fig.7). Both in terms of air-dry samples, as well as after saturation and frost resistance testing, breaking a sample with a load applied in the middle was asymmetric, and exactly along the stylolite seam.

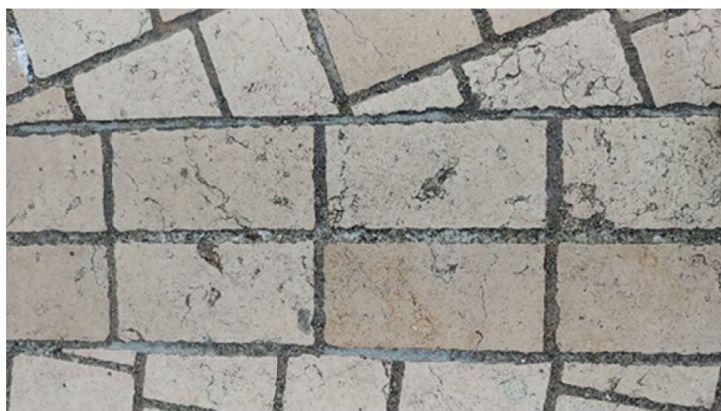
The Mariacki Square example in Krakow constitutes an excellent example of these problems. Selecting the limestone for producing paving stones turned out to be a real challenge. Despite the fact that limestone with low water absorption, the highest mechanical parameters, and very high resistance to water, as well as cyclic freezing and thawing has been selected. It cannot be clearly stated that it was a stone that meets modern durability requirements. The most worrying was the wide dispersion of results, which was a direct consequence of the occurrence of compact discontinuities within some samples, i.e. stylolite seams. This confirmed the concerns, as cracks and slight peeling of the stones appeared within these seams (Fig. 8) after years of pavement use.

Fig. 8. Damages of Hauteville limestone paving stones in Mariacki Square in Krakow

In order to meet the requirements of preserving the historic character and the good condition of the historic pavement of Mariacki Square, the only solution seems to be using non-stylolitic limestone, which is more durable and homogeneous to outdoor conditions.
