PIOTR STRZAŁKOWSKI^{1*}, GRZEGORZ DYDUCH¹**IMPACT OF STRENGTH PROPERTIES OF TIMBER LININGS IN FORMER WORKINGS
ON THE SINKHOLE FORMATION HAZARD. THE CASE STUDY
IS ON THE UPPER SILESIA COAL BASIN, POLAND**

Keywords: old workings timber lining; timber bending strength; sinkhole hazard; wood laboratory tests

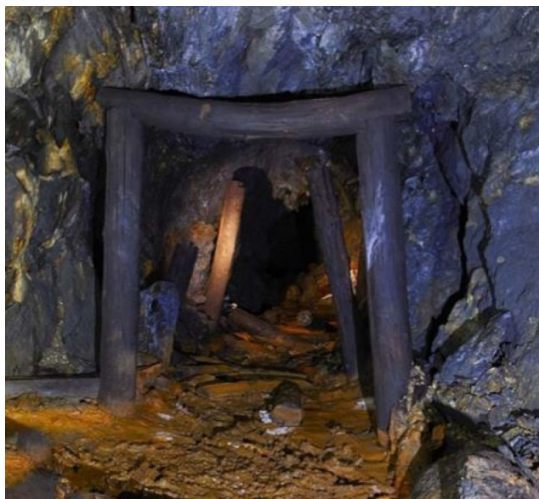
The condition of old wooden support from the 19th century is well illustrated by a photograph taken in adit Marcinków in Sudetes Mountains (Poland). In the photograph, one may note the musty fragments of the lining laying on the floor and the German-type support sets in which the roof bar is bent and broken due to the load exerted by the rock mass. The fracturing of the props may also be noted (Figs. 1 and 2).

Fig. 1. General view of the adit from the 19th century in Marcinków (Sudetes Mountains – Poland – photograph by A. Pastuszak)

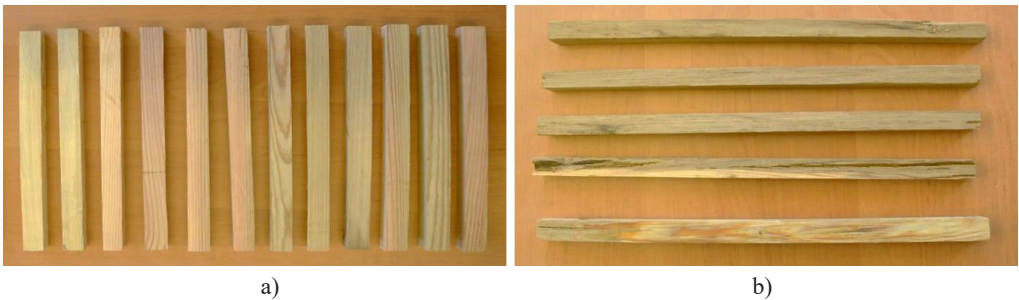
A total of 33 laboratory samples were acquired and prepared from all wood groups in line with the Polish standard PN-77/D-04227 [12] and Polish standard PN-77/D-04103 [11]. The samples were subsequently tested in terms of bending strength according to the provisions of the standard referred to above (Fig. 4, Fig. 5). The moisture content of the samples upon testing varied in the range from 8.9% for group 1 up to 9.4% in case of group 2.

Fig. 4. A view of examples of laboratory samples acquired from cut out fragments from groups: a) 2, b) 5
