LESZEK SZOJDA

NUMERICAL ANALYSIS OF BUILDINGS LOCATED ON THE EDGE OF THE POST-MINING BASIN

Keywords: mining subsidence; masonry structures; numerical analysis; post-mining areas

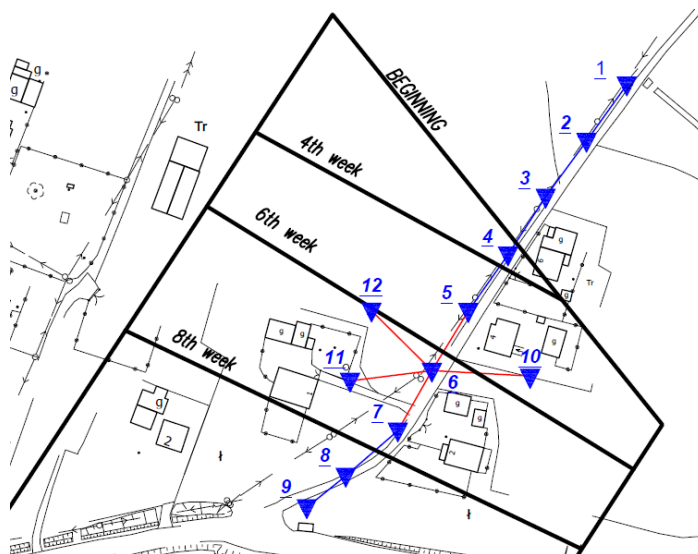
Fig. 3. Location of the points of the field rosette and the progress of the operational front in time (*Source: own study based on materials from the Marcel Coal Mine*)

Marklowice is a small town in the Silesian Voivodeship in Wodzisław County, Poland. Nearly 80% of the area is farmland. The dominant buildings are small, single-family houses with outbuildings. It is a mining area, and the exploitation in the Marklowice region is continuing. Due to the cave-in of exploited deposits lying at a depth of approximately 300 m, very large deformations are forecast here (categories IV and V of mining area deformation in the Polish mining industry). The exploitation analysed in this study is characterised by the following parameters: depth of exploitation – 320 m, the height of the exploited wall – 3 m, and mining technology – caving in. The width of the exploited wall is about 190 m. Due to the high variability and the hard-to-predict pace of change of the deformation rate, the place of the commencement of exploitation is very special, presented in [8]. This interesting area was adopted in the study as a testing ground (Fig. 3).

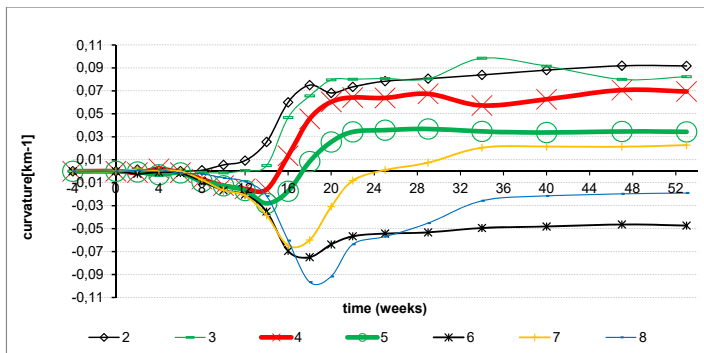
Fig. 5. Variable curvature of the terrain at the points of the field line over time (*Source: own study*)

Based on the known slopes of individual sections of the field line, changes in the terrain curvature were also determined, as observed at the points of the line: 2-8 (Fig. 5).

The diagram in Fig. 5 shows that the accumulation of changes in curvature took place between the 8th and 22nd week after the commencement of the exploitation. The following weeks represented the period of curvature index stabilisation. The maximum convex curvatures were recorded at points 2, 3, and 4, which is consistent with the initial predictions. The closer to the interior of the subsidence basin, the greater the spread of curvature sizes. At points 6 and 8, the end of the curvature is concave. Point 7 shows a slightly convex curvature. The results show that the interior of the basin after exploitation remained ‘wavy’ and variable in terms of curvature.

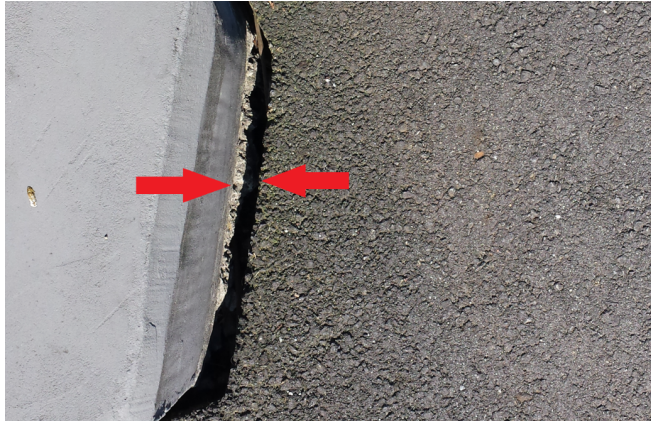
Fig. 8. Detachment of the asphalt surface from building no. 1 (Fig. 7) (Source: own study)

Both of the above conclusions were confirmed by observations of the field situation. The relationships between the terrain curvature and horizontal deformations according to the Budryk-Knothe theory can be seen in Fig. 5 and 6, between the measurement points 5, 6 and 7. Fig. 8 shows the structure of the lower parts of building no. 1 (Fig. 7), together with the surrounding asphalt surface. Tensile deformations, accompanying convex curvatures, caused the asphalt to detach from the structural elements of the building.

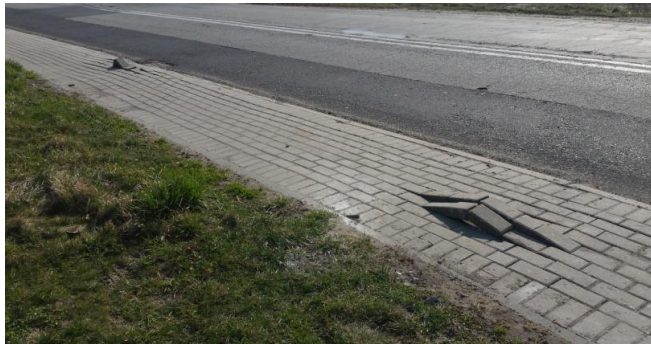
Fig. 9. The uplift of paving stones (location – blue circle, Fig. 7) (Source: own study)

Fig. 9 shows the impact of compressive stresses inside the basin in the bottom zone. In this case, the paving stones on the sidewalk on the main street were raised in several places. The location of the damaged pavement is marked in blue in Fig. 7.

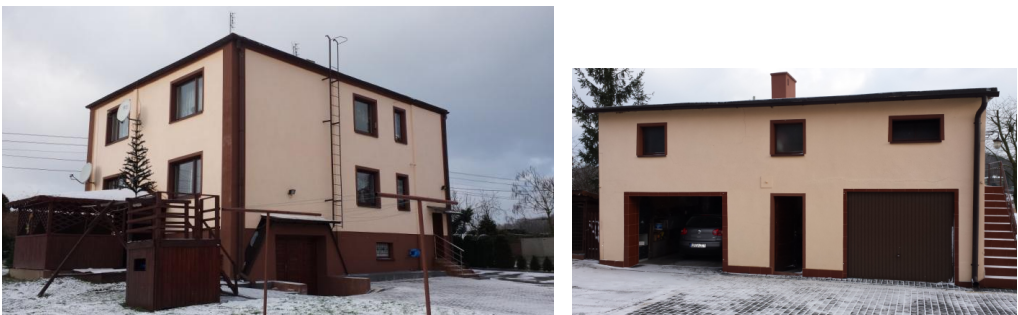
Fig. 10. Buildings # 1 and # 2 located in the zone of the convex curvature of the terrain (*Source: own study*)

In an attempt to take into account the influence of the convex curvature of the terrain on the existing buildings in the area covered by the field research, two buildings, numbered # 1 and # 2, were selected (Fig. 7). Building # 1 is a residential building. It is a two-storey building with a basement made of brick with traditional technology. The dimensions of the building, in projection, are 12.1×10.2 m. Building # 2 is a single-storey outbuilding with an attic serving as a loft (Fig. 10). It was made of bricks using traditional techniques and with dimensions in the projection of 10.1×6.6 m.

Based on the technical documentation of the buildings, and supplemented with an on-site inspection, both objects were modelled as spatial shell models with panel thicknesses corresponding to the actual wall thicknesses, respectively: 38 cm external walls, 25 cm internal walls and

12 cm partition walls for building # 1 and 25 cm for all walls in building # 2. The buildings were made with reinforced concrete ceilings.

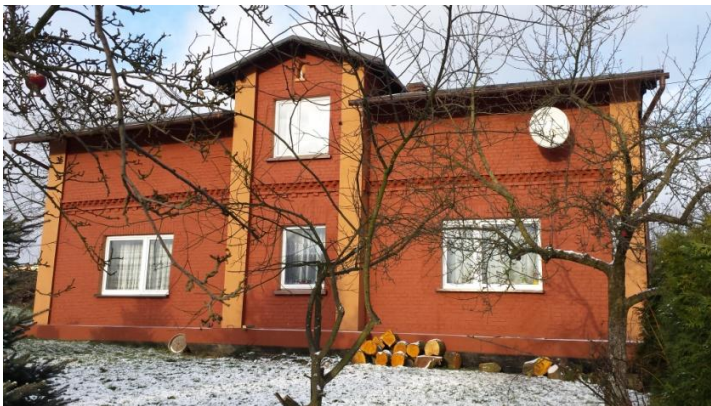
Fig. 15. Southern wall of the building # 3 (Source: own study)

the zone of strong compressions (Fig. 7). Residential building #3 has the dimensions 14.2×9.4 m and has two storeys and a basement. It was built in the 1930s using traditional brick technology, with brick foundations, wooden ceilings and a roof. Fig. 15 shows the southern elevation of the building.

It is worth mentioning that the building is reinforced at the level of the basement walls, with a reinforced concrete band at ground level; this is visible in the photograph (Fig. 15). Such prophylaxis, in the event of sinking occurring, can neutralise ground pressure on the basement walls. For tangential stresses under the footing, it may turn out to be ineffective. Fig. 18 shows the result map of stresses caused by horizontal deformations for building #3.

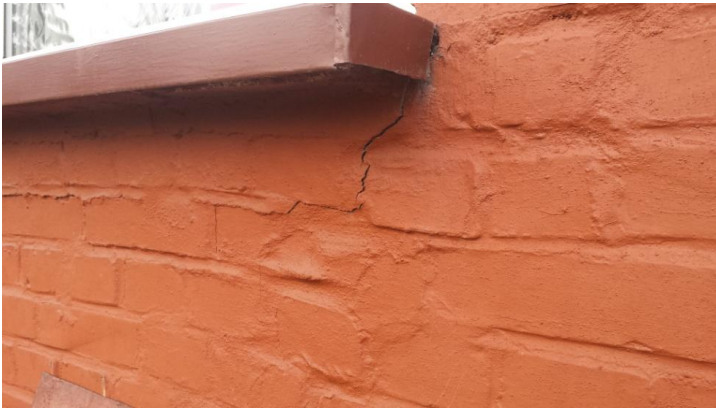
Fig. 19. Crack in the corner of the window opening of building #3 (Source: own study)

The impact of horizontal deformations caused much greater stresses than the previously analysed curvatures. Compressive stresses dominate on the presented map. They do not pose any major threat, especially for the lower, more massive walls of basements. However, it should be noted that, as in the case of the curvature of the terrain, horizontal deformations may cause some concentration of tensile stresses in the corners of the window openings. This poses a real threat to the structure. This is because scratches may form in these places. Fig. 19 shows cracks in the structure of building #3, formed after the exploitation front had passed and corresponding to the stress concentration shown in Fig. 18.
