Research paper

Earthquake protection of reinforced concrete structures with infill walls using PUFJ and FRPU systems

Arkadiusz Kwiecień¹, Ahmet Tugrul Akyildiz²

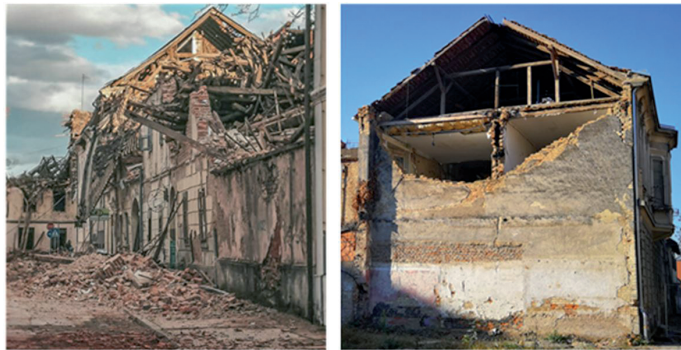
Fig. 1. The Petrinja center immediately after the earthquake in December 2020 (left) and after the removal of debris in October 2021 (right)

Historically, the Balkans are located in a seismic area where a strong earthquake occurred in 1880 near Zagreb [11], with the magnitude of $M=6.4$ – based on the seismic moment scale, corresponding to an intensity of level VIII on the European Macroseismic Scale. It resulted in numerous deaths and significant damages to the brick residential buildings and historic cathedrals. On March 22, 2020, in the morning, two tremors in Zagreb with the magnitude of $M=5.4-5.5$ (successive half an hour apart) caused numerous damages to the buildings, including the collapse of vaults and parts of towers in historic churches. Fortunately, there were no fatalities [11]. At noon on December 29, 2020, a relatively stronger earthquake struck the town of Petrinja (approx. 47 km away from Zagreb), caused 7 victims. Its magnitude $M=6.4$ was similar to this in 1880. The damage in the town was significant due to the low quality of the buildings, mostly made of brick (Fig. 1).

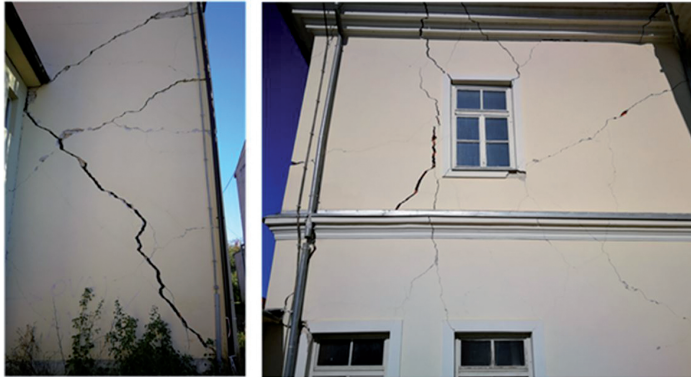
Fig. 2. Wall damage (in-plane) in the center of Petrinja (October 2021)

Damages to the masonry structures of many buildings in Petrinja were reflecting the characteristics of typical failures in the seismic areas, with the concentration of cracks in the plane of the walls (in-plane – Fig. 2) as well as damages resulted in the falling off entire fragments of the walls from the structure (outside their plane – the so-called out-of-plane), mainly in the upper parts of the gable walls (Fig. 3). The latter damage was caused by the lack of connection of the gable walls closing the attics (formed by wooden roof trusses) with stiffening structural elements perpendicular to these walls. Often, out-of-plane damage to these elements was caused by the wooden elements of the roof truss [12], hitting these walls while moving under the influence of inertia forces generated by the earthquakes (Fig. 4).

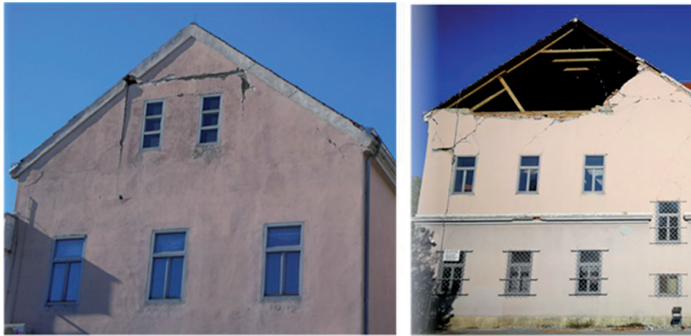
Fig. 3. A closed school building in the center of Petrinja with out-of-plane gable damage (October 2021)

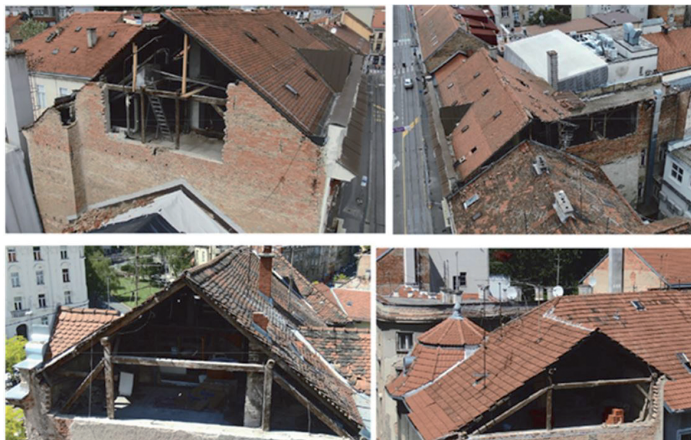
Fig. 4. Destroyed out-of-plane gable walls after the Zagreb earthquake (March 2020), caused by the impacts of wooden roof truss elements [12]

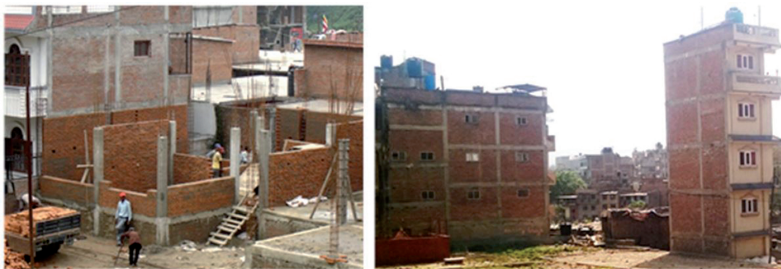
Fig. 6. Structures of buildings in seismic areas made of reinforced concrete frames with brick infill walls (Bhaktapur, Nepal – 2016)

The concept of building as reinforced concrete frame structure filled with masonry block or brick elements is common all over the world in the seismic areas (Fig. 6). First, load-bearing reinforced concrete elements (foundations, columns, beams and slabs) are constructed, and then the infills are made. These infill walls are not considered as load-bearing elements during design, but in fact they are lightly loaded with the additional vertical loads transferred by the frame. However, in the dynamic nature of such a structure during earthquakes, these walls play a role as the secondary load-bearing elements, especially in terms of stiffening the entire building [13].

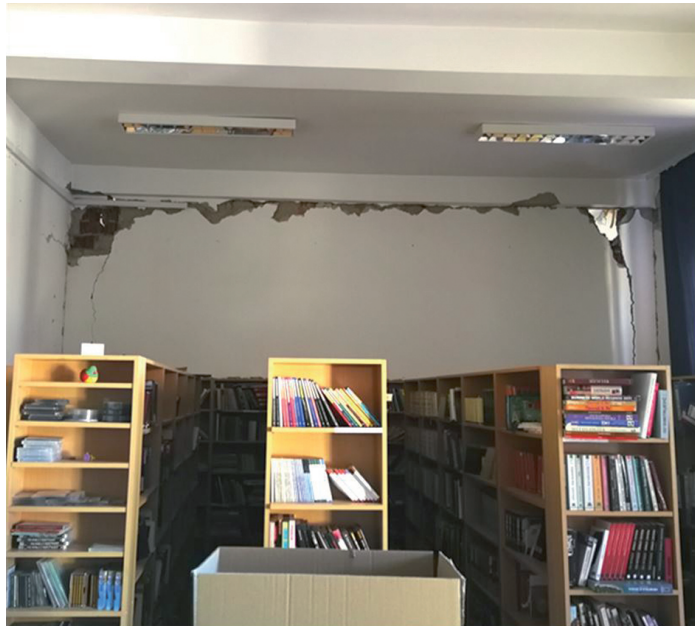
Fig. 8. Detachments at the joint of the infill wall and the reinforced concrete frame and damage to the wall corners (school in Petrinja after the earthquake in December 2020)

damage – compare the real structure in Fig. 8), and then the wall was strengthened on both sides with FRPU (rescue intervention) and tested to the maximum drift capacity. Type B was created by cutting 3 furrows 2 cm wide on the upper and side edges of the wall, which were then filled with injection PUFJ (simulation of wall protection in an existing building). In type C, the inside of the frame was first lined with 2 cm thick prefabricated PUFJ, and then the wall was built (simulation of wall protection in a newly constructed building). A detailed description of the tested elements and the performed tests is presented in [24].

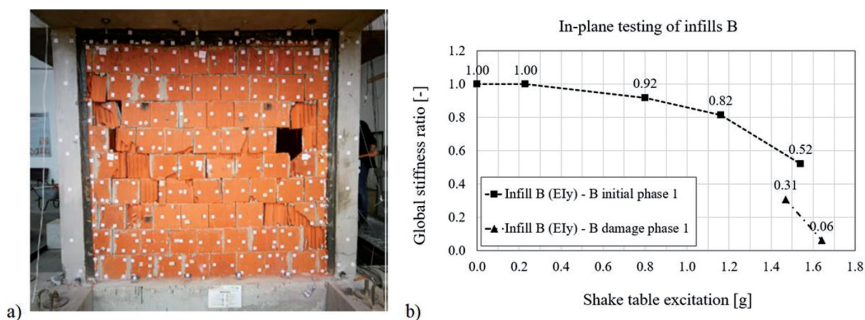
Fig. 17. Phase I: final damage to the B-type wall (a), gradual degradation of the building stiffness (b)

The subsequent phases of the experiment on the seismic table, together with the maximum values recorded during the tests, are presented in Table 2. The recorded values indicate that the PUFJ joint sustained the stability of the very badly damaged B-type walls in the plane of the frame at accelerations above 1.5 g and building drift of 3.7% (well above

the standard requirements of 2%) – Phase I. In the same phase, the C-type wall resisted the out-of-plane excitation of the same level without any damage. The global stiffness of the tested building was degraded to the level of 6% of the initial stiffness (Fig. 17b), which was caused by the work in resonance between the 2.5–4.0 Hz band, dominant in the given scaled Kefallonia 2014 seismic excitation.
