## IMAGING METHODS OF DETECTING DEFECTS IN PHOTOVOLTAIC SOLAR CELLS AND MODULES: A SURVEY

**Maurycy Maziuk, Laura Jasińska, Jarosław Domaradzki, Paweł Chodasewicz**

### Abstract

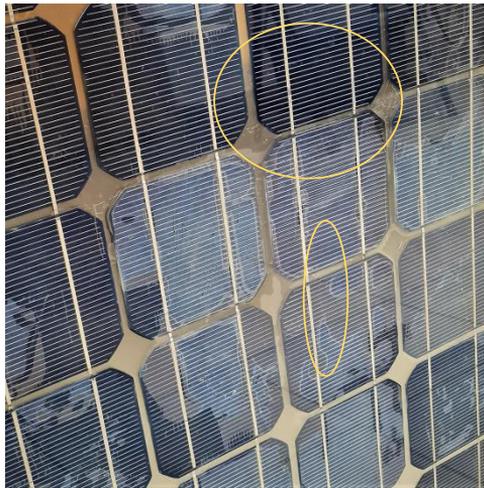
Fig. 2. Delamination of the photovoltaic panel on its surface.

Delamination consists in the loss of cohesion of individual component layers of a solar panel, which can lead to a notable loss of efficiency. It applies to both glass, front and back active area, and also encapsulation. Delamination is easily detectable not only with specialized imaging methods but also during visual inspection. It can appear during production, *e.g.* as a result of a too long/short burnout process, in conservation/storage, but also during transportation or installation and finally during exploitation itself. The appearance of delamination ends up in a lack of separation from external conditions, which can lead to the penetration with water or pollution, resulting in contact corrosion, short circuits of wires, or changes in the cell surface absorption coefficient due to the presence of moisture. An exemplary image of the delamination in a solar panel is presented in Fig. 2.

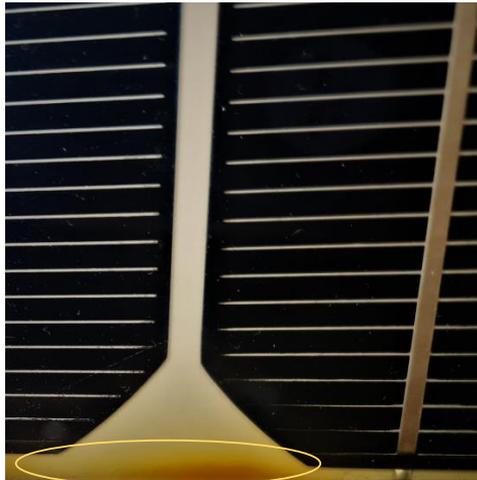
Fig. 3. Yellowing of the EVA film on the photovoltaic panel.

The discoloration of the *ethylene-vinyl acetate* (EVA) foil is one of the most common defects found in PV panels (Fig. 3). Its causes can be wrong manufacturing process (poorly conducted encapsulation process, improper cleaning of the surface of the tempered glass on which the film is applied) or the properties of the material from which the film was made (improperly selected manufacturing parameters) [8]. Depending on the degree of severity, discoloration of the EVA

film can have a different impact (negligible or significant) on cell performance. The reason for this is the change in the absorption coefficient of the surface, which is a direct effect of the presence of discoloration, which can occur over the entire surface of the cell.
