Research paper

Slope stability analysis of post-mining dumps with the use of photogrammetric geometry measurements – a case study

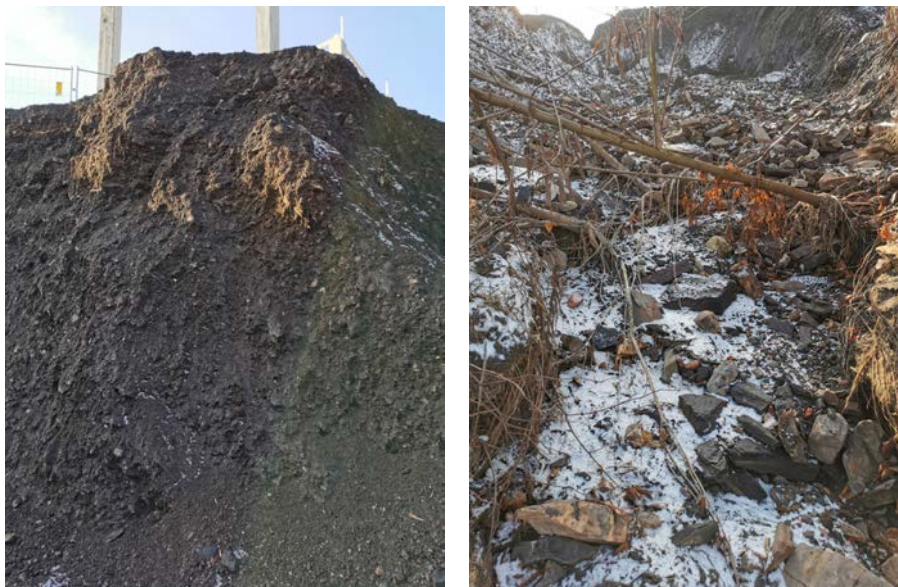
Fig. 1. Various fractions visible in the failure zone (P2 in Fig. 2a), photo. M. Kowalska

Macroscopically the dump consists mostly of fine soils, claystone, sandstone and black unburnt carbonaceous shale with grading ranging from clayey to boulder fractions (Fig. 1), indicating that the waste contains probably the material from the main production and enrichment processes (e.g. washery) [25]. The grains and rock fragments are angular with visible fissility and hard coal occurrence.

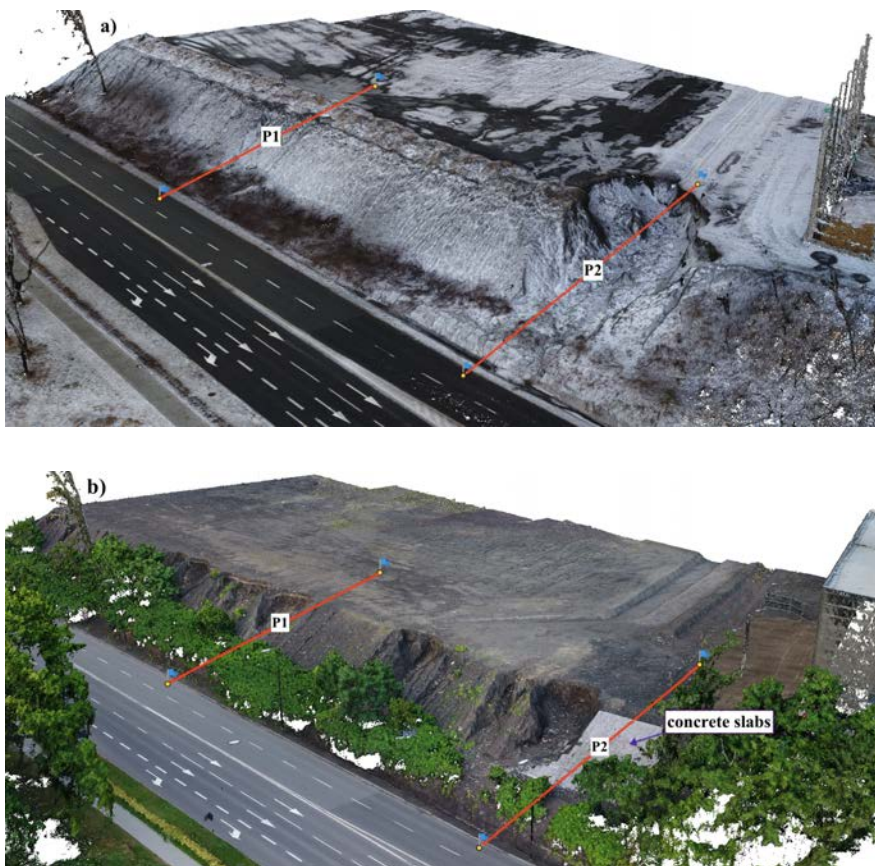
Fig. 2. 3D visualization of the research area: a) 1st measurement (01.2022),
b) 2nd measurement (06.2022)

The measurements were conducted twice: in January 2022 and June 2022. In both cases, the post-processing stage included alignment of the photos and matching them to the ground control points (tracked using GNSS). As the result a cloud of points with the density of 500 points/m² was generated. The obtained 3D models of slopes with two characteristic cross-sections P1 and P2, used in the further analyses, are shown in Fig. 2.

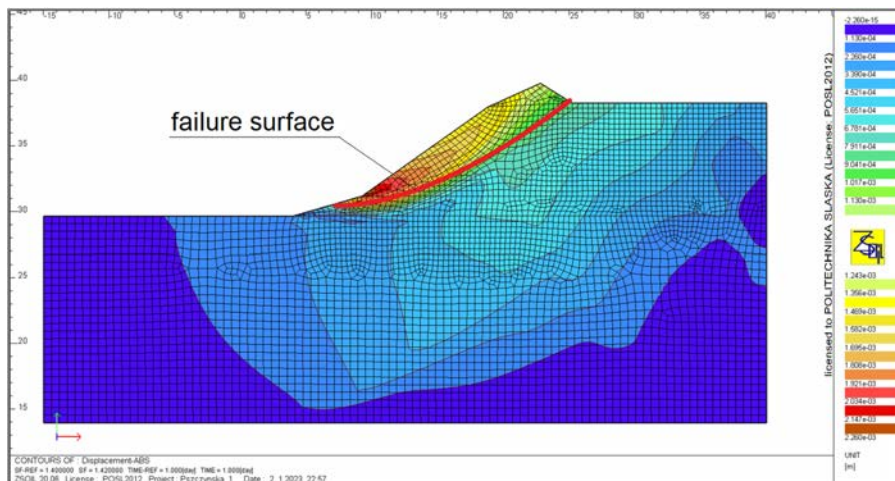
Fig. 6. Map of absolute displacements at the time of failure ($F_s = 1.42$)

The results of the slope stability analysis at $\Delta\text{GWT} = 8$ m and rainfall intensity (RI) of 0.04 m/d are shown in Fig. 6. The obtained factor of safety is equal to $F_s = 1.42$. This means that at the favourable atmospheric conditions (just light rainfall) the slope remains stable, even if the water table difference is relatively high. The shape of the failure surface is similar to the one observed in the photogrammetric measurements in June 2022 (relatively shallow, not reaching below the toe of the escarpment).
