TASKS AND PROBLEMS IN THE BUILDINGS DEMOLITION WORKS: A CASE STUDY

Keywords: demolition works, the risk, construction project, legal regulations

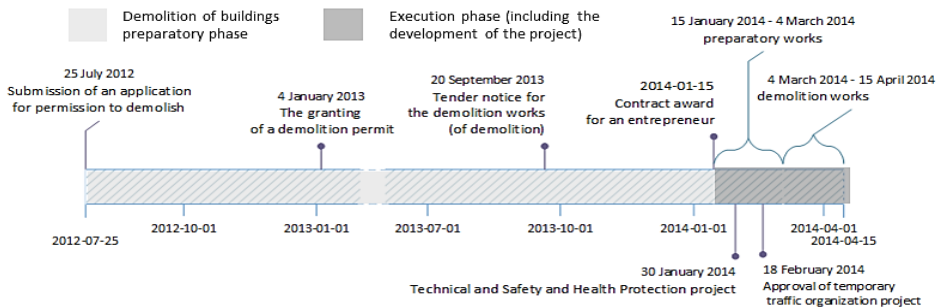
Fig. 2. The course of the investment process of demolition "Rainbow" in Cracow, Source: own work

The preparation phase from the submission of the application to the contract awarded to the entrepreneur lasted 21 months. The execution of the demolition, including the development of the technical design, fencing and site preparation for parking - less than 3 months (Fig. 2).

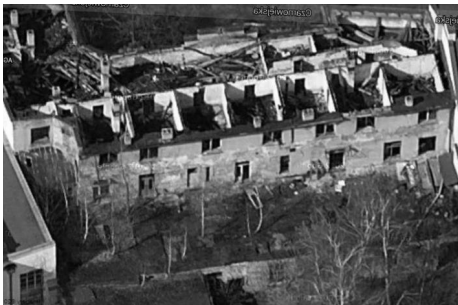
Fig. 3. The top view of the complex of the dry cleaning service "Rainbow" before the demolition, after the fire, around 2012, Source: googlemaps, 06.03.2014]

In the winter of 2011 a fire broke out in the tenement, it was caused by homeless people living there. The fire damaged the building heavily, the roof collapsed, and destroyed the second floor of the building (Fig. 3). During this time the demolition works of individual elements of the laundry-service

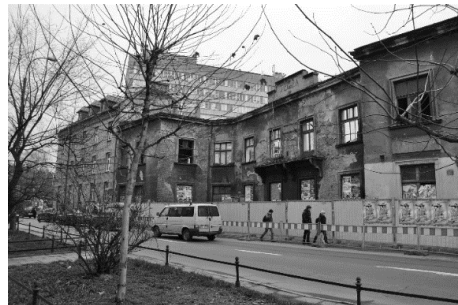
Fig. 4. The view from the Czarnowiejska street on the right wing of the laundry service building "Rainbow", Source: own photo, 06.03.2014

complex had been already conducted by the Investor (AGH University). In June 2013, only the front building remained, visible directly from the Czarnowiejska Street (Fig. 4).

The external walls of the laundry service with a thickness of 45 cm were made of solid brick, combined with lime mortar, anvil-laid thread. Internal walls consisted mostly of wooden boards covered by clay on reed, which was directly applied to the plaster. The floors were made of wooden beam construction or reinforced concrete. Land property was armed in the following networks: water supply, sanitary sewer, storm water and energy network, as well as a central heating network.

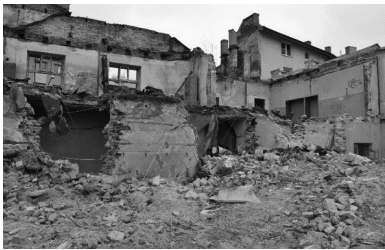
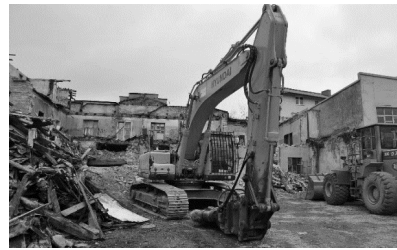
Fig.5. The laundry building "Rainbow" demolition, Source: own photo, 03.2014

Stages of demolition of building	Data
Taking over the site by the demolition company	15.01.2014
Submission of appropriate proposals for demolition works (e.g. permit to exclude sidewalk for the duration of the works, permit to transport heavy equipment, permit to disconnect the media, etc.).	30.01.2014 – 18.02.2014
The construction site area development plan, among others: isolation of the construction site, permanent disconnection of the outdoor-installation powering the facility, marking roads of their run near the active power and water installations, designation of a security zone, preparation of directions and stations for the work of heavy equipment, the designation of a temporary storage place for debris, scrap metal and other materials from the demolition, isolation of the danger zone from the Czarnowiejska Street.	28.02.2014 – 04.03.2014
Demolition works, including: demolition of the outbuildings from the yard, mechanical demolition of the upper floor to the ground level, the demolition of brick walls on the ground floor and the first floor, the demolition of the foundation walls, insulation of heavy foundations and basement foundation walls of the building B7, curing the area, construction leveling layers on the walls of buildings adjacent to the object [Fig.5]	04.03.2014 – 15.04.2014

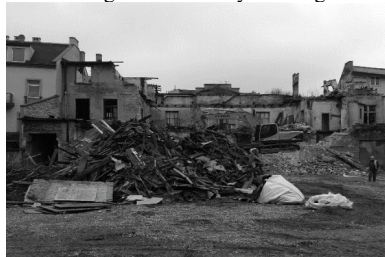
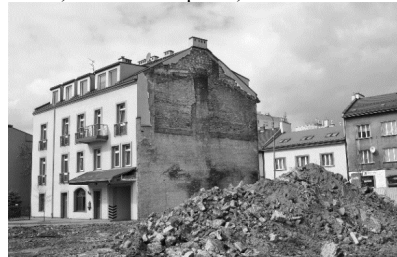
Fig. 6. The segregation of materials from the demolition of the building, Source: own photo, 03 - 04.2014

Segregation of the demolition materials, among others: preliminary debris crushing with steel reinforcement separation, segregation of the demolition materials with cutting into sections to transport, export of the waste materials [Fig. 6]	10.03.2014 – 01.04.2014
Ordinal and finishing works, among others: trimming and leveling the site, hardening the area, (the) execution of the facade on the buildings adjacent to the tenement under the demolition	01.04.2014 – 15.04.2015

The demolition works were entirely mechanized. During the works at the construction site, there was a working group consisting of two operators of heavy equipment, foreman and three unqualified workers, who successively led the segregation of waste and the material loading.

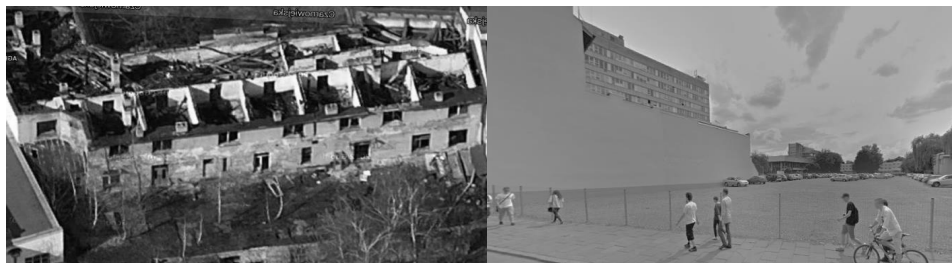
Rys.2. Widok z góry na kompleks pralni chemicznej „Tęcza” przed wyburzeniem, po pożarze, około 2012 [źródło: googlemaps, 06.03.2014] ; Obecnie funkcjonujący parking w miejscu po pralni
