# Fatigue assessment of existing riveted truss bridges: case study

T. SIWOWSKI\*

Roads & Bridges Department, Rzeszow University of Technology, 12 Powstańców Warszawy Ave., 35-959 Rzeszów, Poland

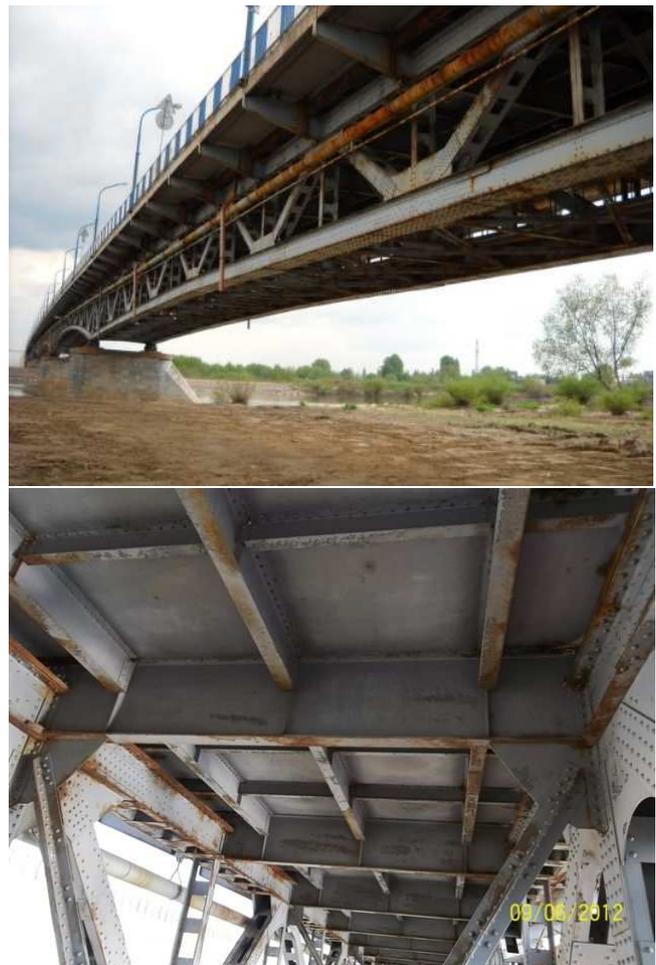
Fig. 1. The existing riveted truss bridge and its deck system

depth from 3.10 m (span) to 5.70 m (support). The girders are braced with the riveted cross-beams on which the deck grid is supported, made up of the longitudinal stringers and the secondary cross-beams. The rolled stringers are locally stiffened with welded ribs and there are the only welded joints in the structural system. The grid is covered with the 10-mm stay-in-place steel pan form connected to the grid with rivets and filled with asphalt concrete. The conventional two-course surface is placed on the deck. The total width of the deck is 6.45 m. The concrete bridge supports are founded on caissons (pillars) and driven wooden piles (abutments).

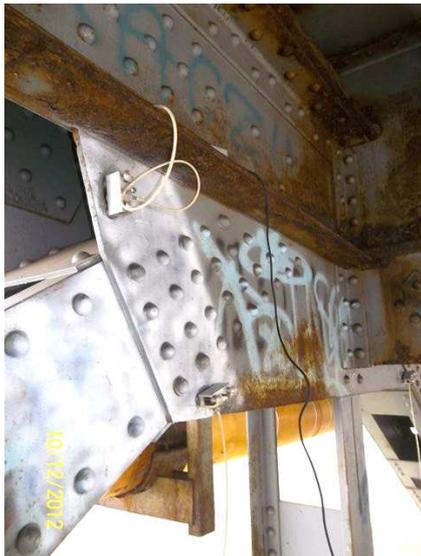
The main goal of the quantitative NDT inspection was to identify “active” cracks propagating under service load and posing a risk to the bridge. Therefore the acoustic emission technique (AE) was chosen as the best method for “active” as well as subsurface cracks (Fig. 7). Since the probability of crack detection increases by loading the examined members with a high but still admissible load on the bridge which results in opening possible cracks, the testing has been carried out under normal traffic on the bridge. The applied method relies on the analysis of acoustic waves generated by active destructive processes that develop in a bridge under service loads [19, 20]. The signals received by the acoustic sensors located on the structure are compared with reference signal database compiled beforehand for specific destructive processes. Thus identified destructive processes are located due to the analysis of differences in time-of-arrival of signals at individual sensors. Identification and location of active destructive processes provides a basis for monitoring which makes it possible to evaluate the technical condition of a bridge. The advantage of the method lies in the fact that it is possible to space sensors in such a way that their measurement ranges cover the whole of the examined bridge structure.

Fig. 7. Acoustic sensors mounted on the gusset plate of the critical diagonal

The intensive AE testing campaign revealed, that a few fatigue microcracks could be initiated in the vicinity of the gusset plates in the truss members [21]. The corrosion destructive processes in riveted connections were also identified as the potential source of microcracks. The signals received by the acoustic sensors indicated that cracks were active only under heavy traffic (lorries). Despite the small number of recorded signals, it is highly probable that fatigue microcracks will propagate in the near future. The most severe destruction was discovered in the members located close to the bridge expansion joints, which are in very bad state of repair. It may constitute a threat when no maintenance measures are implemented on the bridge in next 10 years of required service life.

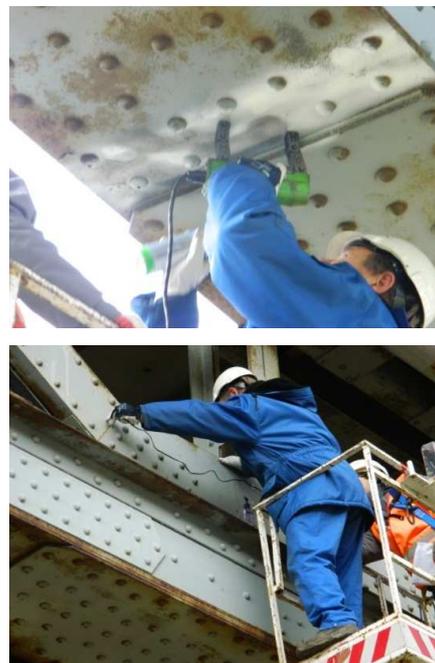
The qualitative NDT inspection of the critical members and cross-sections was carried out by means of magnetic particle inspection (MT) as well as ultrasonic testing (US). The

first method was used to detect any surface cracks of questionable cross-sections. This method is of high accuracy so very small surface cracks can be detected if the surface has been prepared thoroughly. All surfaces under consideration were cleaned with a wire brush. Since the method is not applicable for subsurface damage, the testing extension by means of ultrasonic inspection was required. It is the only method to detect the crack depth and size needed in the prospective fracture mechanics calculation. The commercial ultrasonic equipment with adapted ultrasonic sensors and the oscilloscope was used for inspection (Fig. 8). All hot spots in the rolled sections (stringers) and gusset plates in riveted connections of diagonals were accurately checked against cracks. However, no cracks were found in this comprehensive inspection campaign.

Fig. 8. The qualitative NDT inspection of the critical members and cross-sections
