J. KRAWCZYK*, M. WITASZEK**, K. WITASZEK**

TRIBOLOGICAL PROPERTIES OF TYRE STEEL IN ROLLING-SLIDING CONTACT AGAINST BAINITIC RAIL STEEL

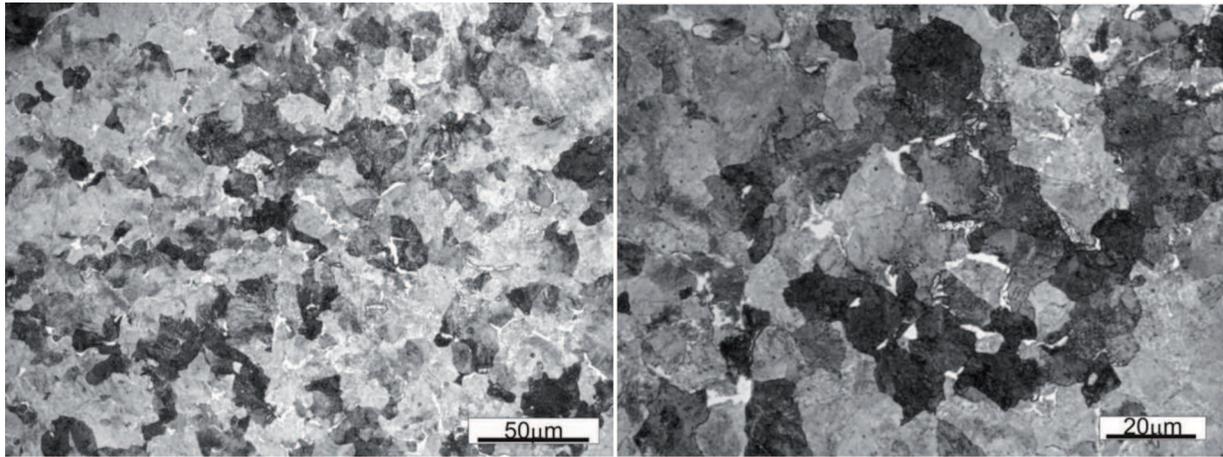
Fig. 1. Microstructure of the tested tyre steel

of a pearlitic microstructure with ferritic precipitates on grain boundaries (Fig. 1). In the range of optical microscopic observations the microstructure of the bainitic steel shows morphologic features of the upper bainite. Nevertheless the bainite transformation temperature and the M_s one enable to conclude that such microstructure have not to show significantly lowered fracture toughness [10]. During tribological tests it was in contact with the bainitic rail steel of the chemical composition and hardness presented in Table 2 and of the microstructure shown in Figure 2.

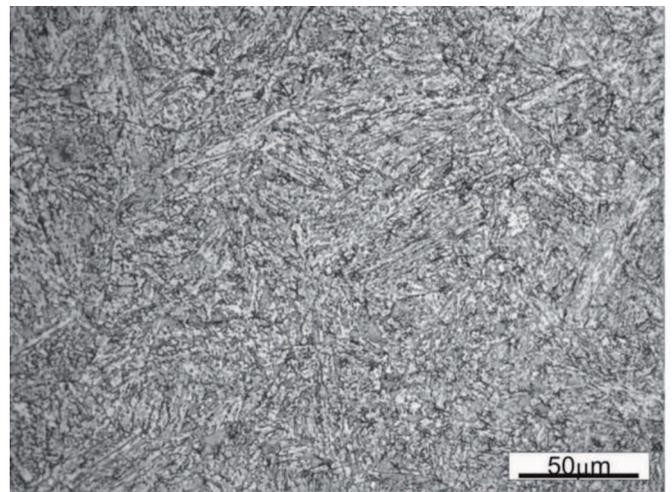
Fig. 2. Microstructure of the bainitic rail steel

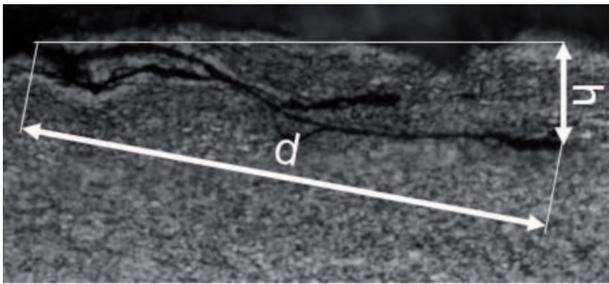
Fig. 3. Crack length (d) and depth (h) determination

when cracks were observed, their length and depth was found (Fig. 3).

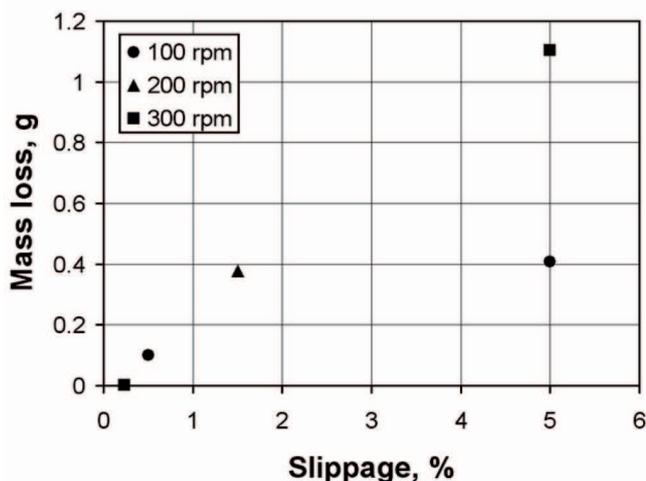
Fig. 4. Mass loss of specimens made of the B6 steel after 72,000 revolutions

The selection of the slippage and rotational speed values was based on data concerning conditions of wheels and rails operation [1, 11]. The results of investigations of the slippage and rotational speed influence on the specimens wear after the tribological tests are presented in Figure 4. In a similar fashion, the slippage and rotational speed influence on the friction coefficient is presented in Figure 5. Since the influence of the rotational speed on wheel tread and flange wear was studied there are results for maximum as well as minimum speeds, both for low and high slippage. These results are completed by another one for intermediate slippage as well as speed. It can be observed that the increased slippage facilitates the tyre steel wear. It should be emphasized that increasing of the rotational speed intensifies this influence. Similarly the increased slippage increases the friction coefficient, whereas, the increased rotational speed seems to have a smaller influence. The reason

ening. The results of the mass loss measurements at a low rotational speed seem to indicate just that (Fig. 4).

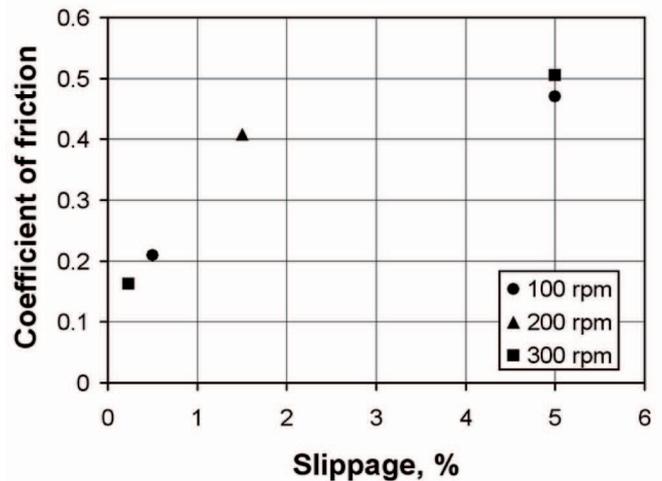
Fig. 5. Coefficient of friction vs. slippage and rotational speed

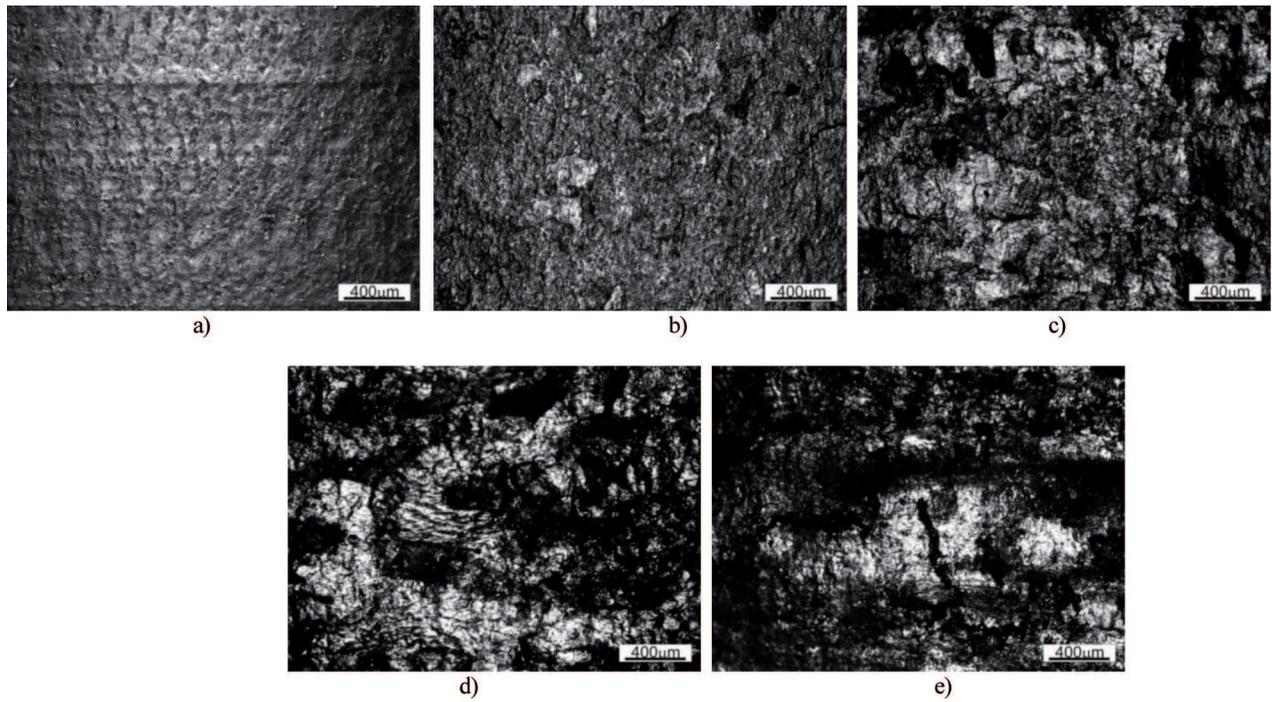
Fig. 6. Surface of tyre steel specimens after tribological tests: a) slippage 0.23%, rotational speed 300 rpm; b) slippage 0.5%, rotational speed 100 rpm; c) slippage 1.5%, rotational speed 200 rpm; d) slippage 5%, rotational speed 100 rpm; e) slippage 5%, rotational speed 300 rpm. The longer side of the photo is perpendicular to the ring axis and parallel to the material flow direction

The surface appearance of the specimens after these tests is presented in Figure 6. When the slippage increases the surface development after the tribological test also increases. At the smallest slippage small cavities and corrugation occurs. A larger slippage promotes gap formations which can indicate the adhesive wear and plastic flow of the material. When the slippage equals 1.5% and 5% the adhesive wear is very intensive (Fig. 6c-e).

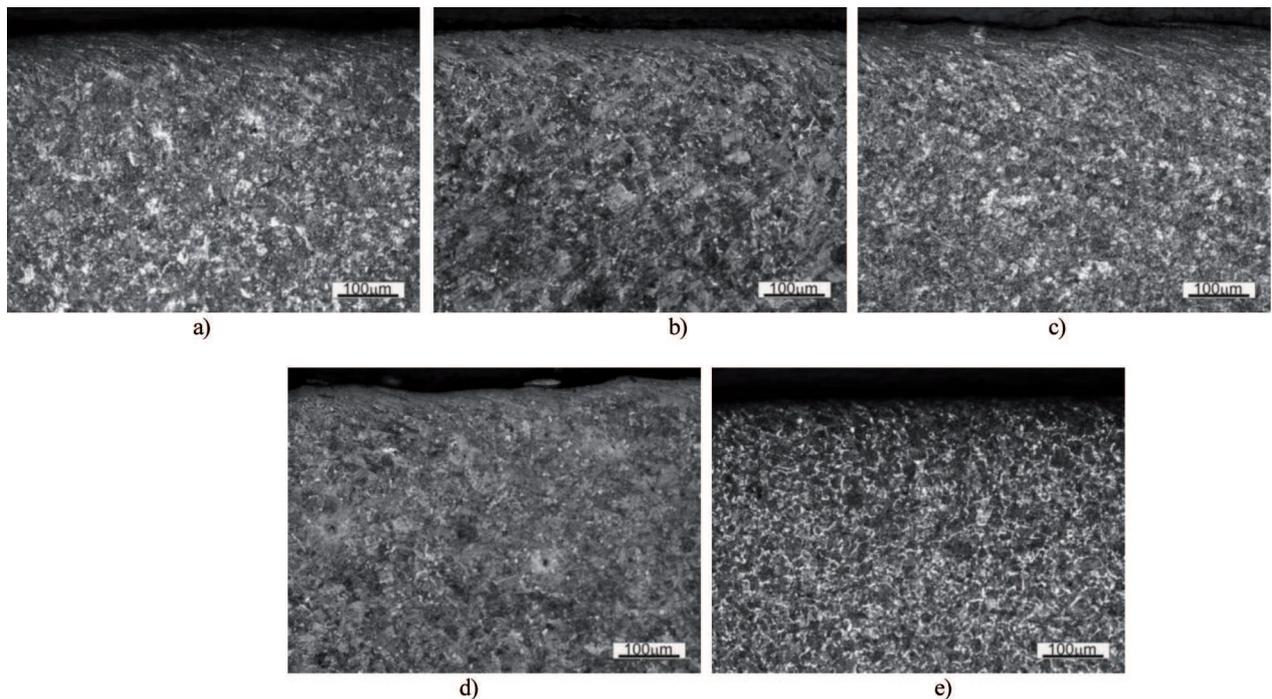
Fig. 7. Morphology of the near-to-surface layer of specimens made of the tested tyre steel (after a tribological test). The cross-sections were made parallel to the rolling direction: a) slippage 0.23%, rotational speed 300 rpm; b) slippage 0.5%, rotational speed 100 rpm; c) slippage 1.5%, rotational speed 200 rpm; d) slippage 5%, rotational speed 100 rpm; e) slippage 5%, rotational speed 300 rpm

Metallographic observations of the parallel cross-sections were performed to determine the thickness of the plastically deformed – due to the tribological test – layer (Fig. 7). This thickness was measured in the micrographs as the depth under the specimen surface at which the microstructure seems to be undeformed. The final result is an average from 10 measurements. Observations were carried out in places where there were no cracks in order to characterise the plastically deformed layer without effects related to the crack propagation. This enables to analyse the deformation state in the surface layer. The averaged results of the plastically deformed layer thickness are presented in Figure 8. This thickness increases when the slippage increases from 0.23% to 1.5%. It corresponds to the mass loss and friction coefficient increase. Thus, the 1.5% slippage increases the plastic deformations zone and also the intensity of such deformations, which supports a higher mass loss of the tyre steel. As the result of the higher mass loss at the slippage of 5% the material is being removed so intensely that the plastic deformation zone is even decreasing, at a low rotational speed. There is also a possibility that the increased slippage cumulates the plastic deformation in the thinner near-to-surface layer, which can strengthen it more intensely than wear.

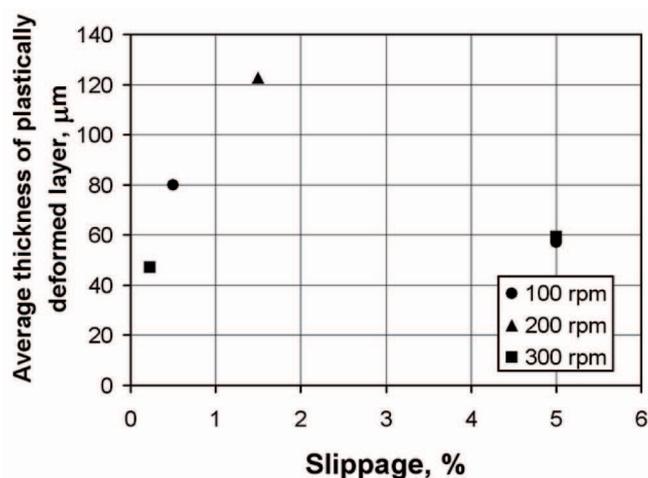
Fig. 8. Average thickness of plastically deformed layer after tribological tests

Inversely, the smaller slippage increases the plastic deformation zone but the intensity of deformations is smaller which more influences the wear than strength-

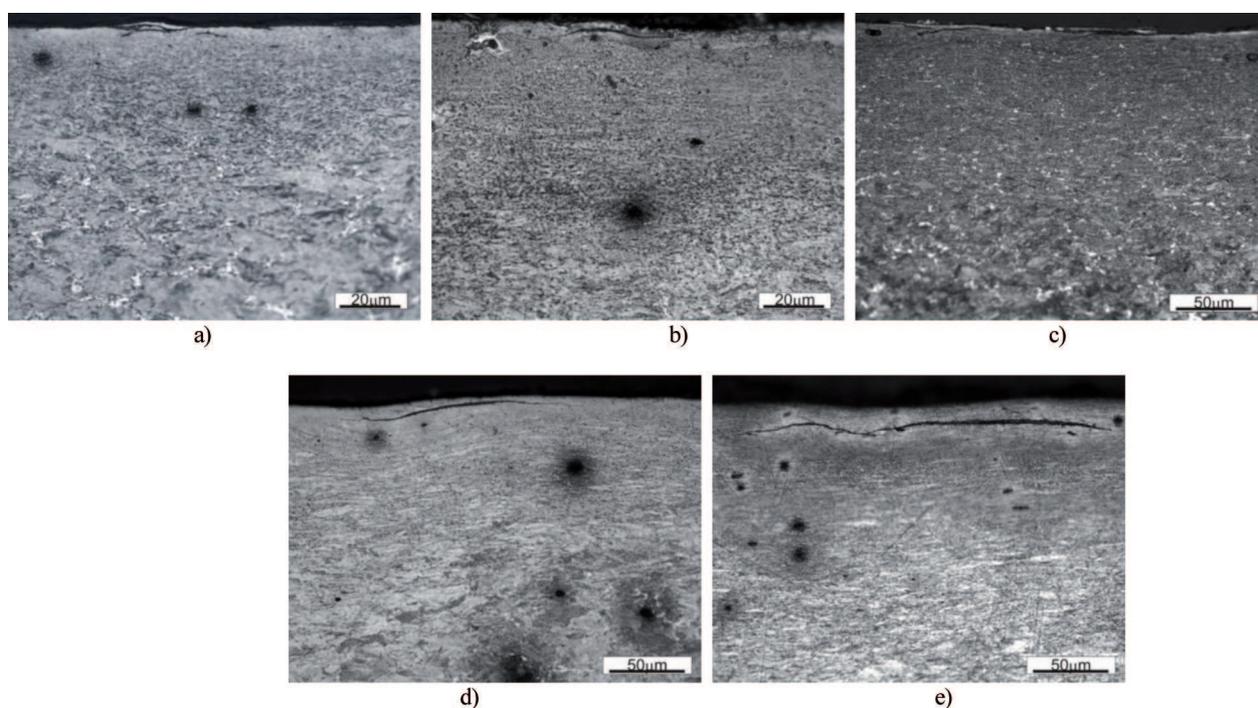
Fig. 9. Morphology of the near-to-surface layer of specimens made of the tested tyre steel (after a tribological test). The cross-sections were made perpendicular to the rolling direction: a) slippage 0.23%, rotational speed 300 rpm; b) slippage 0.5%, rotational speed 100 rpm; c) slippage 1.5%, rotational speed 200 rpm; d) slippage 5%, rotational speed 100 rpm; e) slippage 5%, rotational speed 300 rpm

The analysis of the cracks morphology was performed on the polished sections perpendicular to the direction of the specimen motion (Fig. 9). Magnifications applied in the analysis of the surface layer were selected in a way enabling the clear and complete illustration of the cracks morphology. Such observation geometry allowed for a more precise analysis, especially of crack depths. The averaged length and depth of cracks are illustrated in Figures 10 and 11. Cracks were found for all tested slippages and velocities. Usually the crack

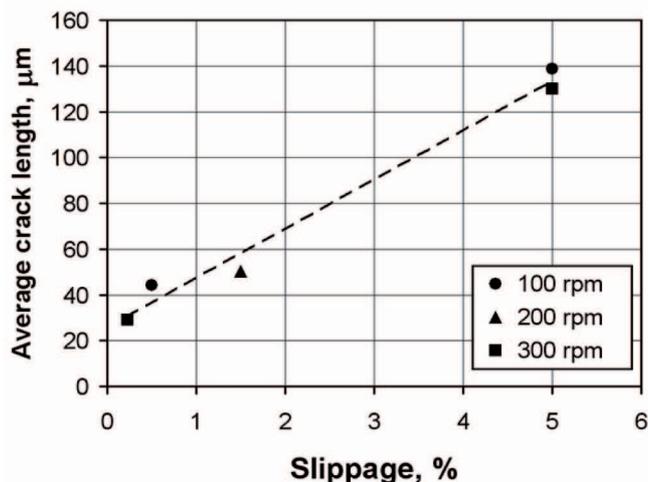
Fig. 10. Average crack length in near-to-surface layer after tribological tests

length increase corresponds to the increased mass loss in dependence of the applied slippage and rotational speed values. It can be observed, that the slippage value has a decisive influence on the crack length, regardless of the applied rotational speed. However, the crack depth does not show such simple dependence, since in this case the rotational speed starts to have an influence. This should correspond to the previously described influence of the slippage and rotational speed on the wear intensity and the surface layer strengthening. The crack depth should be first of all related to the position of the largest tangent stresses point. This point will move farther inside the material when the surface layer will be wearing (its distance from the surface should not be changing a lot), while the slippage increase will shift this point towards the specimen surface [12]. However, the degree of the surface layer deformation, which – in these tests – was determined only indirectly, should be also taken into account in the considerations. It explains why the crack depth, in case of a small rotational speed, seems to be independent from the slippage (a small increase of a mass loss when the slippage increased). However, an increase of crack depths, in case of a high rotational speed, still requires explanations. It is probable that this increase is related to the intensity of the crack propagation into the material, dependent on the surface layer strengthening (which – in turn – depends on the rotational speed).

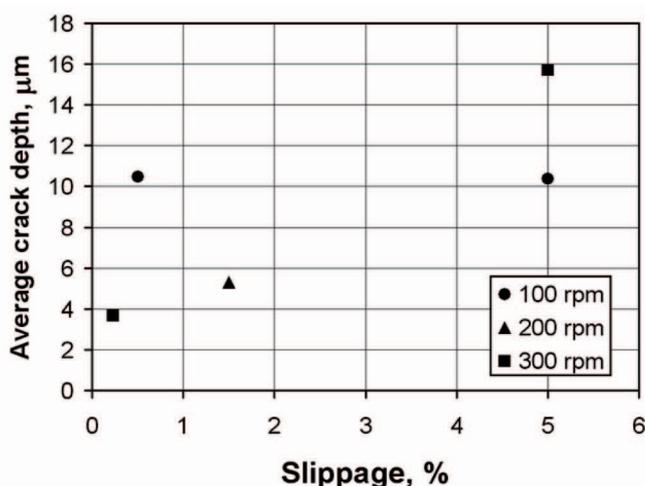
Fig. 11. Average crack depth in near-to-surface layer of the tested material
