The Quality of Welded Connections Elements from the Steel 30HGS and Titanium Alloy Ti6Al4V

Abstract

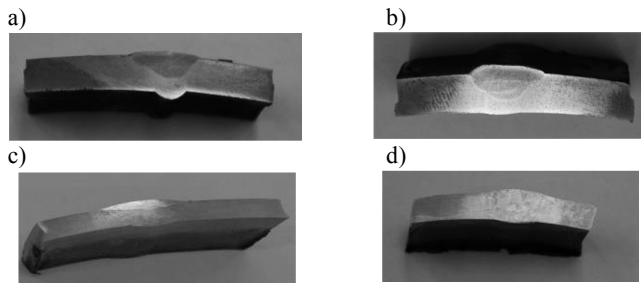
Fig. 2. The metallographic specimens for testing SEM; a-b) from steel 30HGS, c-d) from titanium alloy Ti6Al4V

The testing material was the 30HGS steel and titanium alloy Ti6Al4V, used on the pressure containers in armaments technique. The aim of that work was the analysis of welded head connections one-sided made from the materials mentioned above. The welding was done with GTAW method, in the protection of argon. The welds were applied twice (one on the other) in the titanium alloy and three times in the steel. The heat treatment was done according to the recommendations included in the standards. The part of that container from the steel 30HGS, from which the samples were cut, were presented in the Fig. 1 whereas Fig. 2 presents the view of metallographic specimens done from the cut material.

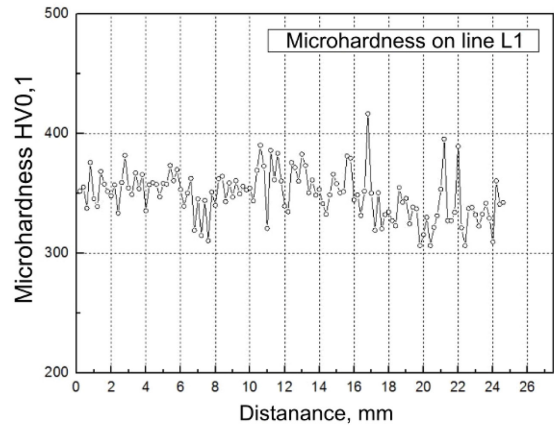
Fig. 4.1. Microhardness HV0.1 calculated along the measuring line L1 for the steel 30HGS

The microhardness measurements done along the measuring line L1 showed higher hardness of the titanium alloy in compares to the steel (Fig. 4.1-2). There was no significant decrease/increase of microhardness in the area of HIZ of the weld.

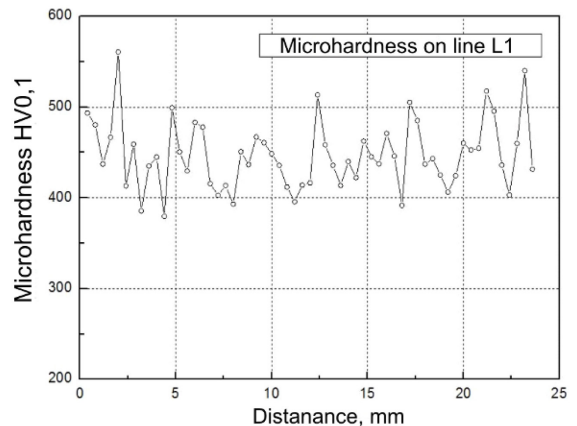
Fig. 4.2. Microhardness HV0.1 calculated along the measuring line L1 for the titanium alloy Ti6Al4V

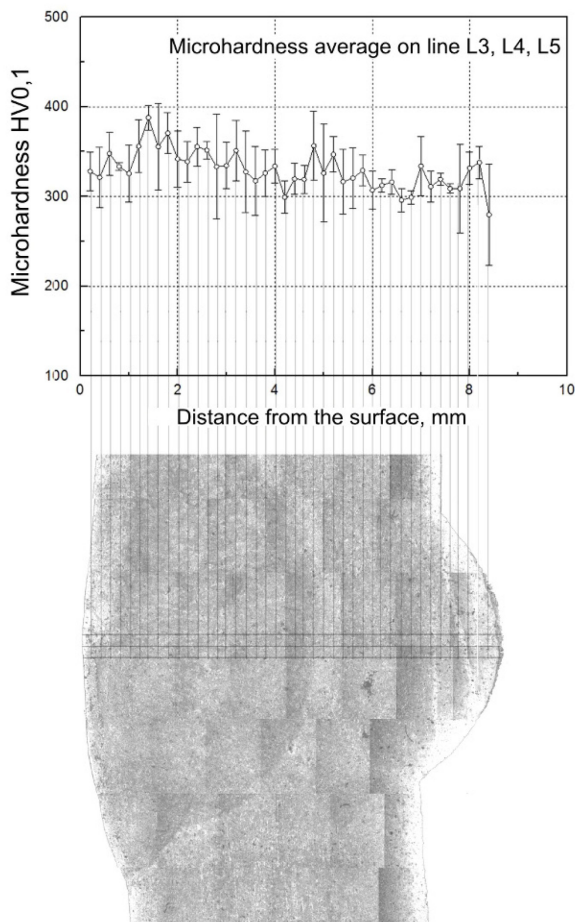
Fig. 4.3. Average microhardness HV0.1 calculated from the measurement lines L3, L4 and L5 for steel 30HGS

It appears from the average microhardness curve calculated from measuring lines L3-L5 (Fig 4.3) that the average value of microhardness on the head connection of the 30HGS steel was about 320 HV0.1. There was no significant decrease/increase of microhardness in HIZ marked one by one of the weld stitches. In the titanium alloy Ti6Al4V (where the double stitches were put) the average value of microhardness in the first weld stitch was about 300 HV0.1 and in the second about 445 HV0.1. The increase of microhardness within the area of HIZ of the first weld stitch was observed. (Fig. 4.4).

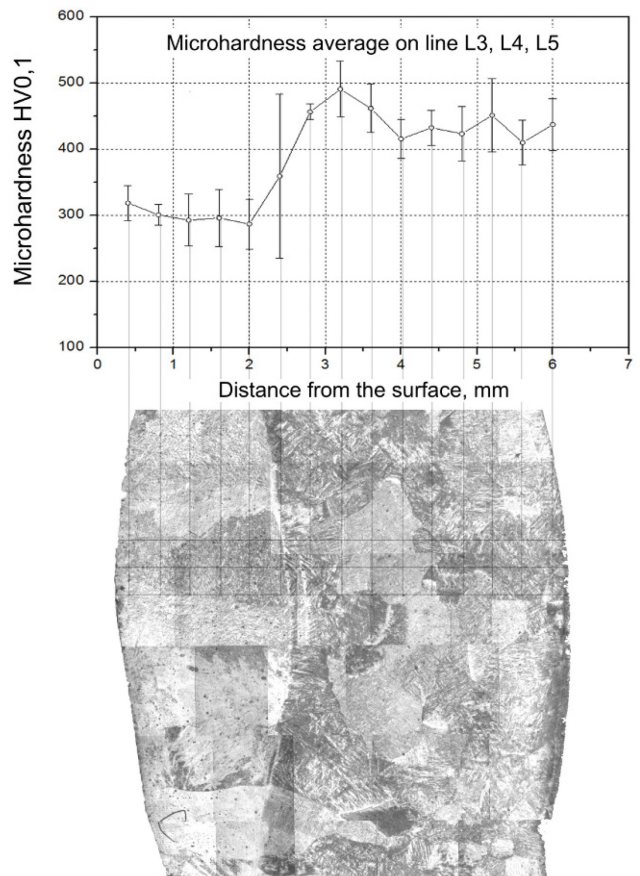
Fig. 4.4. Average microhardness HV0.1 calculated from the measurement lines L3, L4 and L5 for titanium alloy Ti6Al4V

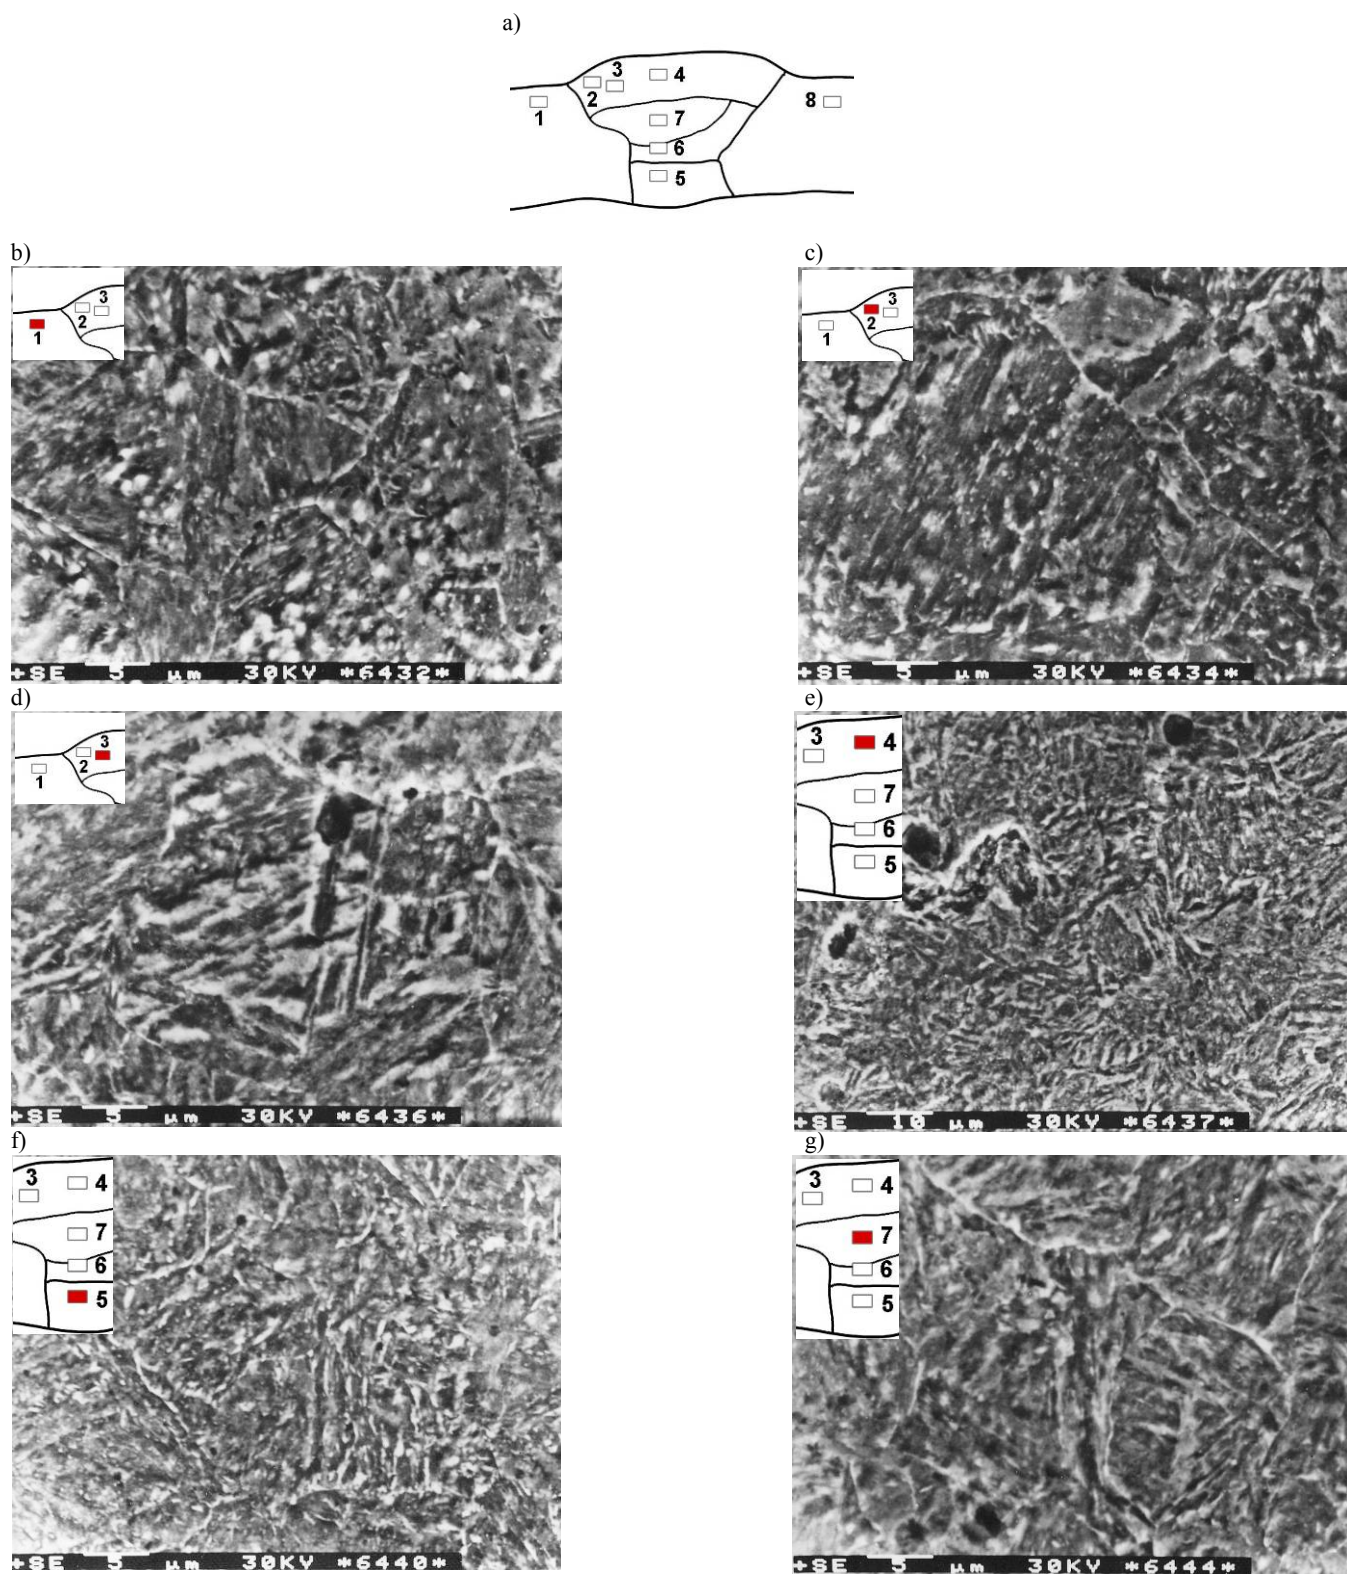
Fig. 5. a) scheme of the weld microstructure observation places of the steel 30HGS, b-g) microstructure of 30HGS steel with marked places on the scheme

The microstructure of the heat influence zone (HIZ) of the head weld 30HGS steel are the products of bainite transformation, on the grain borders of the former austenite there is a light net of carbides phase visible, inside the former austenite, locally there are fine carbides visible of the diameter below $0,5 \mu\text{m}$. The average diameter of grains of the former austenite was about $10-15 \mu\text{m}$ (Fig. 5b). In the remelting zone (RZ) of head weld of the steel, there is a structure made due to the primary crystallization and further heat treatment. Locally there is a net of carbides visible on the borders of the crystals of the primary phase, the matrix is bainite with fine sintered carbides (Fig. 5c). There are non-metallic partial division and gas bubbles visible in the remelted zone in the Fig. 5d,e of the size about $5 \mu\text{m}$. The microstructure of the bottom area of the weld (in the remelting zone) - Fig. 5 f,g is consisted with light net of the carbides phase on the grain borders, inside of the former austenite there are tiny carbides visible below $0,5 \mu\text{m}$.

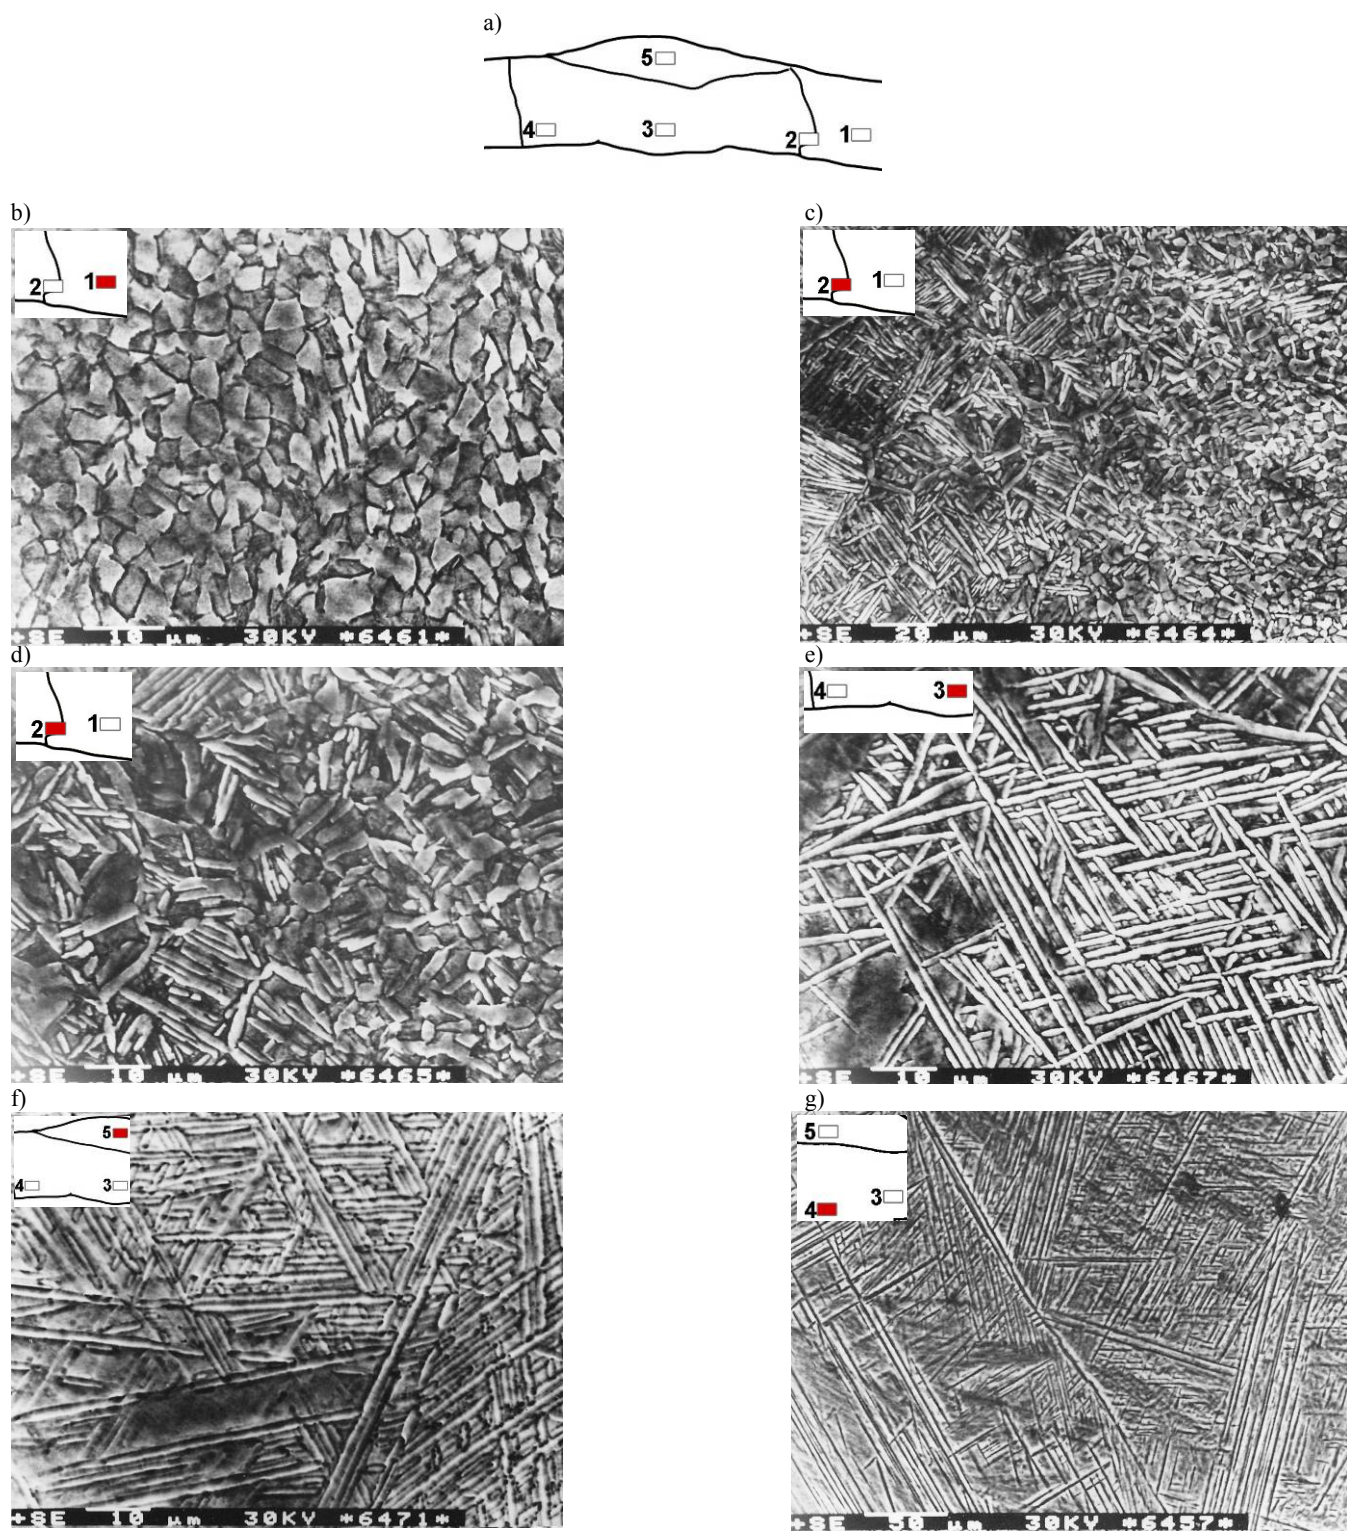
Fig. 6. a) scheme of the microstructure observation of the titanium weld alloy Ti6Al4V, b-g) microstructure of the Ti6Al4V titanium alloy with marked places on the scheme

The microstructure of the titanium alloy Ti6Al4V in HIZ the welds were consisting of phase α and β of the grain size about $5 \mu\text{m}$ (Fig. 6b). There is a visible weld structure on the border of RZ and HIZ in the Fig. 6c,d. On the right there is a heat influence zone with phase α and β and on the left there is a remelting zone, where the coarse plate of α phase and β phase are visible (Fig. 6.e,f). In the remelting zone of the weld there are also single occasional non-metallic partial division and gas bubbles observed.

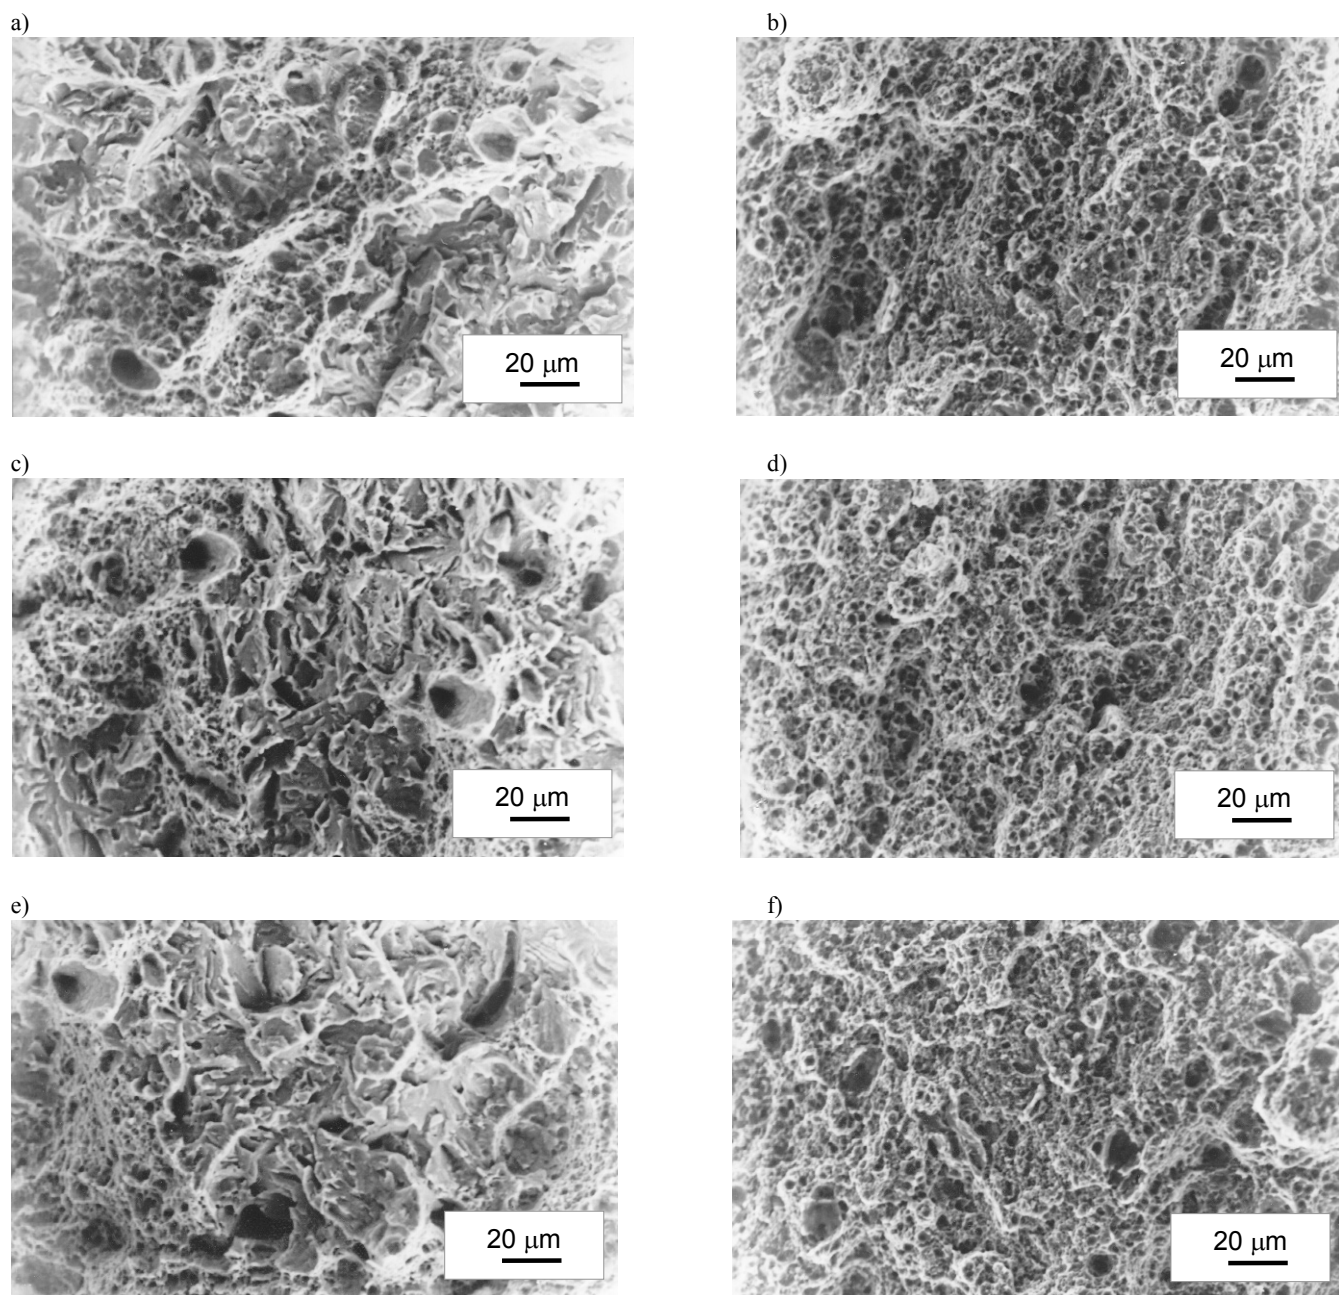
Fig. 7. Fracture of 30HGS steel; a, c, e) of basic material, b, d, f) in the weld, remelted zone

The fractographic research shown the presence, in the basic material of the 30HGS steel mixed fracture: transcrystalline ductile and transcrystalline brittle, whereas (Fig. 7a,c,e). There was a transcrystalline ductile within the remelting zone of the steel weld (Fig. 7.b,d,f). In case of the Ti6Al4V titanium alloy, both in the basic material and within the remelting zone of the weld there was a transcrystalline ductile fracture (Fig. 8a-f). There is a fact worth mentioning, that in both cases: steel and titanium alloy, the pits was visible on the fracture have lower diameter within the weld (in compares to the basic material).

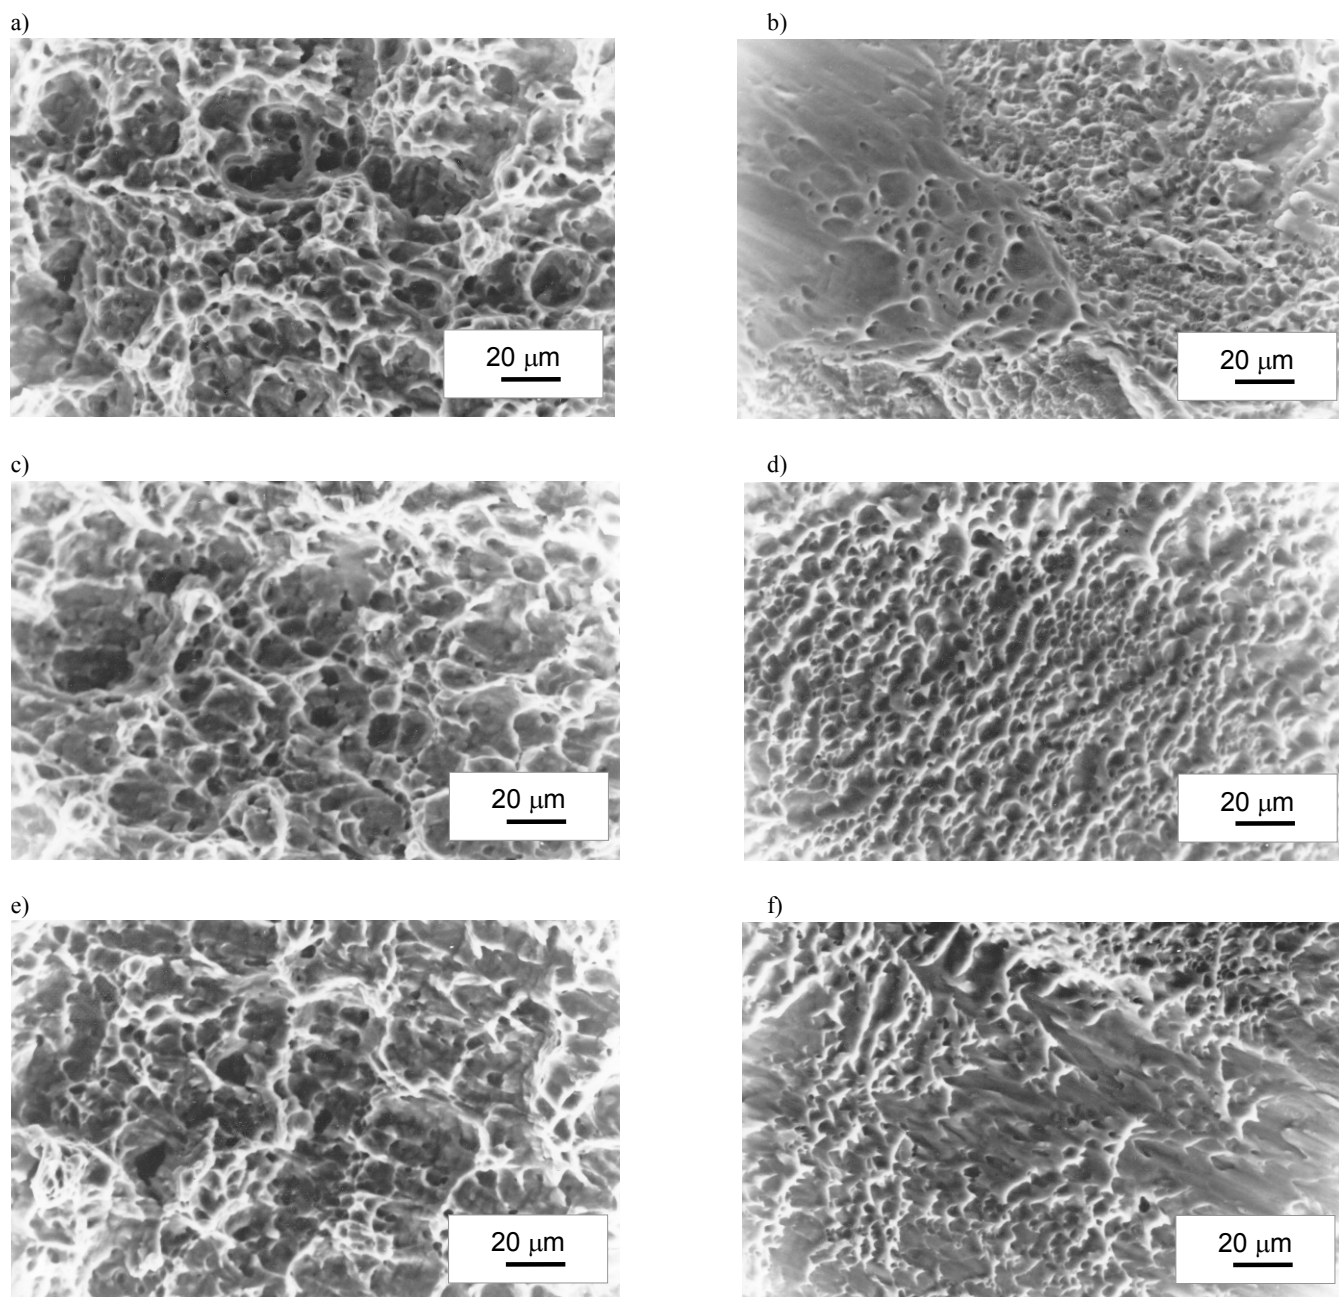
Fig. 8. Fracture of Ti6Al4V titanium alloy; a, c, e) of the basic material, b, d, f) in the weld, remelted zone
