ARCHIVES of FOUNDRY ENGINEERING

ISSN (2299-2944)
Volume 15
Issue 4/2015

Degradation of Creep Resistant Ni - Alloy During Aging at Elevated Temperature Part II: Structure Investigations

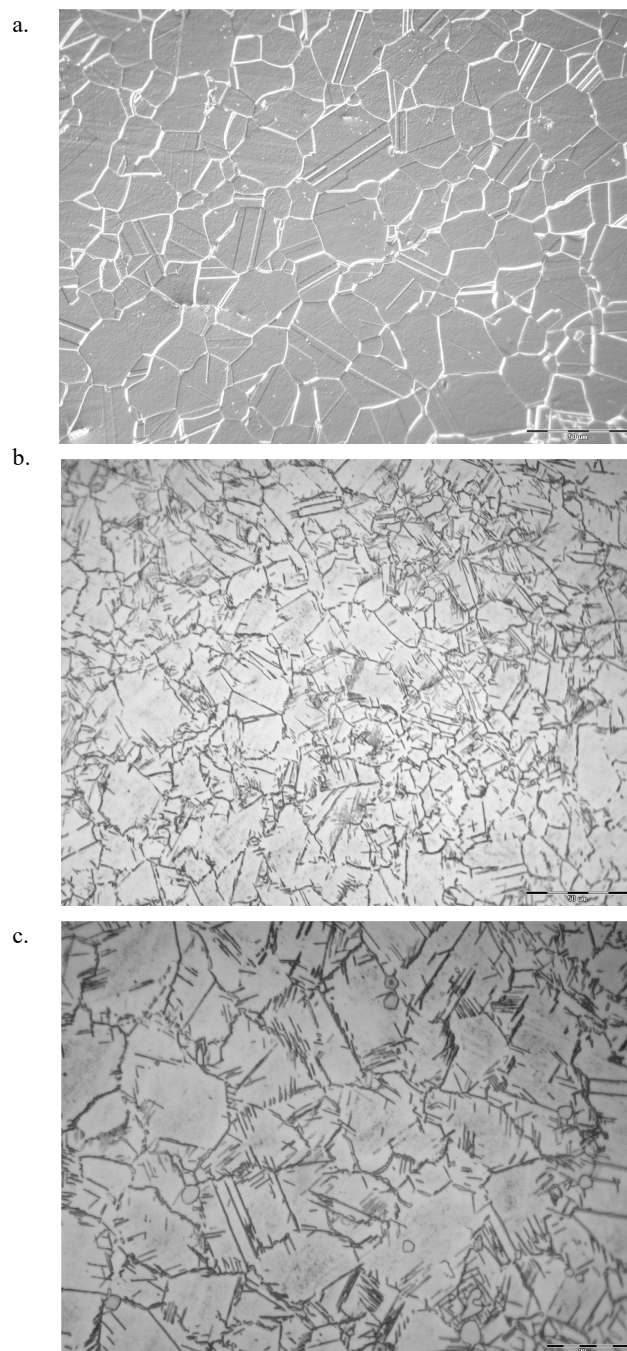
Fig. 1. The microstructure of the alloy after long-term aging at temperature: a - 750K (x500), b - 850K (x500), c - 850K (x1000)

In all three photos (fig. 1 a-c) characteristic twins are visible. The difference between photos are relative large needle-shaped precipitates observed in specimen subjected long-lasting aging at temperature 850K (fig. 1b and c). It is obvious that because too small magnification and resolution obtainable in light microscope no ultrafine precipitates strengthening phases γ' and γ'' are visible.

In fig. 1 the microstructure of studied nickel base heat-resistant alloy after long-term aging at temperature 873 and 973K is presented. As can be seen the structure is quite different.

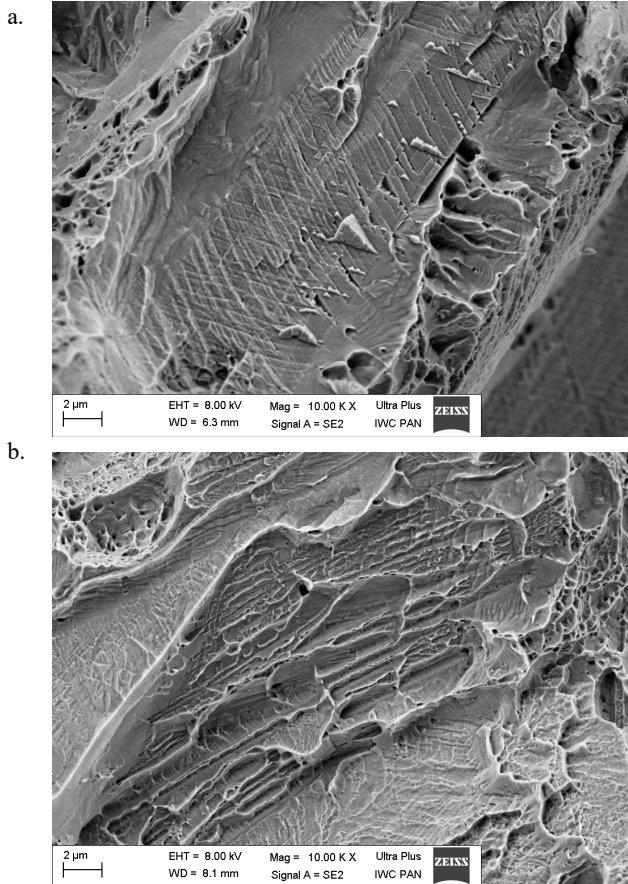
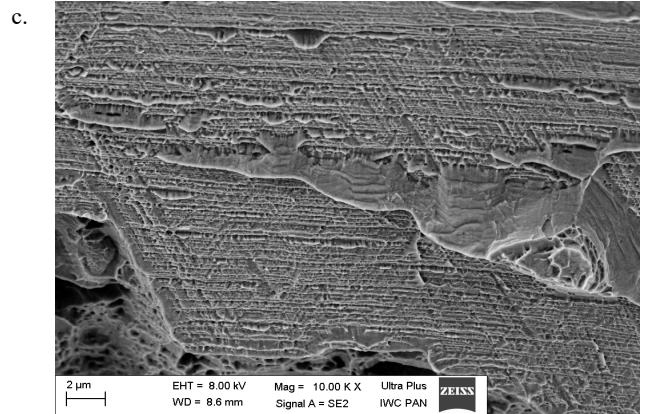
Fig. 2. The morphology of fracture surface of specimen aged at temperature 750K: a - sample 750- x_1 , b - sample 750- x_2 and c - sample 750- x_3

If take a look a little closer a large flat planes can be recognized in first set of micrographs (fig. 2). There is no question that some of them are transgranular cleavage planes with the characteristic river pattern lines (bottom part of fig. 2b) [4].

Besides in fig. 2a and b, small tongues typical for micro-twins are visible [4]. Except of these tongues, fine parallel intersecting lines can be identified in central part in fig. 2a. These can be interpreted as a slip steps formed by sliding dislocation emerging on the specimen surface during tensile test.

Fig. 2 and 3 show some examples of SEM investigations of the samples aged the same time but at different temperature. It is easy to see the different morphology of the fracture surface obtained in specimen broken in tensile test which were subjected long-term influence of high pressure of gaseous hydrogen and temperature. Before the results of SEM will be analyzed it would be convenient to introduce description of the specimen which included temperature and number identifying the distance from inner surface. For example symbol 750 - x_1 denotes specimen aged at temperature 873K taken from place located at $x_1 - 3,1$ mm while 850 - x_3 the specimen aged at 850K but cut from the place in the wall distanced $x_3 = 16,3$ mm from inner surface of the cylindrical chamber.

Brief evaluation of the fracture surface morphology showed in fig. 2 and 3 lead to the conclusion that character of fracture was a mixed mode. However, it can be suggested that fracture surface of the specimen aged at higher temperature looks to be a little more ductile (fig. 3) compare to that showed in fig. 2.

In this part we to concentrate on most essential and interesting results only. First of all it should be stated that the difference in temperature of long-term aging equal 100K leads to observable difference in mechanical properties of studied alloy (see part I). Moreover, the degradation of mechanical properties depends on the position (distance) of the material with respect to the hydrogen source which is the inner surface of the chamber. The most influenced properties of the Ni-based alloy are elongation and impact resistance. As can be seen from graph the (fig. 1c, d - see part I) the influence of hydrogen of elongation and impact resistance is function of the distance from hydrogen source and the higher the closer is the specimen being studied with respect to the inner surface of the chamber. It is not surprising because the hydrogen atoms when adsorbed will diffuse from the surface into the wall of chamber and the highest its concentration will be observed close to the inner surface. It is interesting, that despite substantial decrease of elongation (fig. 1c) the fracture surface exhibit ductile mode characterized by dimples with small contribution of cleavage (figs. 2 and 3). No brittle intergranular fracture was practically identified.

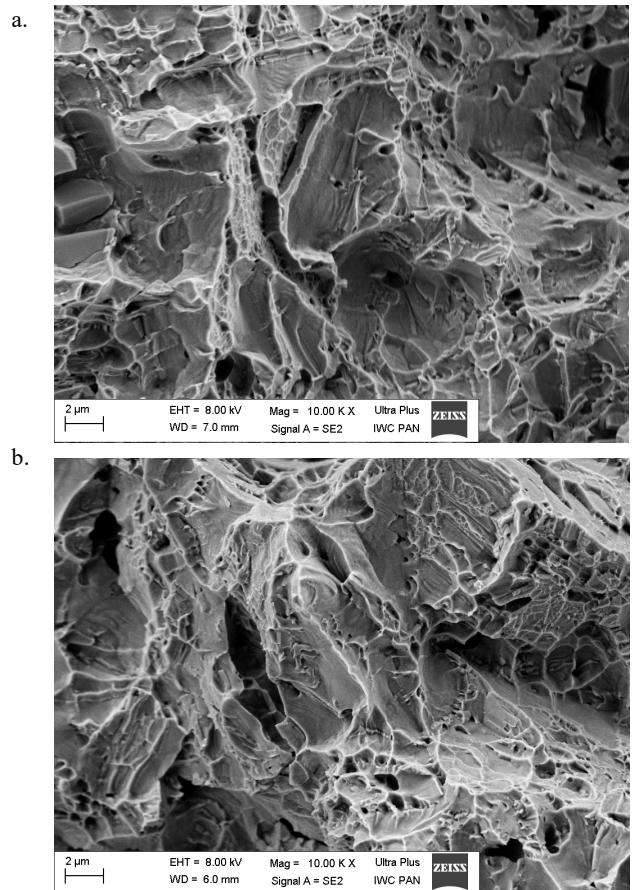
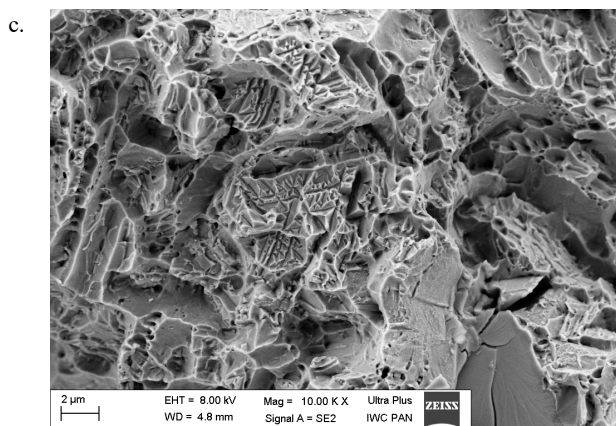
Fig. 3. The morphology of fracture surface of specimen aged at temperature 850K: a – spec. 850-x₁, b – spec. 850-x₂ and c – spec. 850-x₃

The fracture surface of specimens subjected to influence higher temperature is characterized with many relative deep dimples typical for ductile materials (fig. 3). Parallel to these dimples flat cleavage facets can be identified (see bottom right corner in fig. 3c). Moreover, broken brittle particles (see left side in fig 3a) and secondary cracks (fig. 3c) were also observed.

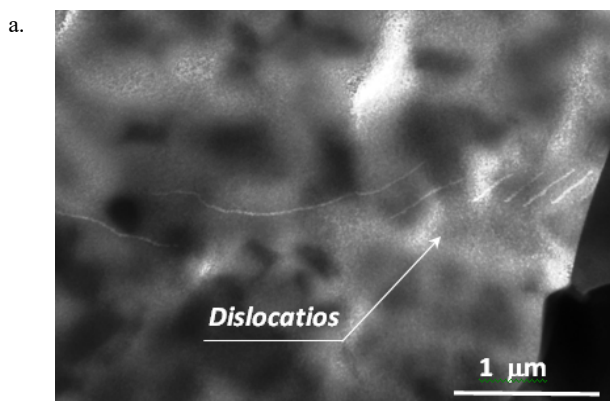
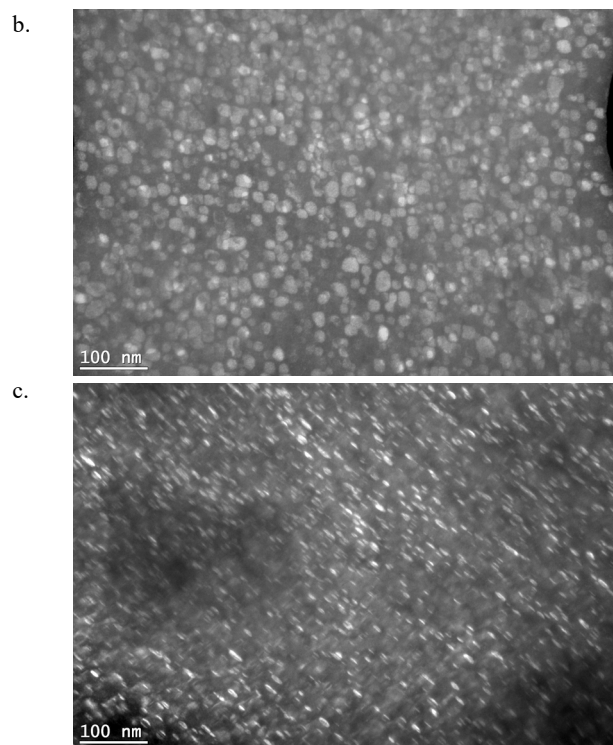
Fig. 4. The structure of alloy subjected to long-term aging at temperature 873K: a – spec. 750-1 (x150.000), b – spec. 750-2 (x250.000) and c – spec. 750-3 (x250.000)

In first photo (fig. 4a) weak beam dark field (WBDF) [5] micrograph showing a few dislocations is depicted. It should be noted that dislocations were rarely observed in this material, although the specimens were tilted in TEM in range of angles to bring the observed areas into correct Bragg condition assuring dislocation observations [6]. The next micrographs (fig 4. b and c) show very fine precipitate observed in dark field condition – DF [6]. In both pictures, size of precipitates is of about 30-50nm, which are probably γ'' and γ' mixtures. Some difference in shape of these precipitates follows from different orientation of disk shaped with respect to electron beam.

The first three micrographs (fig. 4) show the most typical structure of the material after long-term aging at 873K taken from specimen at different distance from inner surface of the chamber.

The next very interesting difference is dislocation structure of studied alloy. As was showed above the dislocations were seldom met in specimens cut from alloy aged at 750K while in case of alloy aged at temperature 850K appeared in high density forming dislocation cell structure (compare fig. 4a and 5b and c). Such observation can be explained by creep taking place at high aging temperature and high stress [9].

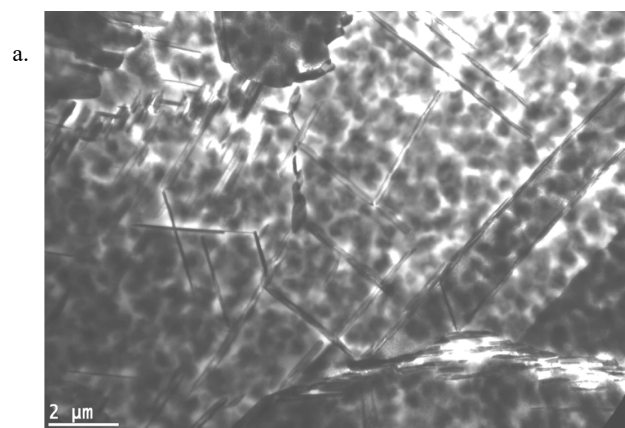
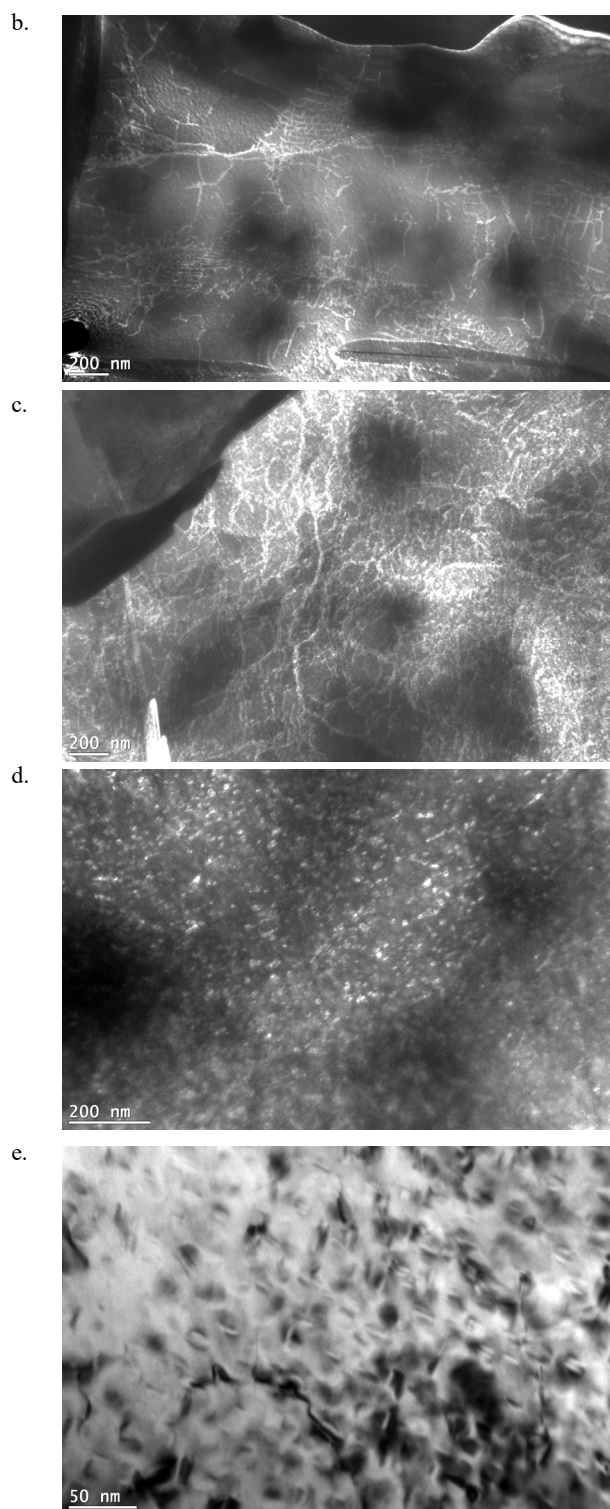
Fig. 5. The structure of the alloy to long-term aged at 850K: a – spec. 850-1 (x75.000), b – spec. 850-1 (x75.000), c – spec. 850-3 (x75.000), d – spec. 850-3 (x150.000) and e – spec. 850-3 (x500.000)

In next set of photos (fig. 5) the structure of alloy aged at temperature 850K is presented. It is easy to see that the structure of alloy aged at higher temperature is distinctly different from that aged at 750K. First of all large needle- or plate-like relative large precipitates are visible (fig. 5a). Contrary to the structure of alloy aged at temperature 750K where dislocations were rarely observed, here many dislocations forming array (fig. 5b) and dislocations cells structure (fig. 5c) are clear visible. Although the authors did not carried out qualitative assessment precipitation density it looks from fig. 5d that the density is lower compare to that observed in alloy aged at temperature 750K (fig. 4c). The last electron micrograph (fig. 5e) illustrates precipitates at very high magnification. The size of precipitates is of about 30-50nm, although the strain contrast is rather weak and the reason is probably not exact fulfillment of Bragg's conditions [7].

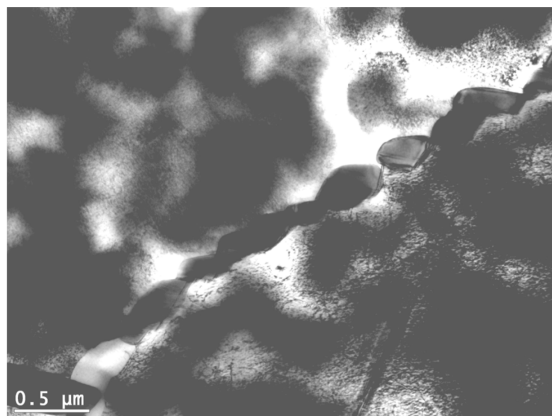
Fig. 6. The example of precipitates with morphology different from the most typical needle-like showed in fig. 5a (x50.000)
