E. MAZANCOVÁ*, D. OSTROUSHKO*, K. SAKSL**, A. NIESŁONY***

JOINT HYDROGEN SUSCEPTIBILITY OF 304 SS WELDED WITH TITANIUM

Keywords: 304 SS-Ti weld, fatigue, hydrogen response, phase analysis

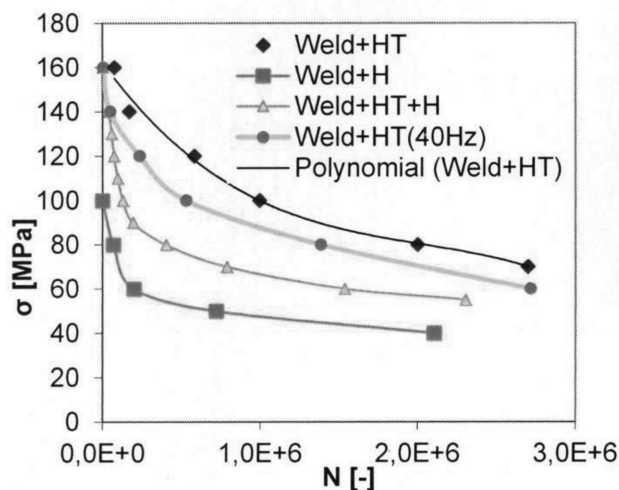
Fig. 2. Dependence of loading on number of cycles to rupture

Results of detected fatigue response are summarised in Fig. 2 and piece of information was presented recently [8]. As Fig. 2 demonstrates, bars after the HT without hydrogen showed the best threshold level at the highest load of 80 MPa while threshold level of the HT samples after hydrogen charging was shifted to 55 MPa and it corresponds to 68.8% life time of the samples without hydrogen charging. Threshold level of life time of samples without the HT and exposed by

hydrogen was lying on level of 40 MPa, representing 50% life time of uncharged samples. It demonstrates an important harmful hydrogen influence on embrittlement of bimetal bonding line, especially being in as-clad state, without the HT. The applied HT represents optimised HT mode being able to make the Ti matrix more homogeneous and to decrease internal stress formed during the explosive welding [13]. Life time of testing bars after the HT and hydrogen charging corresponded to 17% of the tensile strength of samples in as-clad state [8]. Of course, initiation mode of fatigue crack depends on rate of plastic deformation, hence on level of effective tension [19]. In studied case the cycling rate was constant. Beside structure homogeneity, grain sizes play also a role in initiatory stage of failure. Internal stresses formed during welding were decreased after the HT and Ti matrix was simultaneously homogenized and grain size slightly refined as it was presented recently [8]. The bonding line of any bimetal shows typical wavy character, according to the types of joined materials, velocity of clad material, angle of the running material and the explosive type [1, 7, 10]. All fatigue bars were broken in the weld or in curls of the welded area. All fracture surfaces of testing bars did show more or less wavy character as it can be seen in Fig. 3, in given case for hydrogen uncharged sample. At 40 Hz of cycling threshold level of the HT bimetal life time was by 10 MPa lower than at 20 Hz, as it Fig. 2 shows.

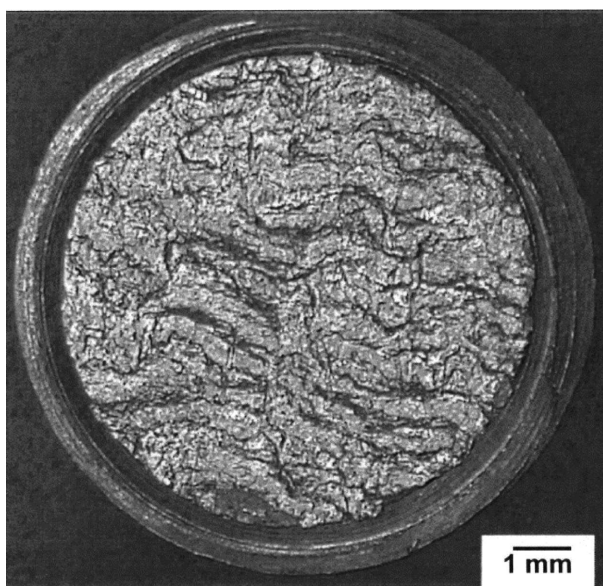
Fig. 3. Fracture surface of fatigue tensile test bar after the HT without H-charging

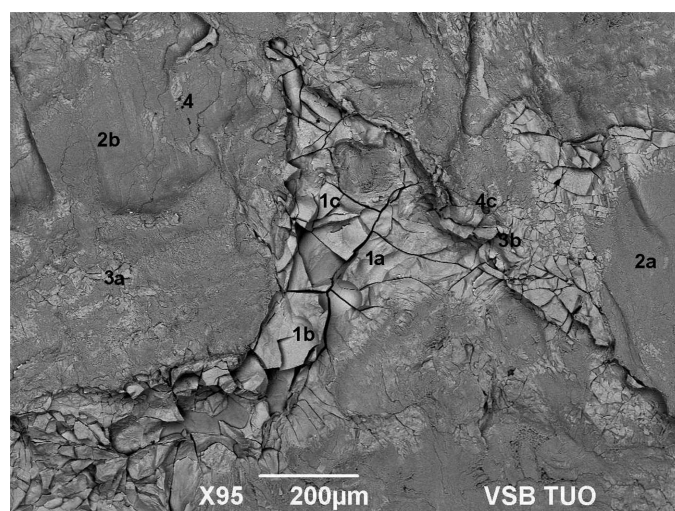
Fig. 4. Fracture surface micrograph showing cleavage fracture and micro-cracks propagation in fatigue bar after hydrogen charging without the HT. Titanium contents (EDA) in regions (1a, 1b, 1c) = 20 at. %, (2a, 2b) = 66 – 97 at. %, (3a, 3b) = 43 at. % and (4, 4c) = 100 at. %

By use of EDX the carried out EDA (energy dispersed analysis) proofed the fracture was preferentially realized in mixture matrix with high Ti content lying in the range from 66 to 97 at. % showing smooth dark surface areas (2a, 2b in Fig. 4) and/or secondarily in lighter grey surface marked as 3a, 3b (with approx. 43 at. % of Ti) in Fig. 4. The brightest smooth cleavage facets (areas 1a-1c in Fig. 4) were observed in minority, showed 20 at. % of Ti and 48 at. % of Fe and could indicate FeTi or Fe₂Ti presence. In curls of weld Manicandan [20] detected slightly higher portion of both elements, also by EDX. Revealed Ti and Fe portions lie in eutectic region of phase diagram for the intermetallic compounds FeTi

and Fe₂Ti. The SEM beam penetrates through sample surface to micro-meter depth and so the analysis is not so precise. Sporadic appearance of pure Ti was also analysed (see black spot 4 and 4b in Fig. 4). The presented results confirm that the cracks initiation and their propagation were predominantly realized in the region with the highest Ti portion as it was also observed in works [1, 8]. Analysis in section across the bimetal interface proved that chemical composition with 65-97 at. % of Ti corresponded to bonding line, whereas the approximately 40 and/or 20 at. % of Ti represented mixed phases situated in curls of the waves. At the interface of the curls and Ti matrix occurrence of practically pure Ti was detected. Consequently, the fatigue bars rupture predominately occurred just at bimetal interface and secondarily in area of mixed phases of curls. Neither un-welded spots nor cavities were detected at the 304 SS-Ti interface and/or close neighbourhood, which could negatively influence the fracture.

showed mixture of (in at. %) 16 Ti, 16 Cr, 57 Fe, 8 Ni and Al, Si and/or Mn balanced was revealed, while the area marked by number 4 consisted of (in at. %) 20 Ti, 11 Cr, 61 Fe, 6 Ni and Al or Si and/or Mn. The last two chemical compositions are similar to ones of areas 1a-1c in Fig. 4.

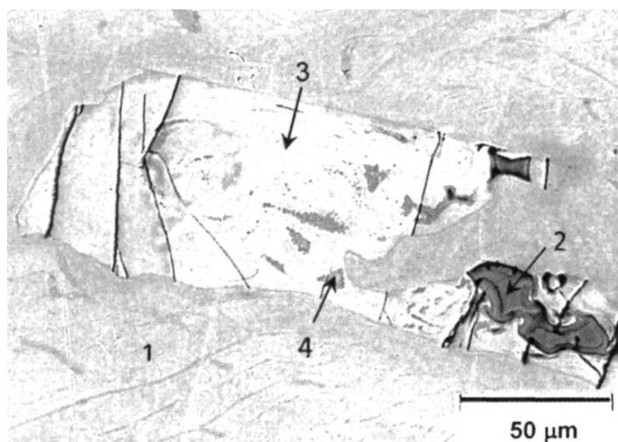
Fig. 5. Micrograph of section after the HIC exposition in NACE corrosive solution [17] with detected crack. Distinct grey regions represent different Ti content of bimetal wave curls (EDA). Mark 1 represents 304 SS, mark 2=90-100 at. %, mark 3=16 at. % and mark 4=20 at. % of Ti

Figure 5 shows SEM micrograph of the welded 304 SS steel with Ti after exposition in corrosive solution. Sample was slightly etched so that grey nuances as well as cracks would be better distinguished. The sinusoidal interface with curls orientated in direction of explosion is obvious. The cracks were detected only in area of mixed phases, mostly located just in curls. Propagation of cracks into basic 304 SS or into Ti was not revealed as it from Fig. 5 and/or from Fig. 6a, 6b follows. By use of EDX different grey regions were analysed. In Fig. 5 the number 1 corresponds to the basic 304 SS, number 2 practically represents Ti matrix (90-100 at. %), and number 3

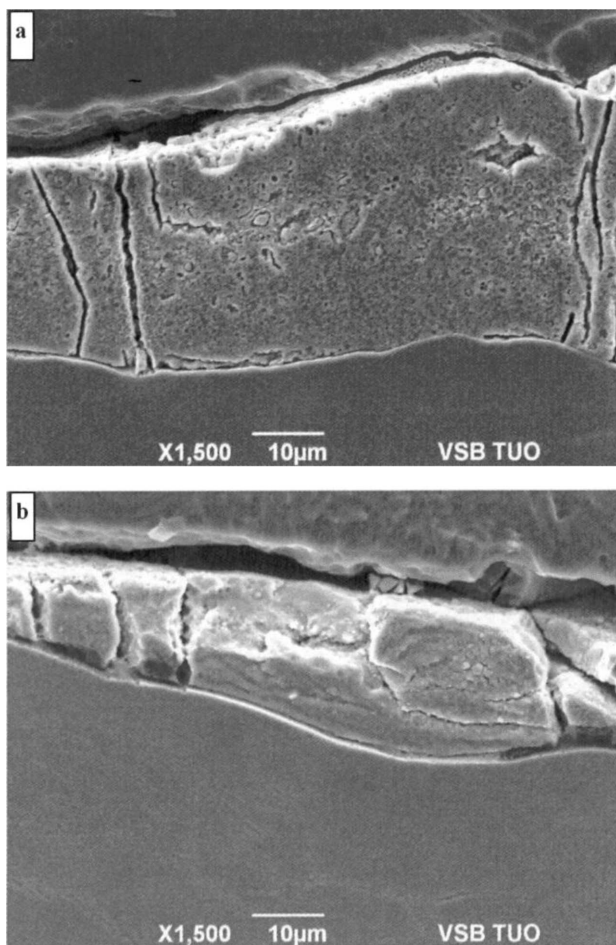
Fig. 6. a) Bimetal interface after HIC exposition without the HT – sample 3; b) Bimetal interface after HIC exposition with the HT – sample 3

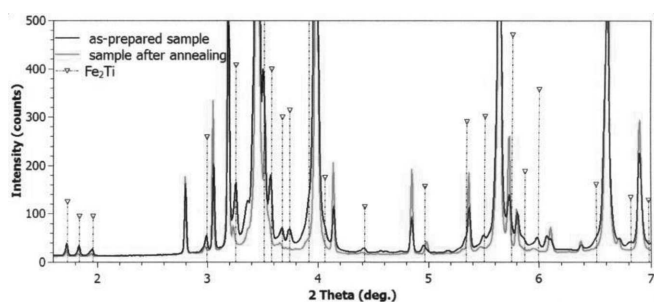
Fig. 7. XRD pattern from the interface area of bimetal 304 SS clad with Ti analyzed using synchrotron (P07) – compared materials without the HT and after the HT

By application of monochromatic synchrotron radiation, phase analysis confirmed at bimetal interface and/or in wave curls Fe_2Ti phase (both in as-received state and after the HT), beside presence of Fe-fcc, Fe-bcc and Ti-hcp, as it the first results indicated [16] and as it newly Fig. 7 demonstrates [21], unlike the results presented by Mousavi et al. [22, 23] who detected FeTi intermetallic phase simultaneously with Fe_2Ti , Fe_4TiO_2 , NiTi and Cr_2Ti under different explosive loads (R in range from 2.1 to 3.93), while Manikandan et al. [20] revealed in similar bimetal FeTi and Fe_2Ti only. They used EDX. Explanation of those differences can be in technology of own welding, which has been know-how of EXPLOMET-Opole. Their explosion conditions could be marked as medium. The Fe-bcc detection may be ascribed to strong plastic deformation during explosion developed by kinetic energy loss at the interface region, friction and shear of two welded materials followed by enormous cooling rate [24]. This leads also to partial melting of the wave crest regions and to a formation of intermetallic particles [4]. Presence of Fe-bcc could, in superposition with some other negatives, influence quality of the bimetal weld, e.g. decrease interface strength and degrade hydrogen response. Even when portion of that phase was sporadic next research pays deeper attention to this founding.
