APPLICATION OF INFRARED THERMOGRAPHY TO NON-CONTACT TESTING OF VARISTORS

Stanisław Galla, Alicja Konczakowska

Gdansk University of Technology, Faculty of Electronics Telecommunications and Informatics, Gabriela Narutowicza 11/12, 80-233 Gdańsk, Poland (✉ galla@eti.pg.gda.pl, +48 58 347 2140, alkon@eti.pg.gda.pl)

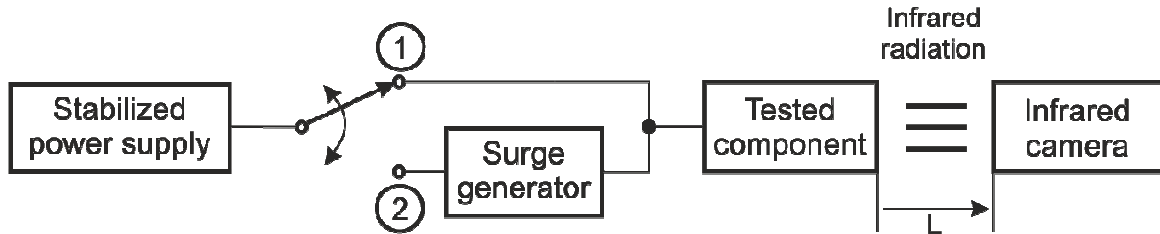
Fig. 1 presents the measurement circuit of varistors, during testing with a constant load (position 1 of the switch) and during testing with a surge generator (position 2 of the switch).

Fig. 1. Measurement circuit of varistors during testing, $L = 0.75$ m; position 1 of switch – measurement with constant load, position 2 of switch – measurement during surges.

The varistors were submitted to load testing in the circuit with a stabilized supply unit (Fig. 1, position 1 of the switch), enabling to obtain the following current values (flowing through the varistors):

First, testing of 10 varistors (5 of each type) with a surge generator was performed (Fig. 1, position 2 of the switch). The varistor thermograms were obtained during application of surges (every 20 s.) for 3 voltage levels: 500 V, 760 V and 1000 V; for each voltage level and each varistor every 5 s. The testing procedure is in accordance with the EN61000-4-5 standard. $N = 41$ measurements (thermograms) were performed with the infrared camera. The varistors were submitted to surges at different voltage levels; the interval between applying successive levels was 24 hours. The test results are compiled in Table 5 (P22Z1 type varistors) and Table 6 (S07K14 type varistors).

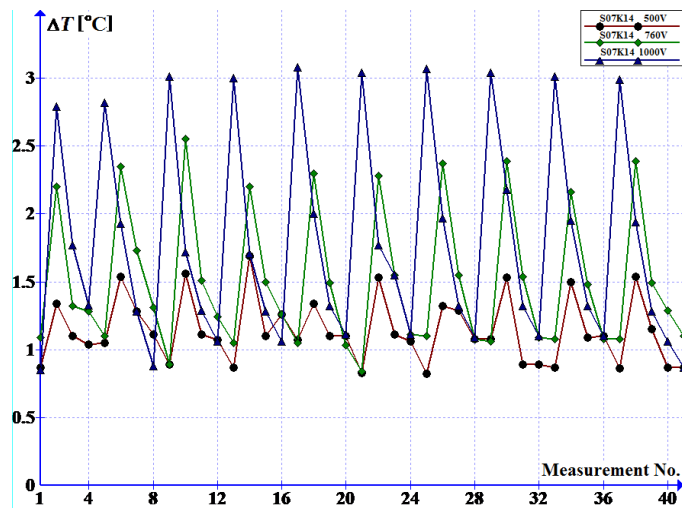
Fig. 3. Temperature increments ΔT recorded in successive measurements with infrared camera during application of surges at 3 voltage levels: 500 V, 760 V and 1000 V for varistor No. 5 of S07K14 type.

On the basis of recorded temperature increments, average values (for tested varistors) were assessed. The values were not exceeding 2°C, 3°C and 4°C for P22Z1 and S07K14 type varistors, for voltage surge levels of 500 V, 760 V and 1000 V (Fig. 2 and Fig. 3), respectively.

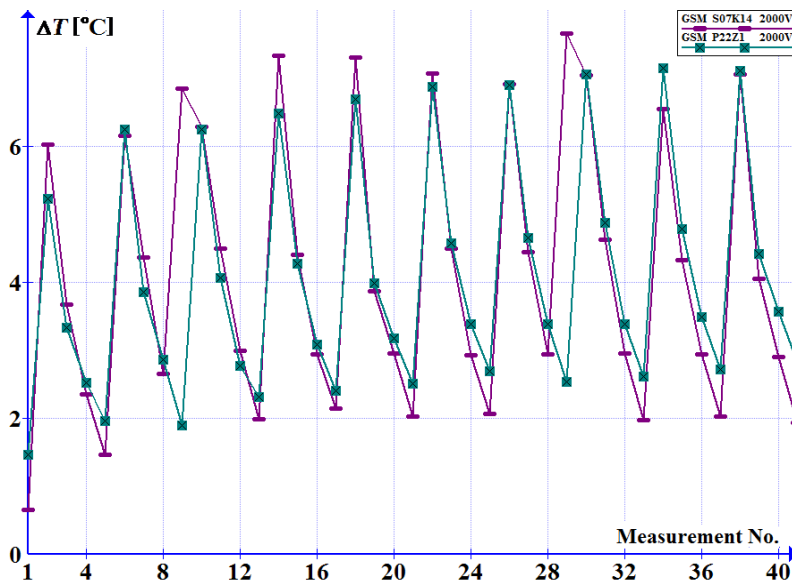
Fig. 5 illustrates that S07K14 type varistors showed a higher temperature increment (7.24°C) than the P22Z1 ones (6.3°C).

Fig. 5. Temperature increments ΔT recorded in successive measurements with infrared camera, during application of surges with 2000 V voltage level for P22Z1 and S07K14 type varistors operating in communication modules No. 3.

The recorded temperature increments for surges with 500 V, 1000 V and 2000 V levels were equal to 1.3°C, 3.15°C and 6.3°C for modules with P22Z1 type varistors, and 1.35°C, 3.52°C and 7.24°C for modules with S07K14 type varistors. The capacitance values of varistors submitted to surges with voltage levels of 500 V and 1000 V, measured 24 hours after completion of tests, have not changed significantly, i.e. to the point that corresponds with losing protective properties by varistors. Thus, it can be stated that the varistors have not changed their protective properties. The temperature increment values on the varistor surfaces have not also suggested loss of protective properties by varistors, i.e. they have not exceeded 6°C. However, the capacitance values of varistors operating in modules No. 3 submitted to surges with the 2000 V voltage level, measured 24 hours after completion of tests, have increased considerably. The temperature increment values on the varistor surfaces were higher – from the 20th measurement on – than the values suggesting loss of protective properties of varistors, i.e. exceeded 6°C (Fig. 5).

The level of changes in capacitance values and temperature increment values for varistors operating in modules No. 3 suggests recommending their replacement with other varistors before launching the GSM modules into the market.
